Effect of laser shock processing on erosive resistance of 6061-T6 aluminum

Abstract: Application of laser shock processing (LSP) on 6061-T6 aluminum was made in order to evaluate its response to the erosive wear by silica sand. Impact angles of 15°, 30°, 60° and 90° were tested, two particle speeds (37 and 58 m/s) and two LSP irradiation conditions were used. Erosion marks were characterized by 3D profilometry and SEM analysis was conducted to identify the erosion mechanisms for each tested angle. The results showed a maximum erosive wear at low impact angles (ductile type behavior). Erosion strength and the erosion mechanisms were not affected by the application of LSP and they were attributed to the high strain rate of the erosion phenomena. A few differences encountered on the erosion plots were explained on the basis of the surface roughness left by the LSP process. The maximum mass loss and the maximum erosion penetration happened in different impact angles (15° and 30°, respectively). Finally, a well-defined erosion mechanism transition was observed, from cutting action at low impact angle, to crater formation at 90° of incidence.

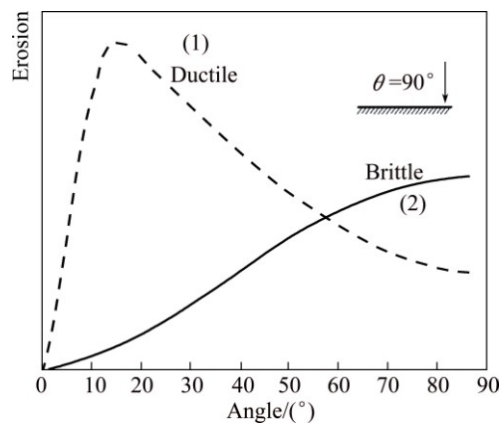
Fig. 1 Ductile (1) and brittle (2) erosive wear behaviors

Erosive wear occurs due to the repeated impacts of erodent particles in a fluid flow hitting the surface of the material; for example, the aircraft turbine blades while flying through dust clouds [3], thermal power plants and pneumatic transport systems [4], fossil energy plants [5] and carbon processing plants [6]. Erosive behavior can be classified as ductile or brittle, depending on the angle that maximum erosion occurs, as shown in Fig. 1. When the maximum erosion occurs at low impact angles, the material has a ductile behavior; if it occurs at high angles close to 90°, it has a brittle behavior [7].

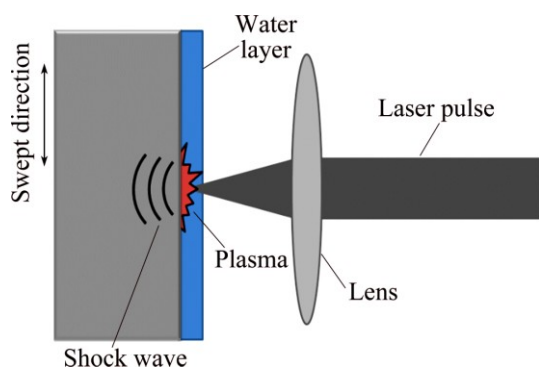
Fig. 2 Schematic of laser shock processing (LSP) principle

materials. The possibility to focus a laser beam over a metal surface, allows local treatments to be carried out, in order to improve the properties of bulk material [8]. Laser shock processing (LSP) is a surface treatment technique used for a wide number of metal and alloys; which was first recognized and explored during the decade of 1960 [9]. This treatment occurs when a high density laser beam impacts the surface of a metallic material [10] generating an expanding plasma due to the solid to vapor transformation on the surface of the material. This plasma generates a shock wave that causes residual stress up to a few millimeters depth in the material, as shown in Fig. 2, as happens in LSP treatments on 6061-T6 aluminum [1,11,12]. Improvements of properties due to LSP treatments have been widely demonstrated in materials such as titanium, copper, aluminum alloys and steels [13]. One of its most important uses is in aeronautic and automotive industries; its benefits are related to fatigue, corrosion and wear resistance [11].

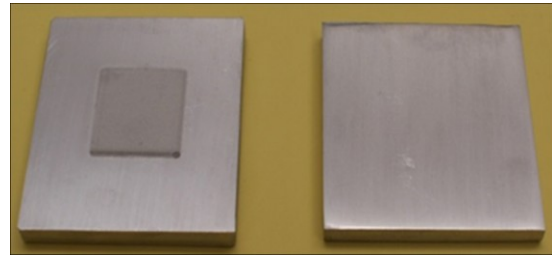
Fig. 3 Specimens with and without LSP treatment

oblique impact. One batch of specimen was surface finished to a roughness less than 1 μm . A second batch of specimens were LSP treated, these were not ground because this process is able to change the residual stress state induced by the surface LSP treatment and they were tested in the as-obtained condition. Its average R_a roughness was 8.2 μm . Figure 3 shows the specimens with and without LSP.

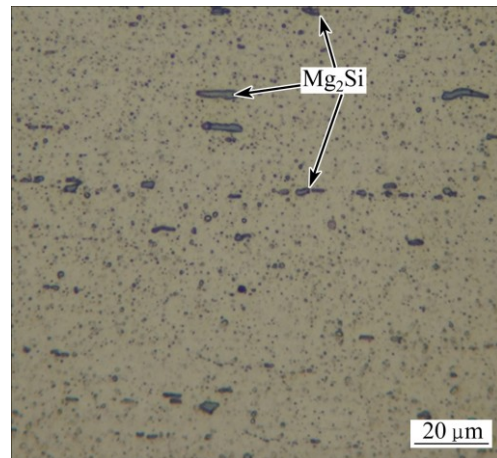
Fig. 4 Typical microstructure of 6061-T6 aluminum alloy

Microstructure was obtained using Barker's reagent, which is composed of 85 mL H₂O, 10 mL H₂SO₄ and 5 mL HF. Microstructure shows an aluminum matrix with Mg₂Si precipitates [18], as shown in Fig. 4.

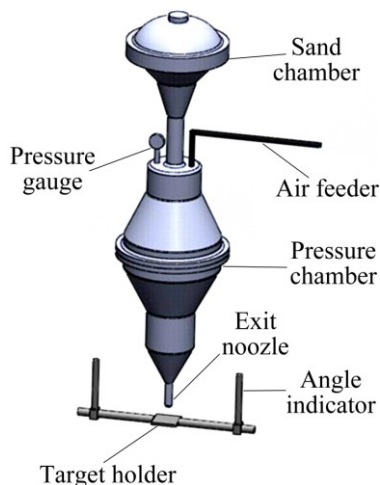
Fig. 5 Schematic of erosion testing machine

Erosion tests were carried out according to ASTM G76–95 [21] using a sand-blast type machine, which is schematically shown in Fig. 5. On this configuration, sand is poured into a superior chamber that allows the sand to pass to an inferior chamber where a pressurized mixture of air and sand is generated. The mixture travels through an outlet nozzle to hit the specimen which is tilted to a specified angle. Impact distance was set to 25 mm. Nozzle inner diameter was 2 mm and it was replaced when it increases in 10% according to Ref. [21]. 150 μm silica sand was used as erodent, its morphology and particle size are shown in Fig. 6. Dry air flux with a dew point of -45 °C was used as carrier fluid. Specimens were impacted at 15°, 30°, 60° and 90° and blow pressures of 6.895 and 20.685 kPa. Each condition was repeated at least 3 times obtaining an average error of 3.2%.

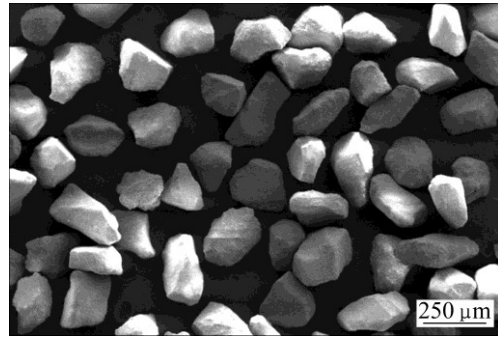
Fig. 6 Size and shape of silica sand

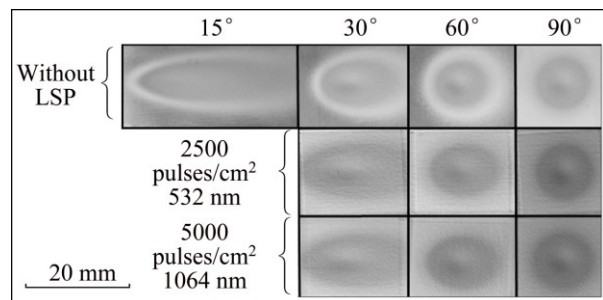
Fig. 7 Erosion wear marks

Figure 7 shows photographs of the wear marks generated by the silica sand impacts for each angle and pressure used. At 15° and 30° impact angles, an elliptical shape mark is created with an eccentricity of 0.93 and 0.81, respectively; at a 60° impact angle, the mark is still elliptical but with a decrement in its eccentricity of 0.43; and at 90° impact angle, the erosion mark has a circumferential shape. In all cases, pressure did not have influence on the shape of the generated mark.

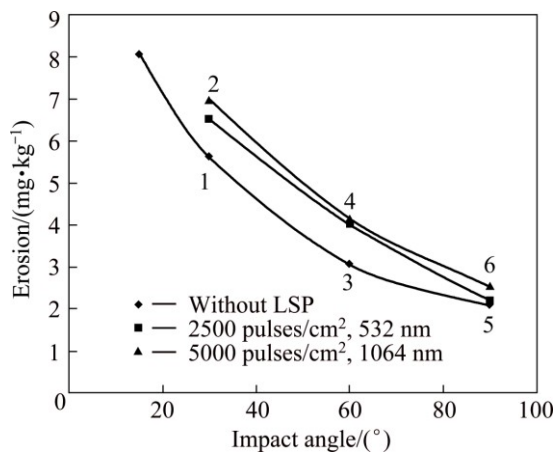
Fig. 8 Plot of erosion vs impact angle at blow pressure of 6.895 kPa

In all cases, a ductile behavior was observed. Figure 8 shows an erosion rate vs impact angle at 6.895 kPa drag pressure for both specimens with and without LSP. It can be observed that there is a decrease in erosion strength of the specimens treated with LSP, mainly in the 5000 pulses/cm² condition ($\lambda=1064$ nm). The biggest difference in erosion rate as a function of the impact angle (Points 1 and 2 in Fig. 8) was observed at 30°, followed by the 60° impact angle (Points 3 and 4) and finally, there is a convergence in erosion values when approaching to normal incidence angle (90°).

The difference in erosion of the samples impacted at 30° shown in Fig. 8 (Points 1 and 2; 0.0015 g), can be explained on the basis of the initial roughness of the LSP treated sample (8.2 μm , R_a). For this specimen, the surface presented hills and valleys as shown in Fig. 9 and for this angle the initial roughness is important because the erosion mechanism has a large amount of cutting action. This cutting action is the result of a major tangential component during the impact, capable to cause larger mass detachment in a material that presents ductile behavior as it is shown for this case. The cutting capability decreases as the impact angle increases.

Similarly, in the case of 60° impact angle (points 3 and 4 in Fig. 8) with an eroded elliptical surface area shown in Fig. 10(d), the mass calculated of the hills and valleys is 0.0010 g, which is very close to the mass difference 0.0011 g.

At 90° (points 5 and 6 in Fig. 8), the mass calculated is 0.0004 g and similarly it can be explained by the minor eroded area, as shown in Fig. 10(f), but mainly because this impact angle does not have the tangential component, then, the initial surface condition shown in Fig. 9 has a lower effect. That is, the hills formed by the LSP treatment are easier to remove for a low impact angle. At 90° impact angle only craters are formed, as it will be discussed in Section 3.3. The lower wear values for the ductile behavior is explained by the fact that the normal impact expends a lot of energy in such a plastic deformation that not necessarily detaches metal.

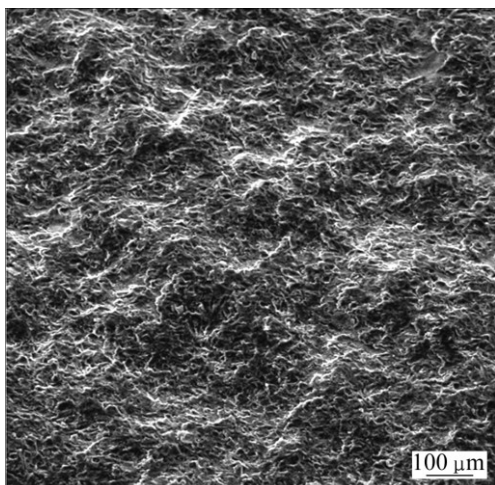
Fig. 9 Roughness after LSP treatment

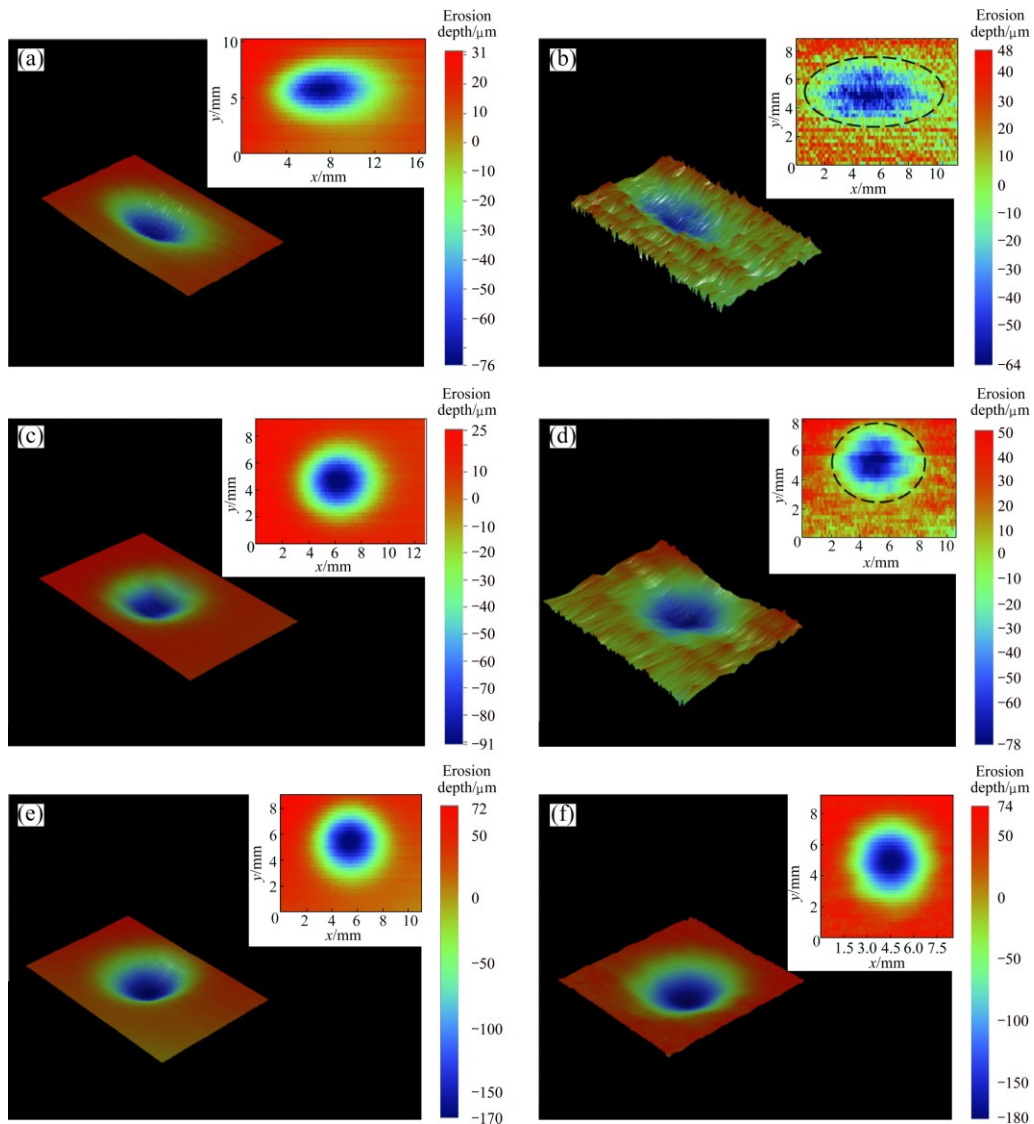
Fig. 10 Erosion marks at 30° impact angle (a, b), 60° impact angle (c, d) and 90° impact angle (e, f): (a, c, e) Without LSP; (b, d, f) With LSP

Figure 10 shows 3D images of the topography and maximum erosion depth of specimens tested at 30°, 60° and 90° at 6.895 kPa pressure. The eroded mass due to the initial surface roughness can be calculated based on the erosion mark ellipse (Fig. 10(b)) with the depth between the hills and valleys of 31.9 μm (see Fig. 11). For the 30° impact angle, a mass of 0.0014 g is obtained, which is comparable with the difference in erosion mass of 0.0015 g for this case.

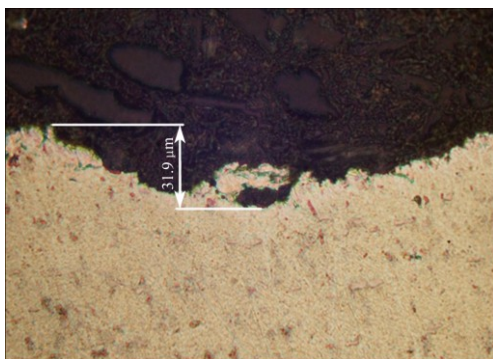
Fig. 11 Roughness after LSP treatment

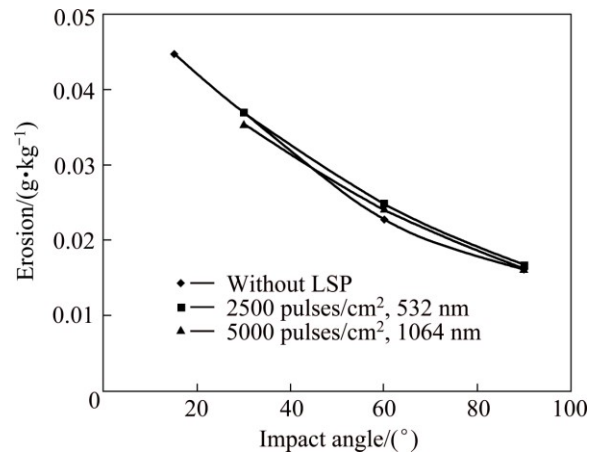
Fig. 12 Plot of erosion vs impact angle at 20.685 kPa blow pressure

Figure 12 shows that no difference exists between erosion amount for specimens with and without LSP treatment, at 20.685 kPa blow pressure for each impact angle. For this case, the erosion rate at lower impact angles did not show a significant difference. The ratio of total removed mass to the contained mass in the hills and valleys by the LSP is in the order of 24 times which makes the initial surface effect negligible.

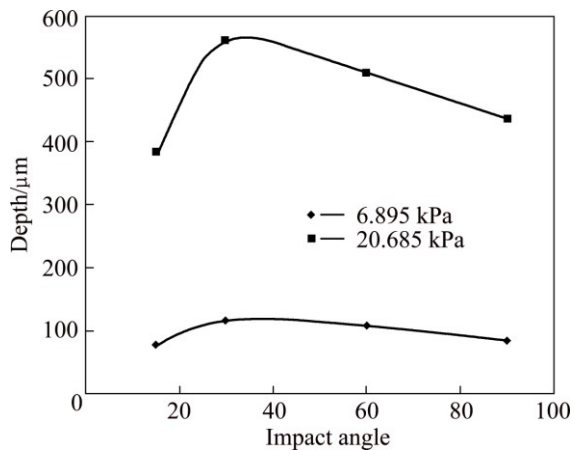
Fig. 13 Maximum erosion depth penetration on specimens without LSP treatment

Figure 13 shows the maximum erosion depth penetration for both impact particle speeds of 37 and

58 m/s (6.895 and 20.865 kPa, respectively). It is observed that the maximum penetration values occurred at 30°, whereas the 15° angle corresponds to the maximum mass loss. Then, there is no correspondence between the angle of maximum erosion and the angle of maximum penetration depth, which is important for applications where the thickness loss defines the useful lifetime of the metallic component.

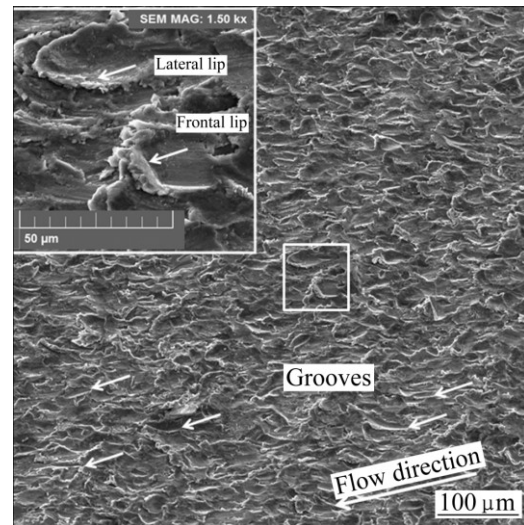
Fig. 14 Erosion surface without LSP treatment at particle speed of 58 m/s (6.895 kPa blow pressure) and 15° impact angle

Figure 14 shows the erosion caused by impacts at 15°, it can be noticed that cutting action made by erosive particles is the main reason of material removal typical for impact at low angles. The tangential component of the particle speed has a greater contribution than the normal component, generating the formation of grooves with some plastic deformation in lateral lips shape or frontal lips shape in the erodent flow direction.

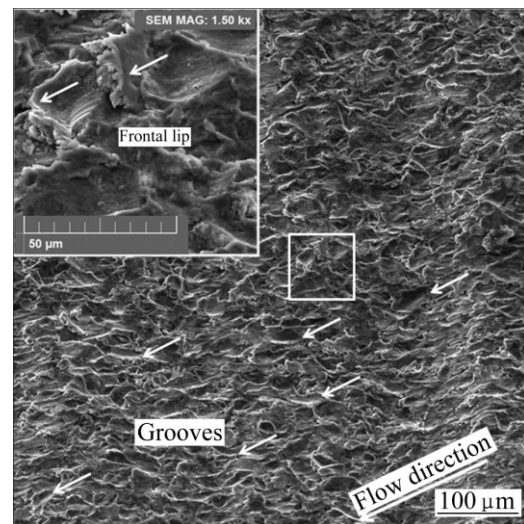
Fig. 15 Erosion surface without LSP treatment at particle speed of 58 m/s (20.685 kPa blow pressure) and 30° impact angle

Figure 15 shows the erosion mechanism caused by 30° angle impacts. In comparison with erosion at 15°, it can be noticed that cutting action has decreased but the formation of grooves is still part of the erosion mechanism, but these are shorter. However, plastic deformation has increased considerably in the form of lateral and mainly frontal lips which are susceptible to be detached by subsequent impacts.

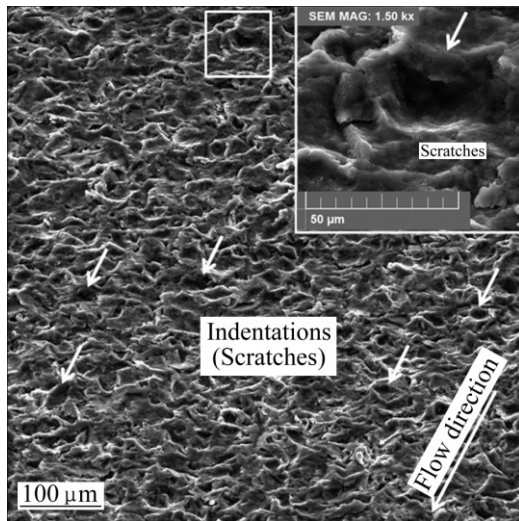
Fig. 16 Erosion surface without LSP treatment at particle speed of 58 m/s (20.685 kPa blow pressure) and 60° impact angle

The erosion surface at 60° impact angle is shown in Fig. 16. There is a considerable increment of the plastic deformed material, in such a grade that the groove

mechanism is not clearly identified. Some indentations with a symmetrical shape can be noticed, which can be attributed to the erosion ellipse eccentricity close to the zero value.

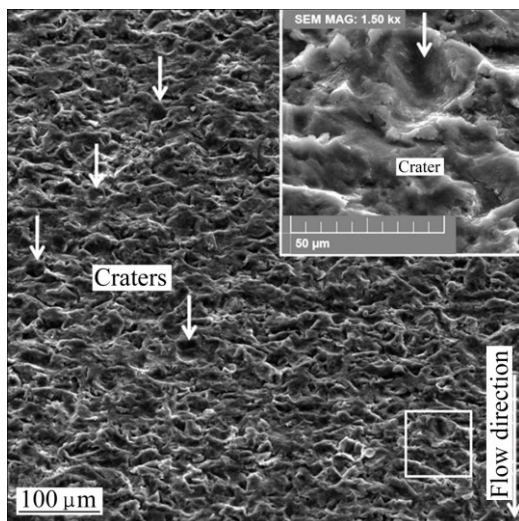
Fig. 17 Erosion surface without LSP treatment at particle speed of 58 m/s (20.685 kPa blow pressure) and 90° impact angle

Figure 17 shows the erosion surface at 90°. Because there is only normal component of the particle speed, it causes damage on the surface by the formation of craters and displacement of material around the impact point. Subsequent impacts cause the detachment of ulterior material which is the principal wear mechanism typical for ductile materials at this erosion angle.

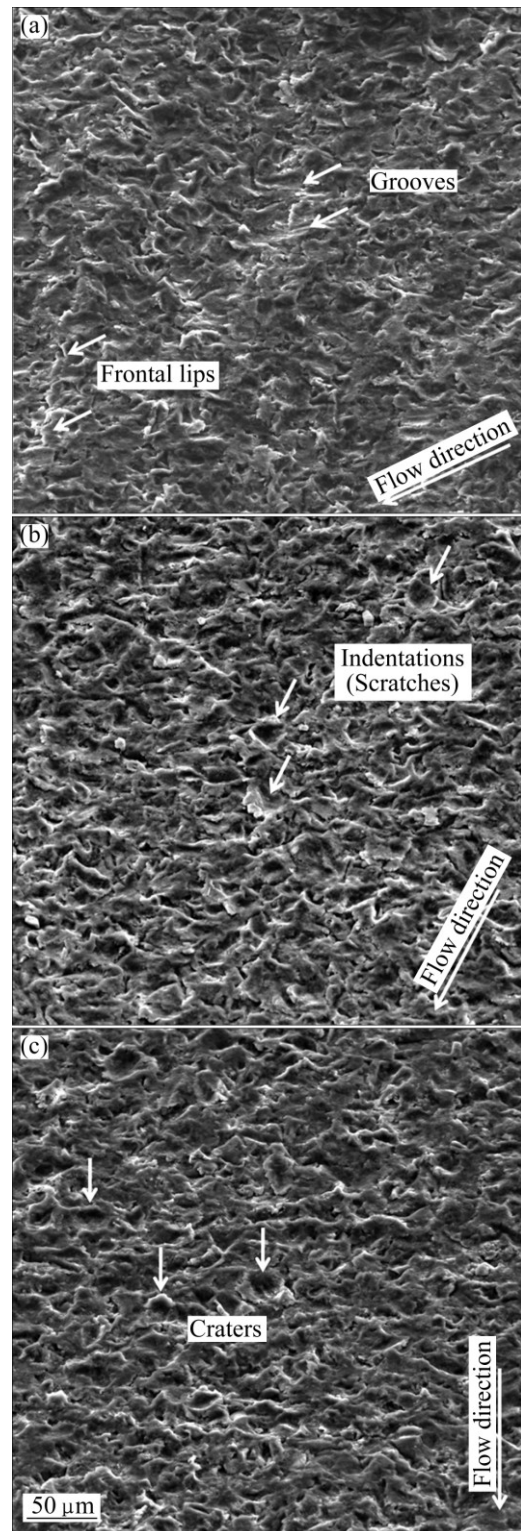
Fig. 18 Erosion surface with LSP treatment at particle speed of 58 m/s (20.685 kPa blow pressure): (a) 30°; (b) 60°; (c) 90°

Figure 18 shows the erosion mechanisms for the case of the LSP treated samples. There was no difference found on the wear mechanism in specimens with and without LSP at the two particle speeds used. This result is attributed to the adiabatic conditions of high strain rate of the erosion phenomena, as it was explained previously.
