Effect of flame rectification on corrosion property of Al–Zn–Mg alloy

Shuai LI, Dan GUO, Hong-gang DONG

Abstract: The corrosion resistance of Al–Zn–Mg alloy subjected to different times in flame rectification was investigated based on the exfoliation corrosion test. The results indicate that the flame rectification deteriorates the exfoliation corrosion resistance of Al–Zn–Mg alloy. The corrosion resistance of Al–Zn–Mg alloy is ranked in the following order: base metal>two times>three times>one time of flame rectification. The exfoliation corrosion behavior was discussed based on the transformation of precipitates at grain boundaries and matrix. With increasing the number of times in flame rectification, the precipitate-free zones disappeared and the precipitates experienced dissolution and re-precipitation. The sample was seriously corroded after one time of flame rectification, because the precipitates at grain boundaries are more continuous than those in other samples.

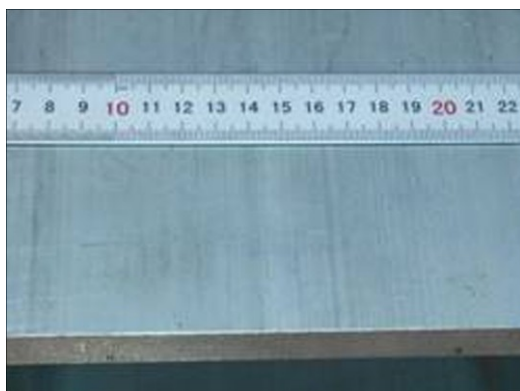
Fig. 1 Profile of as-supplied Al–Zn–Mg alloy

The base material used in this work was 10 mm-thick extruded Al–Zn–Mg alloy plate in T5 condition, as shown in Fig. 1. The chemical composition and some basic properties of this alloy are listed in Table 1 and Table 2, respectively. The samples were heated using oxygen–propane flame to 350 °C (± 10 °C) for different times, and the details are listed in Table 3. The temperature of heated samples was measured by a Tempilstic temperature pen (TS0350) during flame

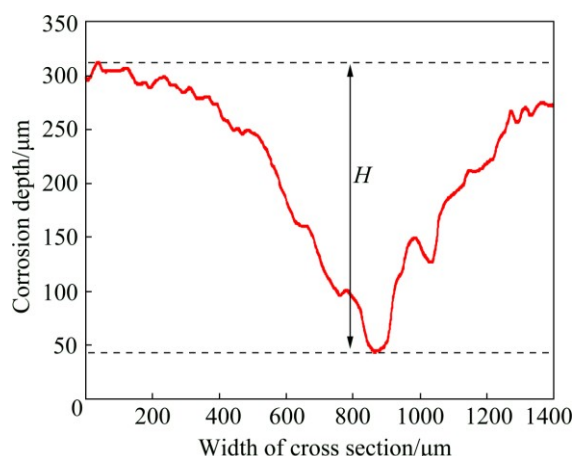
Fig. 2 Height variation curve of cross section

According to the Chinese National Standard GB/T 22639–2008, the samples in dimensions of 100 mm \times 35 mm \times 10 mm were prepared for exfoliation corrosion test [24]. The exfoliation corrosion solution was prepared by following steps: Dissolve 234 g of reagent grade NaCl, 50 g of KNO₃ in distilled water, and add 6.3 mL of concentrated HNO₃ (70%) then dilute to 1 L. So, the solution contains 4.0 mol NaCl, 0.5 mol KNO₃ and 0.1 mol HNO₃. The specimens were immersed in the corrosion solution for 48 h with the temperature maintained at (25 \pm 2) °C. The exposed area is 35 cm², and the ratio of solution volume to metal surface is 35 mL/cm². The surface morphologies after immersion test were examined by scanning electron microscopy (SEM). Moreover, the corrosion resistance was evaluated by a confocal laser scanning microscope (CLSM). In order to quantitatively analyze the corrosion susceptibility of the specimens, the average height difference was measured based on the CLSM pictures. To obtain the height difference along *X*-axis, the cross sections paralleling to *X*-axis were obtained (the cross sections were equidistant), then the height difference was acquired through the height variation curves, as shown in Fig. 2. Ten different areas with the sizes of 2560 μ m \times 2560 μ m of the specimens were measured, then the average of height difference was calculated. Similarly, the height difference along *Y*-axis was obtained.
