Effect of heat treatments on failure mechanism of SiC_p/2124 Al composite^①

Abstract: The mechanical response of a 17% (volume fraction) silicon carbide particles reinforced 2124 Al composite prepared by powder metallurgy techniques was studied by altering the matrix strength with different heat treatments. The fracture mechanisms and the deformation microstructure were examined by scanning electron microscopy. The results show that matrix strength appears to play an important role in influencing the behaviour of the composite under hardness and tensile loading conditions and also fracture mechanisms. The high matrix strength results in a larger decrease in yield strength due to the increasing damage probability. The tensile yield strength values decrease under peak aged and overaged condition whereas under the solutionized condition the opposite effect can be seen.

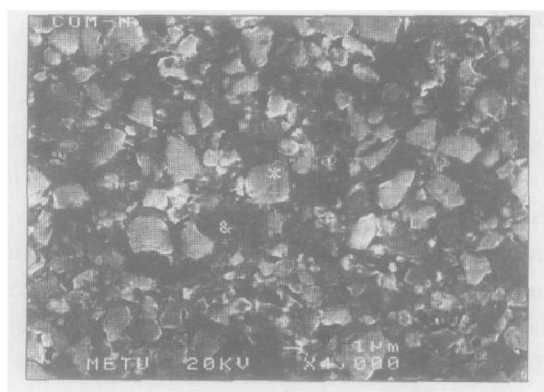
Fig. 1 SEM fractograph of composite material

loy powders blended with 17% of abrasive grade SiC particulate had irregular shapes with sharp corners. The average size of the SiC particulates was 3 μm . The production route began with baking of the SiC_p to drive off excess moisture followed by blending of the weighed powder constituents, cold compaction into cons, vacuum degassing, hot isostatic pressing at 500 °C, hot forging at 475 °C and hot rolling at 475 °C. The chemical composition and microstructure of materials are given in Table 1 and Fig. 1, respectively.

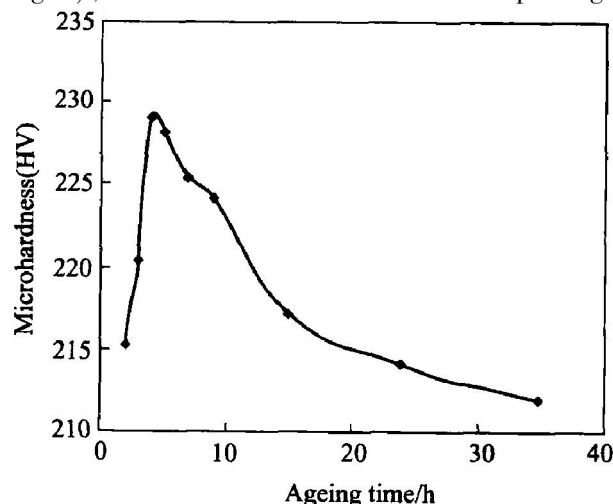
Fig. 2 Variation of hardness value as function of ageing time for composite material

In order to determine the optimum time of the peak and overageing, different duration was determined for ageing time after solution treatment for the same ageing temperature. According to the macrohardness measurement taken on the aged samples at an ageing temperature of 190 °C (Fig. 2), 4 h and 24 h were decided as peakageing

and overageing time, respectively.

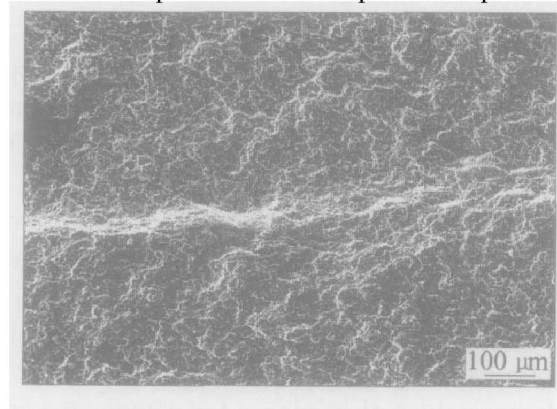
Fig. 4 SEM fractographs for presence of reinforcement free region on fractured surface section under as-received condition

by small reinforcing particles after the blending and hot isostatic pressing process^[12]. This is the case for the MMCs with large matrix: reinforcement particle size ratios, i. e. containing 3 μm in diameter of SiC_p . So, the fracture surface of the MMCs with these features also shows localized areas of a delamination type failure between the layers of reinforcement free material and the layers of reinforcement rich material either side of them. A proposed mechanism of formation and failure of these delaminations is shown in Fig. 5^[12]. It can be seen that a prior matrix powder particle is

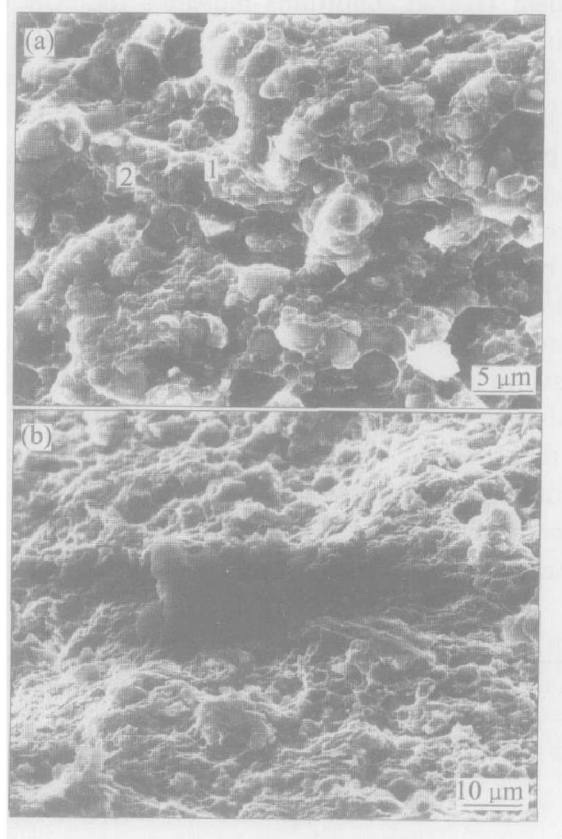
Fig. 3 SEM fractographs under as-received condition

- (a) —Fracture surface of composite material;
(b) —Coalescence of voids

Examination of the fracture surfaces of failed tensile specimens reveals the mechanisms of failure in these MMCs. Fig. 3 shows the fracture surface of the tensile specimen under as received condition. The dimples (marked as 2 in Fig. 3(a)) are formed due to failure of the matrix between the reinforcing particles. The failure of the material is by coalescence of voids (Fig. 3(b)) nucleated by the fracturing of reinforcing particles (marked as 1 in Fig. 3(a)). This is in agreement with previous findings. In this case, many of the dimples contained whole reinforcing particles indicating that void nucleation is caused by decohesion between the matrix and reinforcing particles. This is again in agreement with the previous results. These fracture surfaces also reveal a number of interesting features which suggest changes in failure mechanisms with variations in local spatial distribution of the reinforcing particles. Fig. 4 shows the SEM micrograph of the fractured surface section of an as-received MMC material, indicating the presence of such reinforcement free layers. These layers are caused by rolling flat large matrix particles which are highly necklaced

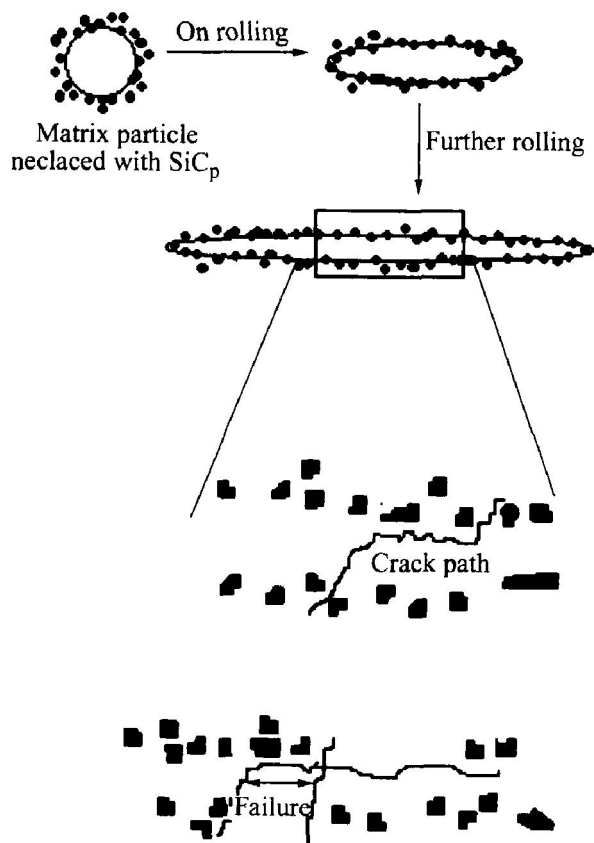
Fig. 5 Schematic diagram for formation and failure of thin layers of matrix between layers of SiC_p rich material in MMCs

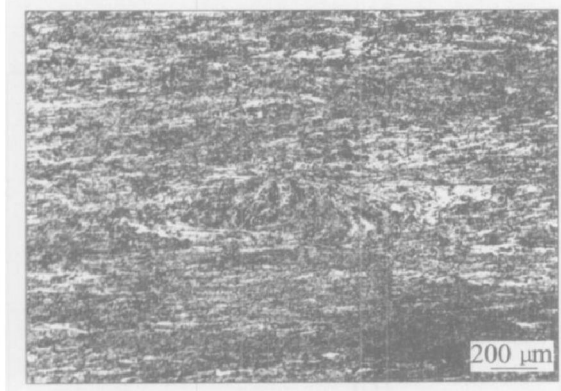
Fig. 6 Optical micrograph for thin layers of matrix between layers of SiC_p rich material just beneath fracture surface under as-received condition

necklaced by small reinforcing particles, which becomes elongated and thinner during rolling such that it becomes a thin layer of matrix rich material bounded by thin layers of reinforcement rich material. An example of this is shown in Fig. 6. This is in agreement with previous findings^[16]. Failure is initiated by the nucleation of voids at reinforcing particles. These voids coalesce and form regions of failure (cracks) within the reinforcement and void rich region (Fig. 7(a)). One of these cracks then grows across the thin matrix rich region. Final failure then occurs by the joining of the crack in

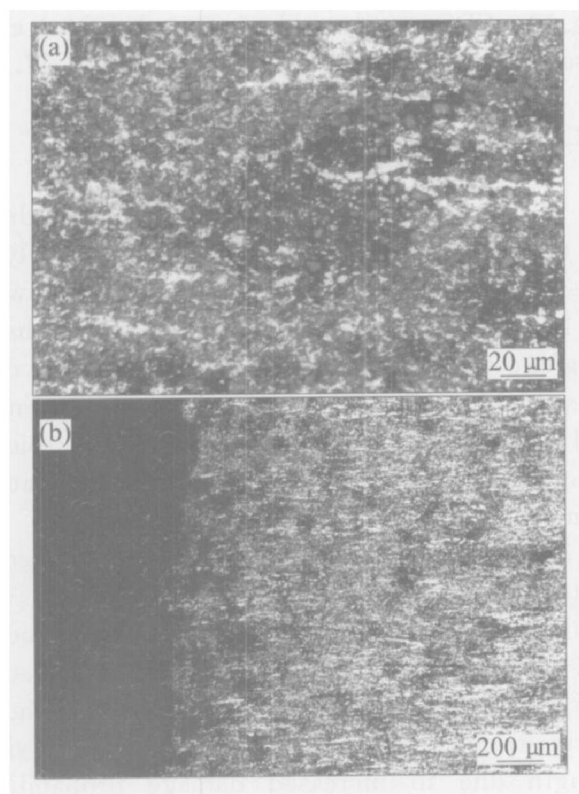
Fig. 7 Optical micrographs for failure of delamination under as-received condition
(a) —As coalescence of voids initiated at around of reinforcing particles;
(b) —As joining of crack in matrix rich region

the matrix rich region with a crack remote from it in the next reinforcement rich region (Fig. 7(b)).

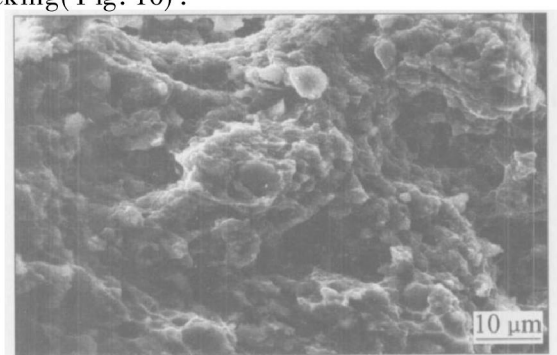
Fig. 8 SEM fractograph for tensile fracture surface of MMC under OA condition

The features of tensile fracture of the specimens under the OA conditions are illustrated in Fig. 8. It also exhibits particle fracture and particle pull-out. Though extensive matrix deformation around the particles is evident, it depends on the heat treatment. It was noted in Al alloy matrix composites, a higher increase in strength was observed with softer matrix^[17]. The heat treatments were chosen in order to change the matrix strength over a wide range by varying the precipitate size and their distribution as it plays an important role in relieving the triaxial internal stresses between the reinforcement and the matrix^[18]. The decrease in yield stress with particle loading under the case of peak-aged condition might be due to the rapid initiation of damage just at the onset of gross yielding. On the contrary, in the lower matrix strength levels (SA temper) an increase in yield strength was noted, which indicates that the damage is minimum before the yield. Thus, the high matrix strength causes a large decrease in yield strength due to increased damage probability under the SA condition. In that manner, it was determined that the matrix strength has an important effect on the fracture mechanisms of SiC_p/Al composites. For the composite with low matrix strength under the SA and OA conditions, failure is initiated by nucleation, growth and coalescence of voids in the aluminium alloy (Fig. 9). For the composite with a strong matrix (PA condition), failure is caused by tearing of the SiC/Al interface and by SiC particle cracking (Fig. 10).

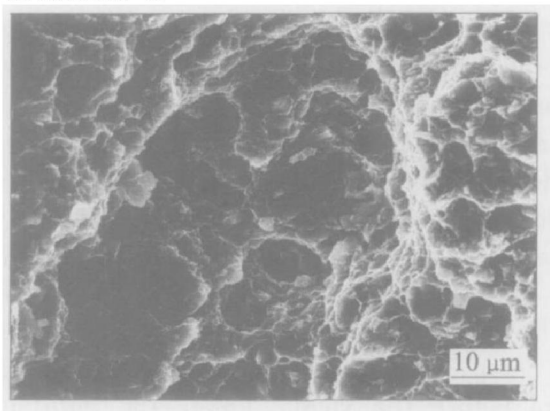
Fig. 9 SEM fractograph for tensile fracture surface of MMC under SA condition

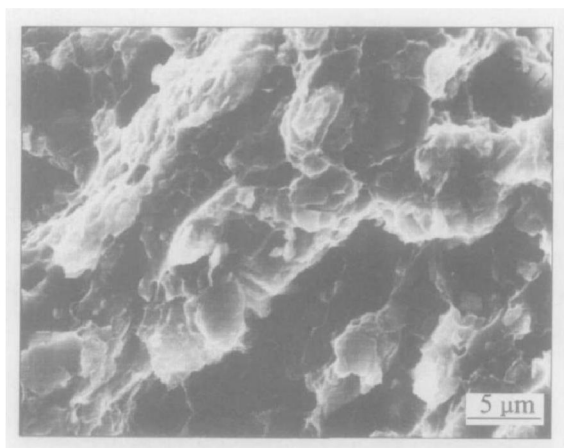
Fig. 10 SEM fractograph for tensile fracture surface of MMC under PA condition

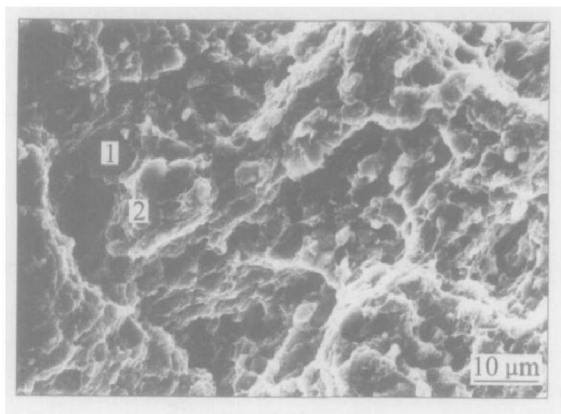
Fig. 11 SEM fractograph for two different types of SiC fracture surface

ultaneously^[19] and give rise to secondary cracks (marked as 1 in Fig. 11). Some SiC particles on the fracture surfaces show a ductile tearing along the SiC-Al interface (marked as 2 in Fig. 11). A SiC particle adhering with ridges originated from tearing of the aluminium matrix is verified by EDS analysis (Fig. 12) taken on that tearing failure near the SiC_p/Al interface. This indicates that the aluminium content at marker 2 is much higher than that at marker 1.

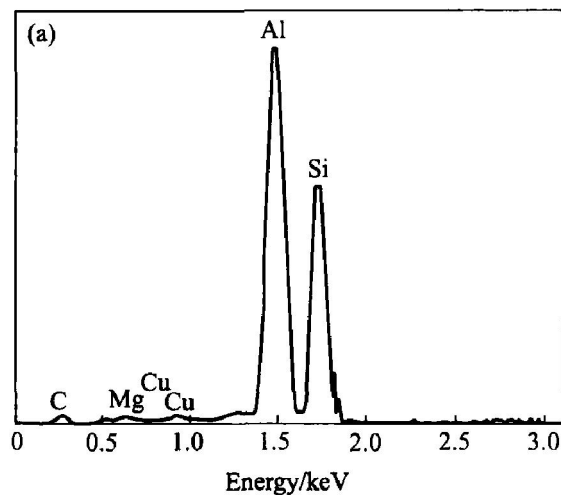
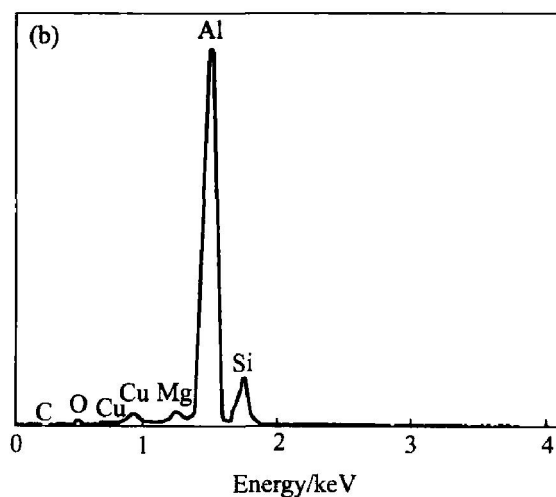
Fig. 12 EDS patterns taken at marker 1(a) and marker 2(b) of sample as shown in Fig. 11.
