Fatigue fracture of high-strength Al-Zn-Mg-Cu alloy

Abstract: X-ray diffractometry(XRD), optical microscopy(OM), scanning electron microscopy(SEM) were used to study the fatigue fracture of the T7451 Al-Zn-Mg-Cu alloy (470 °C, 60 min+115 °C, 8 h+165 °C, 16 h). The study reveals mainly the microscopic structure of the alloy in the process of crack formation and crack growth. The fatigue fracture is characterized by three zones: fatigue crack source zone, fatigue crack propagation zone and fatigue fracture zone. The fatigue damage preferably incubates at the fractured inclusion particles at or near (about 25 μm) the specimen free surfaces, and these brittle Fe-rich intermetallic inclusion particles are (7–10) μm × (11–14) μm in size. Some features such as “feather-like”, “river and range” and boundary extrusions can be observed in the fatigue propagation zone, and in the fatigue fracture zone the surface is rough and uneven.

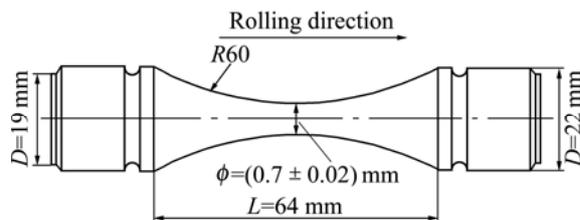
The fatigue specimen was sampled along the longitudinal direction of the plates. Fig.1 shows the dimension and orientation of the sample. In order to get a further understanding on the fatigue property of the 30 mm Al-Zn-Mg-Cu alloy plates from microscopic view, metallographical observation, XRD phase analysis and SEM observation were performed on the alloy plates after heat treatment.

**Fig.1** Orientation and dimensions of fatigue sample

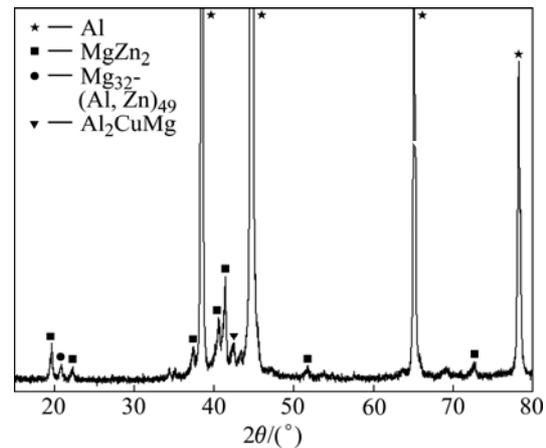
The XRD pattern of the Al-Zn-Mg-Cu alloy plates after T7451 treatment is shown in Fig.2. It is shown that in addition to the Al matrix solid solution, there are massive η' (MgZn₂) precipitates and particles like Al₂CuMg and Mg₃₂(Al, Zn)₄₉.

**Fig.2** XRD spectrum of Al-Zn-Mg-Cu alloy plate

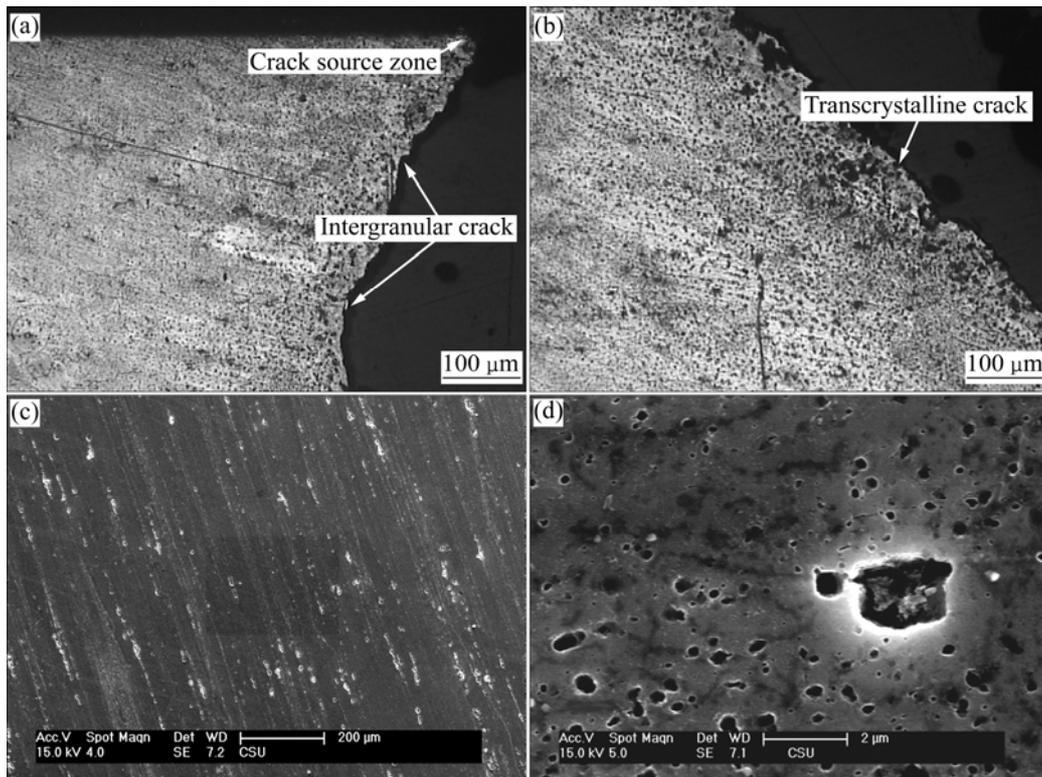
Crossing the crack source zone, we got the cross-section of crack propagation path, and then ground it. The metallographs of cross-section at or near the crack source zone are shown in Figs.3(a) and (b), and the SEM micrographs of the surface of the fatigue sample are shown in Figs.3(c) and (d).

The cracks near the crack source zone of the fracture are intergranular (Fig.3(a)). Going deep into a certain depth, the cracks transform into transcrystalline (Fig.3(b)). In Fig.3(c), some particles can be identified easily due to their distinct hoar color. The energy spectrum analysis confirmed that they are Fe-rich intermetallic particles. Fig.3(d) reveals that on the surface of the specimen there are some coarse particles, and the fatigue damage is obvious. The specimen surface is crisscrossed by some clearly visible micro-cracks.

Fig.3 OM microstructures of fatigue fracture (a, b) and SEM micrographs of sample surface (c, d)

In Figs.3(c) and (d), thousands of inclusion particles are located near or at the free surface. However, only one or a few fractured particles induce predominant fatigue cracks and most of the fractured particles do not induce fatigue cracks in the matrix.

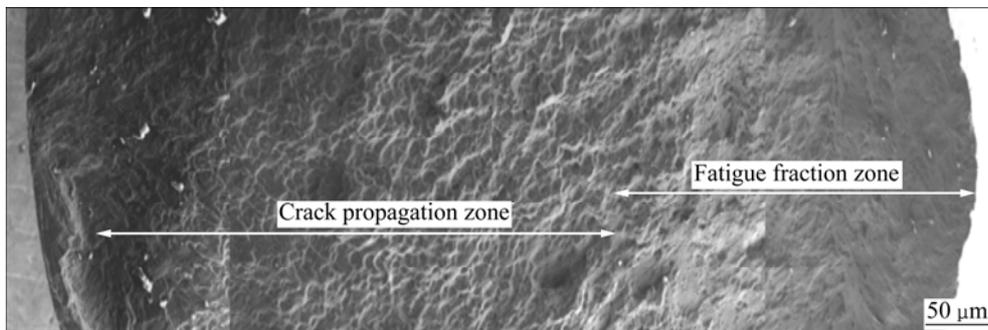
The characteristic of fatigue fracture of the sample with stress amplitude of 330 MPa is shown in Fig.4. The fracture is obviously composed of three zones: crack source zone, crack propagation zone and fatigue fracture zone. The crack source zone is approximately 25 μm from the free surface of the specimen. In the region close to the crack source zone, the cracks show obvious radial morphology. Then with the propagation of fatigue cracks, the opening mouths of the cracks become broader; the cracks distribute sparser; and the growth of the crack is accelerated[10]. When the crack length increases to the critical crack length of the material, the material fractures instantly and meanwhile forms a rough surface. In the area near the free surface we could see the slanted rupture. On the whole fracture surface, the crack source zone is the smallest in size, and the fatigue crack propagation zone takes up half of the surface.

Fig.4 Fractograph of fatigue fracture samples for Al-Zn-Mg-Cu alloy (stress is 330 MPa, $R=0.1$)

2) The fatigue fracture is composed of fatigue crack source zone, fatigue crack propagation zone and fatigue fracture zone. The crack source zone is approximately 25 μm from the free surface of the specimen. In the region near the crack source, the cracks show obvious radial morphology. Then with the propagation of fatigue cracks, the cracks distribute sparser, and the growth of the cracks is accelerated. The fracture morphology of the fracture zone is similar to that of the static loading fracture, and the surface is rough and uneven. On the whole fracture surface, the crack source zone is the smallest in size, and the fatigue crack propagation zone take up half of the surface.

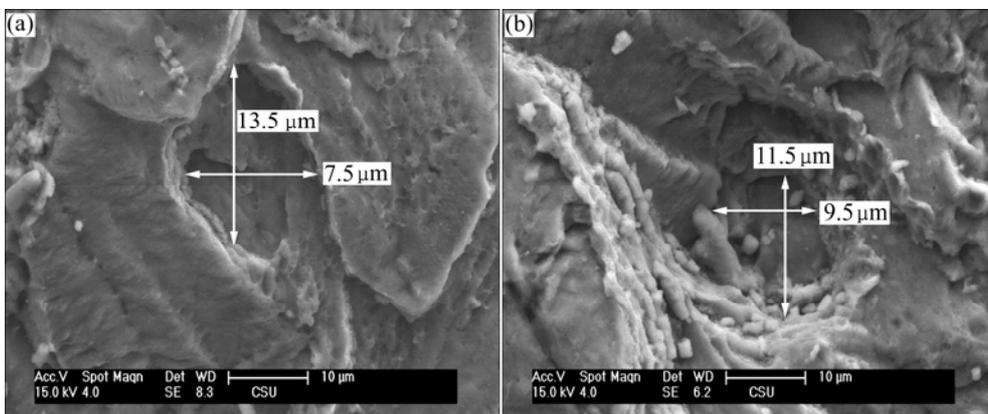
Fig.5 shows SEM images of the initiation sites of the fatigue crack on the Al-Zn-Mg-Cu alloy specimen. From the high magnification fractograph of the fatigue surface we can see the particles that induced the fatigue crack and the nearby fractured inclusion particles. The voids left by the missing particles indicate that the particles that induced the initial formation of the fatigue damage are (7–10) μm × (11–14) μm in size.

Fig.5 SEM images of fatigue crack initiation sites for samples

1) Fatigue damage incubates at the fractured Fe-rich inclusion particles at or near the specimen free surfaces. However, only one or a few fractured particles induce predominant fatigue cracks and most of the fractured particles do not induce fatigue cracks in the matrix. The particles that induce the initial formation of the fatigue damage are $(7-10) \mu\text{m} \times (11-14) \mu\text{m}$ in size.

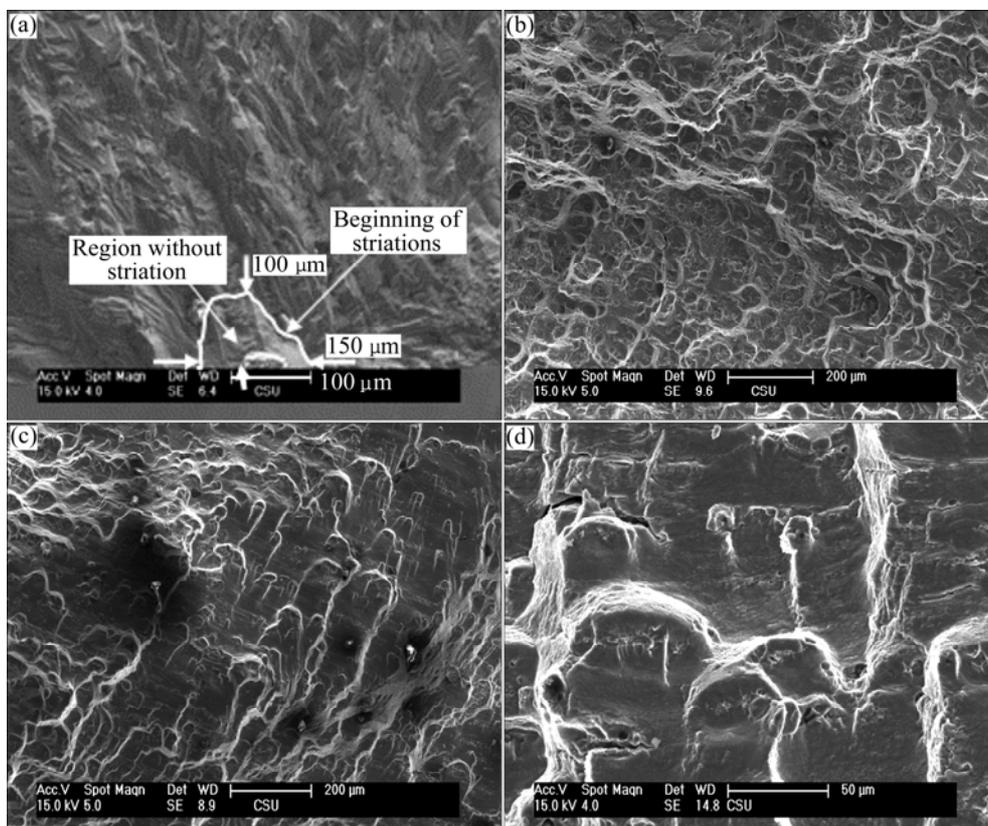
Following fatigue damage incubation, the fatigue propagates into the matrix and towards the center of the

specimens as shown in Fig.6(a). The fracture surface of the specimen is perpendicular to the uniaxial loading direction, which is also the rolling direction of the alloy

plates. Initially, in the vicinity of the crack source, the fractographs reveal a nonplanar region. In this region, no striations are observed. As the crack propagates further, the fracture surface displays many micro-cliffs, arranged in an ordered fashion parallel to the crack propagation direction. This feature is commonly called “river and range” in Ref.[11]. Striations are visible on the micro-cliffs. Under high magnification, the micro-cliffs have a step-like pattern formed inside of a grain, which seems to demonstrate lateral slippage at the crack tip during fatigue crack propagation.

The phenomenon known in the literature as “feather-like features” is observed, accompanied with grain boundary extrusions as shown in Figs.6(b) and (c). High magnification images of these areas show many dimples with precipitant particles located at the center, signifying pore development under microscopic plasticity. In the meantime, some secondary fractures at the grain boundaries are noticeable as shown in Fig.6(d).

Fig.6 SEM images of crack initiation and propagation sites: (a) Crack source and further crack propagation; (b, c) Feather-like features; (d) Secondary fractures

Fig.7(a) shows the overall crack growth region at the fracture surface. The striation is first visible at a zone of $100\ \mu\text{m} \times 150\ \mu\text{m}$ (Fig.6(a)) from the crack formation site. Figs.7(b)–(d) show the spacing of the striation at various distances from the crack formation sites. There is a uniform increase in striation distance as the crack

Following fatigue crack incubation, the deviation of growth direction occurs during the propagating process due to the various resistances acted on the crack tips[13]. Thereafter the fatigue cracks propagate continuously on each plane respectively, and different fracture surfaces intersect and form some steps which constitutes the radial morphology on the fracture surface (Fig.4). And the grain boundary extrusion grows up generally with the increase of the number of cycles. The corresponding squeezing part propagates towards the depth of the slip band and forms a crystallographic incision. Based on the physical model of the fatigue crack growth, the fatigue fashioned subcritical propagation occurs during the process of constant opening and closing of the crack tip [14]. The fatigue cracks enter the stable growth zone when they orient perpendicularly to the loading direction. In this region, besides some fracture features in common with that under static loading, such as intercrystalline and dimples, the striation that is peculiar to the fatigue fracture could also be observed. The arraying directions of the striations at different regions are not identical, but the propagation trend of the micro cracks is basically consistent with the growth direction of the macro cracks.

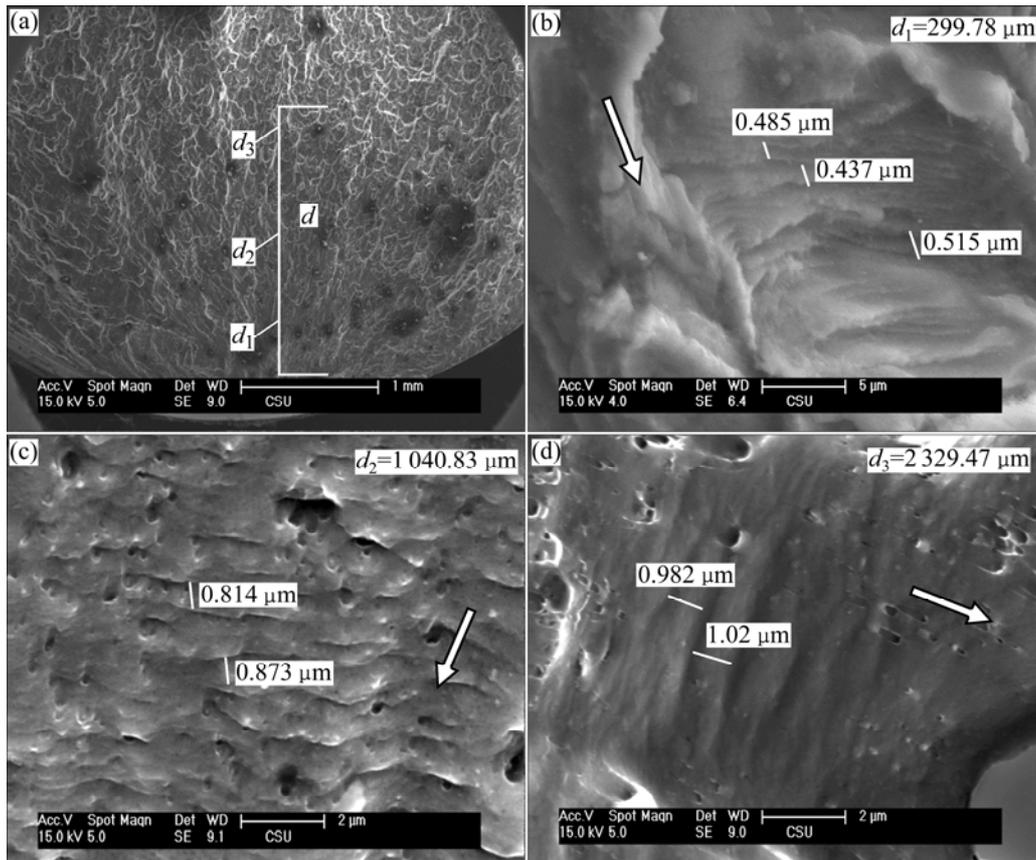
length increases. The steady increase of striation distances indicates steady-state crack propagation in the region.

Fig.7 SEM images of fatigue striation (d shows distance of fatigue striation measured in crack initiation site, arrows indicate crack propagation directions): (b) Striation measured at 299.78 μm from formation site; (c) Striation measured at 1 040.83 μm ; (d) Striation measured at 2 329.47 μm

The striations on the fracture surface are basically a group of textures parallel to each other, and their normal direction is consistent with the propagation direction of the cracks[15]. Depending on grain misorientation, grain boundaries and second phase particles, the crack would be transferred onto another flat surface; therefore, striation in different regions sometimes locates at planes of different height. In the regions where striations could be recognized, the striation distances broaden as the crack increases in size.

3) At the zone of $100 \mu\text{m} \times 150 \mu\text{m}$ from the crack formation site, there is no striation. After further propagation of cracks, some typical fracture morphology such as “river and range”, “feather-like features”, dimples and secondary cracks with the grain boundary extrusions could be observed. In the regions where striations could be recognized, the striation distances broaden as the crack increases in size.

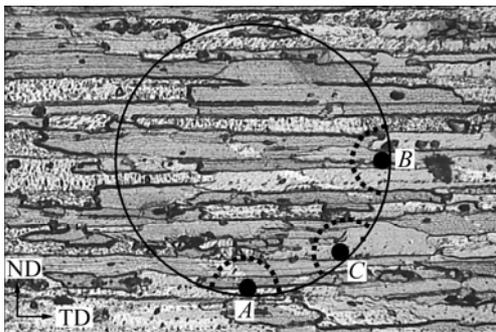
Consider a scenario with three particles located on the free surface of the specimen along the normal, the traverse and the bisection of the two directions (denoted *A–C* in Fig.8). Let the three points be centers and draw three circles of $40\ \mu\text{m}$ diameter representing imaginary

Fig.8 Schematic drawing of cross section of specimen with background of grain morphology according to rolling direction

cracks. The circle at point B intersects the greatest number of grain boundaries of the three points, and the circle at point A intersects the fewest grain boundaries. The grain boundaries normally act as a blockage of crack growth and reduce the crack driving forces due to the energy induced by pile-up dislocations. Therefore, the fractured particles on the free surface of the specimens at point A , with the surface normal direction coinciding with the short transverse direction of the rolling plate, are more likely to induce final fatigue failure than the particles at points B and C , given that other
