## Dynamic fracture of Ti-6Al-4V alloy in Taylor impact test

**Abstract:** The dynamic fracture behaviors of Ti-6Al-4V alloy at high strain rate loading were investigated systemically through Taylor impact test, over the range of impact velocities from 145 m/s to 306 m/s. The critical impact velocity of fracture ranges from 217 m/s to 236 m/s. Smooth surfaces and ductile dimple areas were observed on the fracture surfaces. As the impact velocity reached 260 m/s, the serious melting regions were also observed on the fracture surfaces. Self-organization of cracks emerges when the impact velocity reaches 260 m/s, while some special cracks whose “tips” are not sharp but arc and smooth, and without any evidence of deformation or adiabatic shear band were also observed on the impact end surfaces. Examination of the sections of these special cracks reveals that the cracks expand along the two maximum shear stress directions respectively, and finally intersect as a tridimensional “stagger ridge” structure.

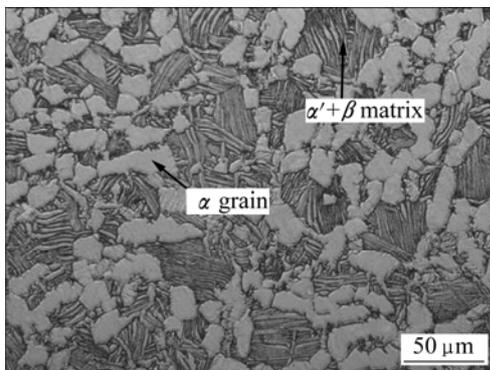
**Fig.1** Optical microstructure of Ti-6Al-4V alloy before test

In the current study, all specimens were made of the conventional commercial Ti-6Al-4V alloy, whose chemical compositions are listed in Table 1. Before being tested, the alloys are in the bimodal ( $\alpha+\beta$ ) state at room temperature after the following heat treatment process: annealed at 950 °C for 1 h in the  $\alpha+\beta$  region, and cooled down in the air to room temperature. Fig.1 shows the typical metallography of the bimodal microstructure of the alloy, consisting of the predominant equiaxed  $\alpha$ , whose grain size is between 20 and 50  $\mu\text{m}$ , and acicular  $\alpha'$  and transformed  $\beta$  matrix, whose length is between 30 and 40  $\mu\text{m}$ .

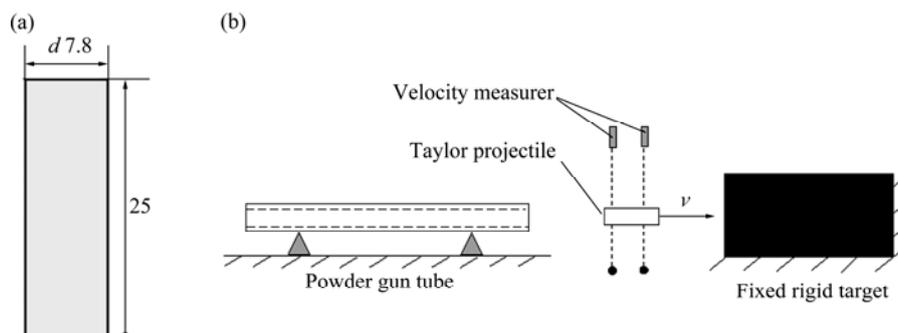
**Fig.2** Shape and dimensions of cylinder specimen used for Taylor impact test (unit: mm) (a) and schematic diagram of Taylor impact test device (b)

The cylindrical specimens (see Fig.2(a)) are 7.8 mm in diameter and 25 mm in length, and the ratio of length to diameter is approximate 3.2. A lathe was employed to

A traditional Taylor impact test device was used, as shown in Fig.2(b). The cylinder was fired with a powder gun against a rigid 603 Armored Steel target and a counter was employed to get the velocity of the specimen before impacting on the rigid target. The tests were performed over a broad range of impact velocities, from 145 m/s to 306 m/s. After being impacted, the deformed projectiles were all recovered; and if the specimen fractured, the fragments split away from the cylinder would be also recovered as more as possible.

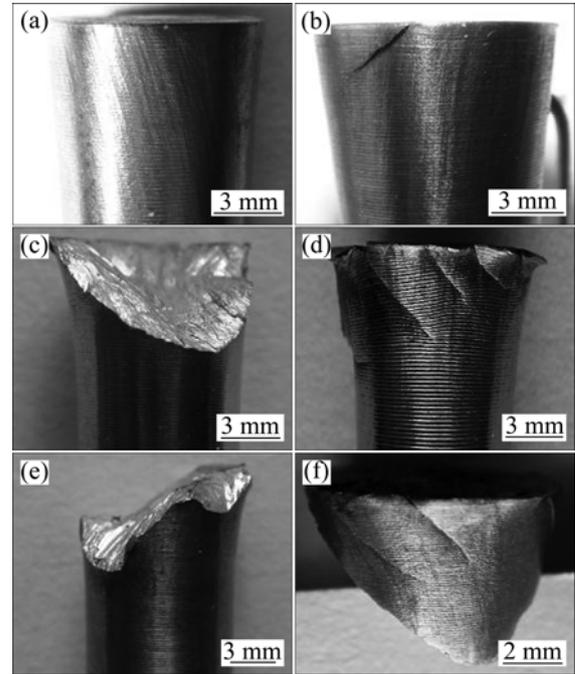
**Fig.3** Morphologies of plastic deformed and fractured projectiles with increase of impact velocity: (a)  $v=198$  m/s; (b)  $v=224$  m/s; (c) and (d)  $v=260$  m/s; (e)  $v=282$  m/s; (f) Fragment splitting away from cylinder,  $v=282$  m/s

According to the plastic deformation and fracture characteristics, which are also listed in Table 2, the projectiles with the increase of impact velocity can be classified into three main stages, as shown in Fig.3. When the impact velocity is low, ranging from 145 m/s to 214 m/s, only plastic deformation is observed on the head of the projectiles, which is called “only plastic deformed stage”. As shown in Fig.3(a), in this stage, there are several clusters of plastic flow lines observed on the lateral surface of the projectile along the direction of compression. Fig.4 presents the relationship between the impact velocity ( $v$ ) and the total plastic strain of the yielded portion ( $\varepsilon_p$ ) which is calculated by Eq.(1). It can be seen from Fig.4 that the extent of plastic deformation

ranges from 217 m/s to 236 m/s. Fig.3(b) presents the typical specimen in this stage: only one or two cracks can be examined on the head lateral surface of the projectile with an angle of about  $45^\circ$  with the impact end surface, which is the evident characteristic of specimens in critical fractured stage. When the impact velocity exceeds 236 m/s, specimens fracture seriously, and the head of all projectiles splits off. Fig.3(c) shows the specimen loaded with the velocity in “complete fractured stage”. The specimen presents a typical sheared fracture surface and Fig.3(d) reveals that more than one parallel cracks can be observed on the head lateral surface of the projectile in this stage. As we further increase the impact

velocity to larger than 260 m/s, the fracture surface of projectiles is rugged, and cracks also appear on the lateral surface of the fragment splitting away from the cylinder, as shown in Figs.3(e) and (f).

In addition, it is recognized that the shear stress field in the specimen during the loading process is so complicated that there maybe exist many shear planes on the different shear directions[14]. These shear planes intersect each other and the cracks expand through the specimen along these shear planes, resulting in more than one fragments splitting away from the specimen, and finally forming a rugged fracture surface, as shown in Fig.3(e).

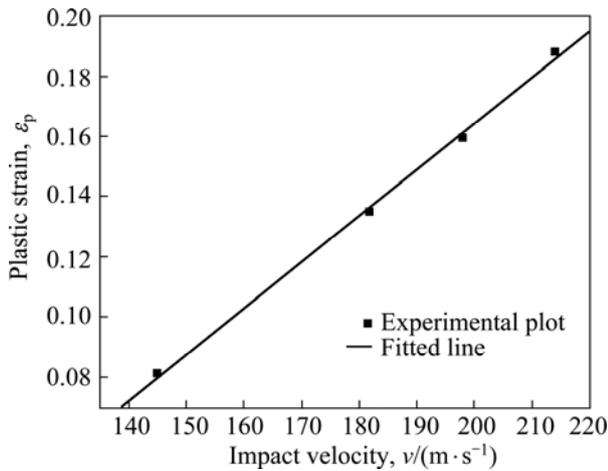
**Fig.4** Approximate linear dependence between the impact velocity ( $v$ ) and the plastic strain of the specimen ( $\epsilon_p$ ) when impact velocity being low

of the head of specimen is approximate linear dependence on the increase of the impact velocity in only plastic deformed stage. As the impact velocity increases, the alloy begins to fracture and turns into the “critical fractured stage”. The critical impact velocity of fracture

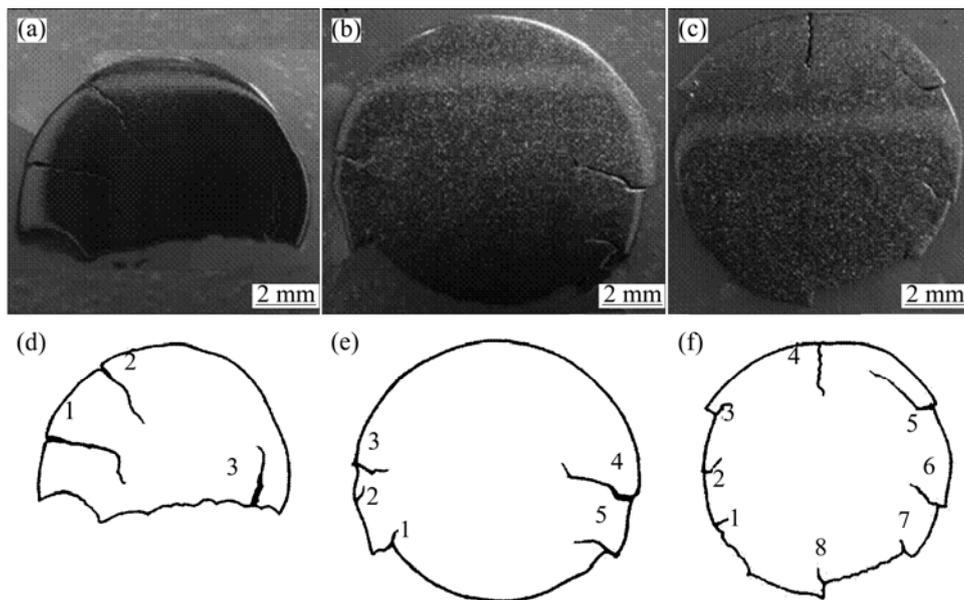
**Fig.5** Distribution of cracks on impact end surface with different impact velocities: (a)  $v=261$  m/s; (b)  $v=267$  m/s; (c)  $v=282$  m/s; (d), (e), (f) Schematic diagrams of (a), (b) and (c), respectively

Some researchers[15–19] have noticed that, on certain loading conditions, such as the radial collapse of a thick-walled cylinder, the shear bands do not expand randomly, but with a well established and characteristic pattern, which is called “self-organization”. In the current test, we also observed a similar phenomenon. Fig.3(d) shows some regularly distributed cracks emerging on the lateral surface of the projectile when the impact velocity exceeds 236 m/s. As we further increase the impact velocity, the distribution of cracks around the edge of the impact end surface is also not random, but symmetrical. Fig.5 presents the main cracks almost expanding towards the centre of the specimens on the impact end surface as a “self-organization” pattern. At the same time, the higher the impact velocity achieves, the more symmetrical the cracks distribute. The cracks expand along the shear bands, so the regularly spaced adiabatic shear bands result in these self-organized cracks.

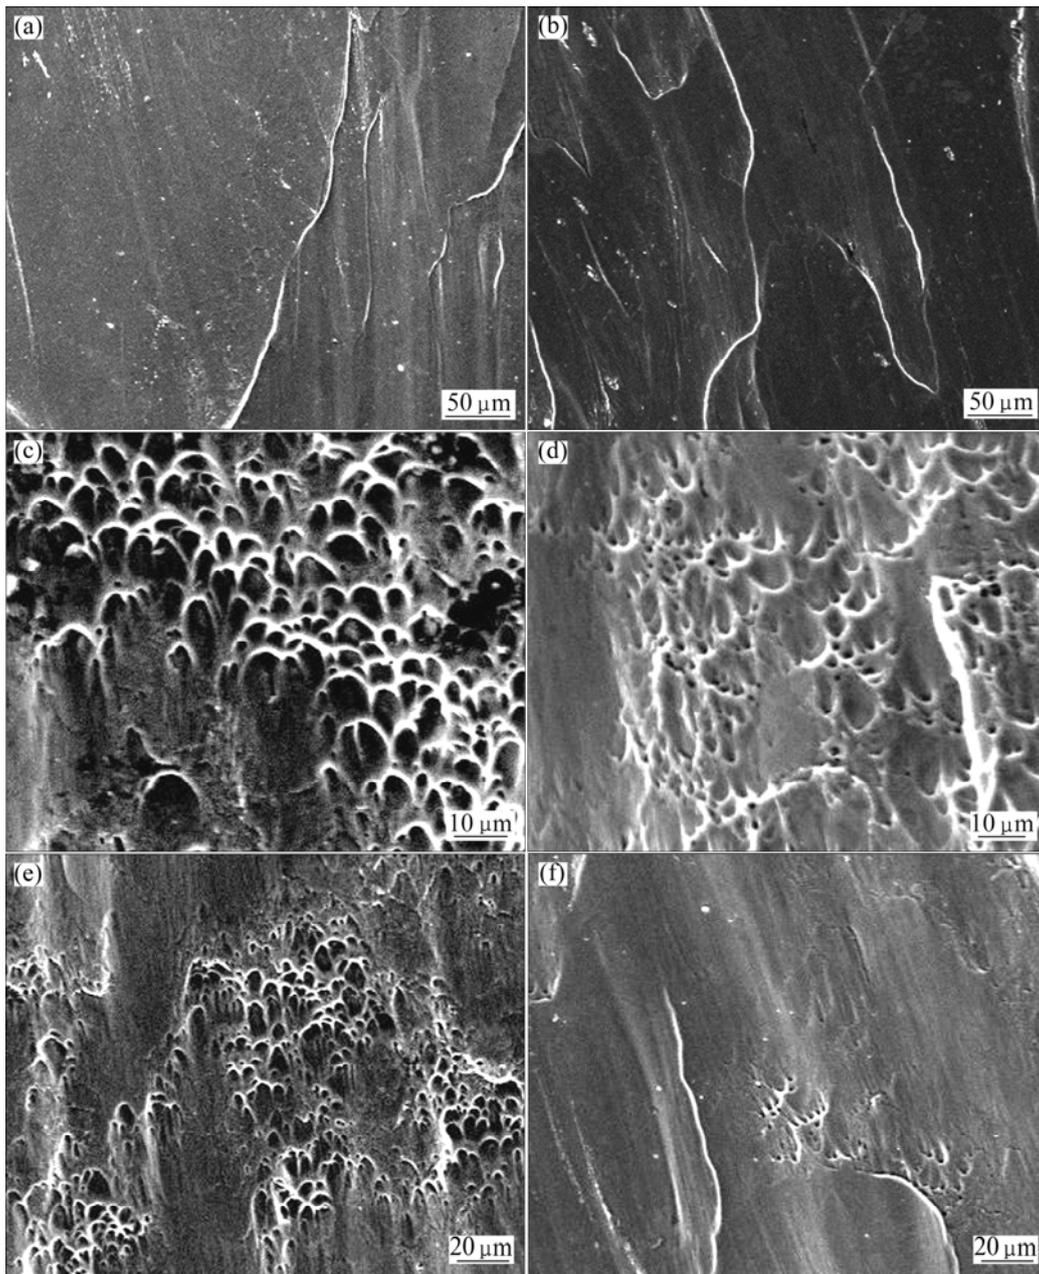
**Fig.6** SEM fractographs of fracture surface with relatively low impact velocities: (a) Smooth smeared surface,  $v=244$  m/s; (b) Smooth smeared surface,  $v=253$  m/s; (c) Ductile dimple area,  $v=244$  m/s; (d) Ductile dimple area,  $v=253$  m/s; (e) Boundary between these two areas,  $v=244$  m/s; (f) Boundary between these two areas,  $v=253$  m/s

Microscopic analyses of fracture surface of the recovered cylinders in the complete fractured stage were carried out by SEM, as shown in Fig.6. In a relatively low impact velocity range, the fracture surface can be classified into two main areas, namely the “smooth and smeared surface” and the “ductile dimple area”, which

have been reported by other investigators[2, 13] (see Figs.6(a)–(d)). The smooth and smeared surface corresponds to the upper and center location of the fracture surface. Meanwhile, the ductile dimple area is on the side and nether fringe of the fracture surface and around the smooth and smeared area. On the whole fracture surface, the area of smooth and smeared surface is larger than ductile dimple area, and the boundary between these two areas is dim. In addition, as shown in Figs.6(e) and (f), several clusters of dimples distributing along the edges of the smooth surfaces were observed, and in certain areas, some elongated dimples were also

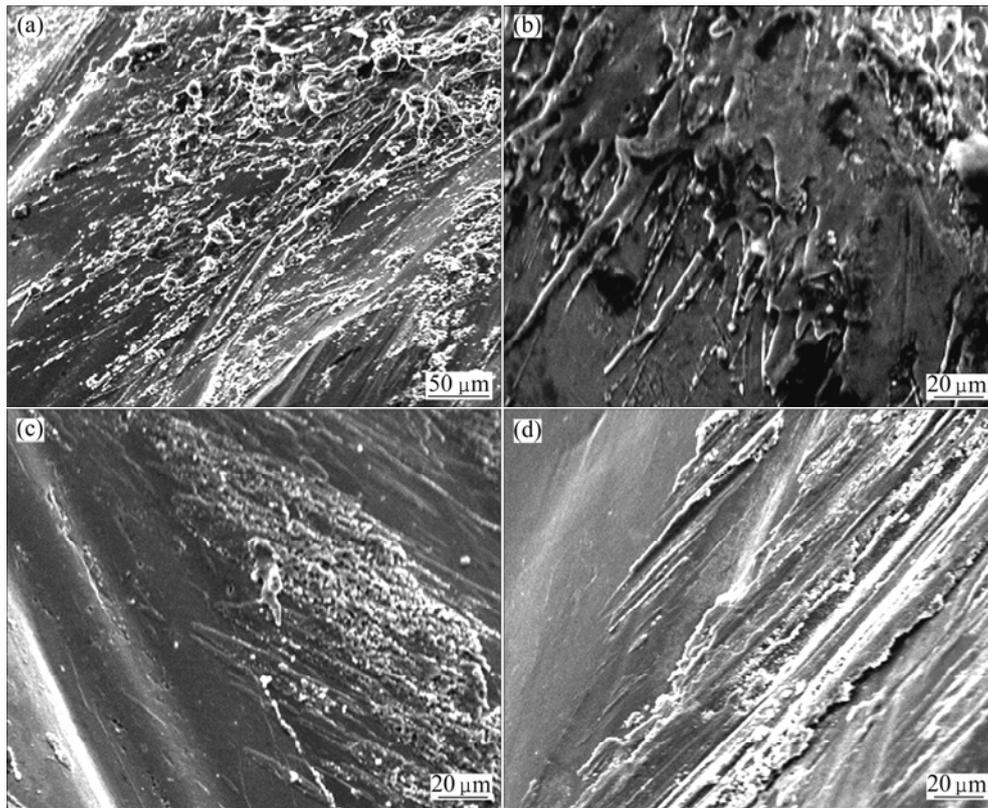
**Fig.7** SEM micrographs of serious melting regions on fracture surface with high impact velocities: (a)  $v=260$  m/s; (b) Amplificatory micrograph of (a); (c)  $v=282$  m/s; (d)  $v=306$  m/s

Fig.7 and Fig.8 present fracture surfaces of projectile loaded with higher impact velocities. As shown in Fig.7, when the impact velocity exceeds 260 m/s, there appears a new area, namely the “serious melting region”, besides the “smooth and smeared surface” and the “ductile dimple area”. These serious melting regions were always observed on the upper side of the smooth and smeared surface, which indicates that a significant melting of the original shear area material takes place prior to shear fracture of the specimen. In addition, in Figs.7(b) and (c), a large number of

“splat-like and knobbly” deposits and “splash” structures were observed, implying pressing and rubbing caused by mating displacement between the fragment and the fracture surface of the specimen in the shear fracture process, which maybe results in splashing of the melting alloy drops along the shear fracture direction, and Fig.7(d) reveals the trace of rubbing evidently.

deformation takes place, the temperature rises more sharply. In the present test, the sudden temperature rise within the ASB even exceeds over the melting point of the Ti-6Al-4V alloy, and makes for the absolute melting of the alloy in the main shear plane, as shown in Fig.7. The melted alloy liquid is propelled by the shear stress and flows on the shear plane along the direction of maximal shear stress, ultimately forms the main smooth and smeared surface on the center of the fracture surface (see Figs.6(a), 6(b), 8(a) and 8(b)). Meanwhile, on account of the tensile stresses in the tension zone surrounding the shear zone[4, 20], the ductile dimple areas form and distribute around the smooth and smeared surface. When the impact velocity reaches a relatively high speed, some small smooth planes appear in the ductile dimple area at the boundaries between the smooth surface and the dimple areas, as shown in Fig.8(e). Those small smooth surfaces may be caused by rubbing between the fragment and the fracture surface while the fracture surfaces are still soft due to the high temperature in the shear region[13]. On the other hand, the augment of the tensile stress, as a result of the increase of the impact velocity, accounts for the more elongation of the ductile dimples and then results in the alternate emergence of the smooth areas and the ductile dimple areas (Fig.8(f)). In addition, as shown in Fig.9, the

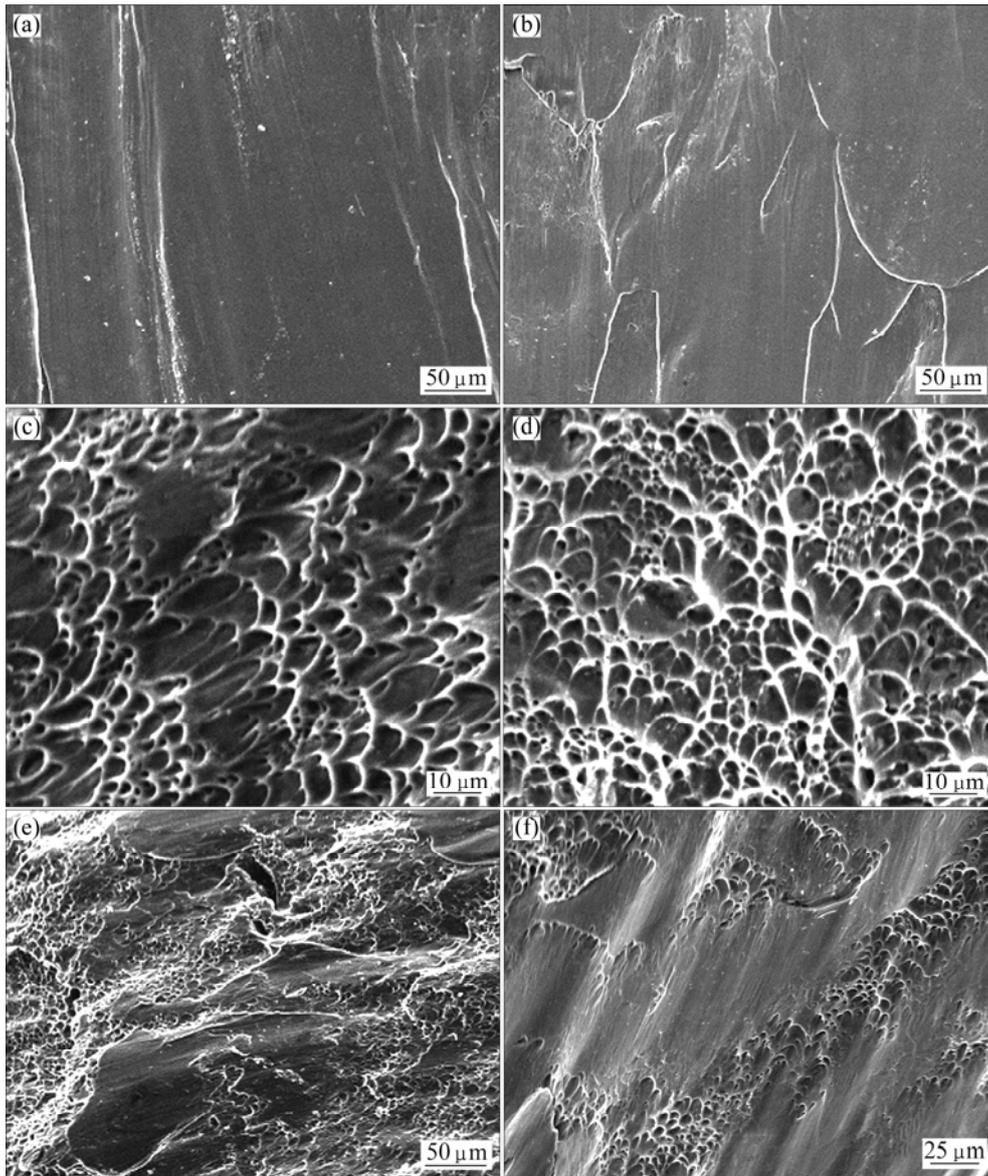
**Fig.8** SEM fractographs of fracture surface with high impact velocities: (a) Smooth and smeared surface,  $v=282$  m/s; (b) Smooth and smeared surface,  $v=306$  m/s; (c) Ductile dimple area,  $v=282$  m/s; (d) Ductile dimple area,  $v=306$  m/s; (e) Small smooth planes in ductile dimple area,  $v=282$  m/s; (f) Alternate smooth areas and ductile dimple areas,  $v=306$  m/s

Figs.8 (a) and (b) show the smooth and smeared surfaces under a high speed impact condition. By comparing with the instance at a relative low impact velocity, it presents no significant changes. But as shown in Figs.8(c) and (d), more and more dense and elongated dimples were observed, which indicates that the tensile stress within the shear band augments as the impact velocity increases. In the high impact velocity range, the boundaries between the smooth area and the ductile dimple area become clear. Besides, Figs.8(e) and (f) reveal that some relatively small smooth planes appear in the ductile dimple area, even the smooth areas and the ductile dimple areas emergence alternately in certain areas.

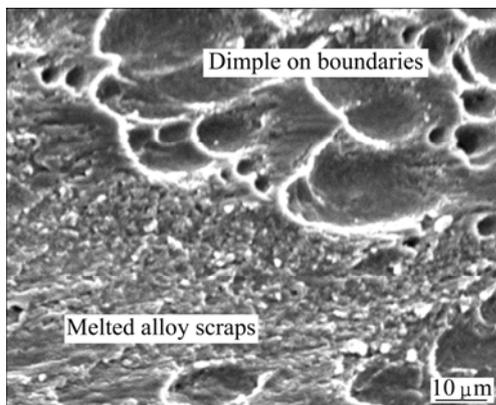
**Fig.9** SEM micrograph of melted alloy scraps filling in dimples at impact velocity of 306 m/s

mating displacement between the fragment and the fracture surface of the specimen can also “transport” scraps of the melted alloy from the melting regions to the boundaries between the smooth surface and the dimple areas, and those melted alloy scraps filling in the dimples can also form some smooth planes on the boundaries between the smooth surface and the dimple areas.

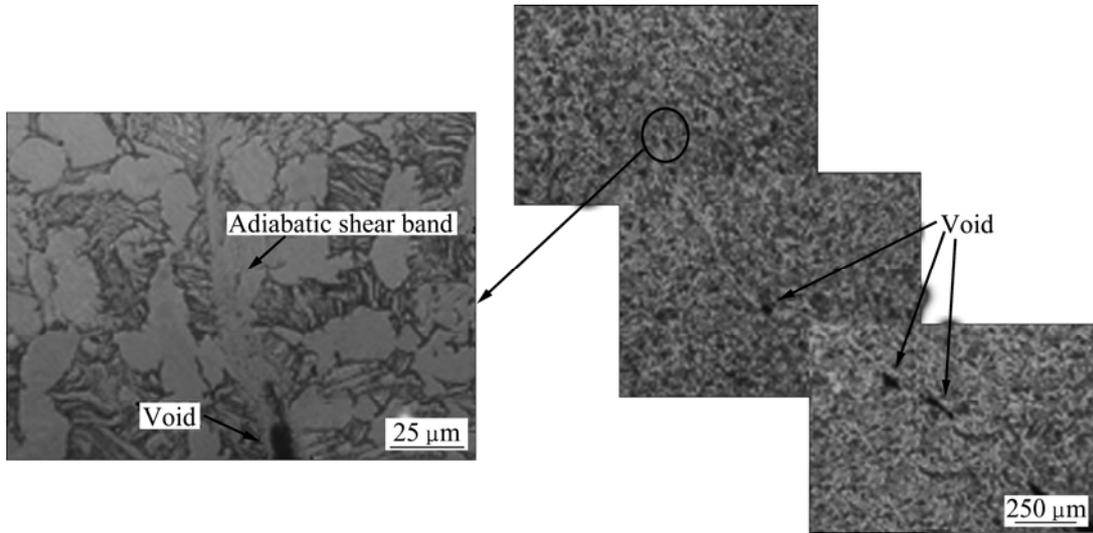
**Fig.10** Optical micrographs of adiabatic shear band on impact end surface of critical fractured stage specimen at impact velocity of 236 m/s

The metallographic analyses of the impact end surface of specimens in the “critical fractured stage” and the “complete fractured stage” were studied by optical microscope. Fig.10 shows the single white adiabatic shear band without branching off, which is observed in

the critical fractured stage specimens. By comparing with those formed on the SHB loading condition, reported in Ref.[13], the shear bands formed in the Taylor test are narrower and longer due to the more acute shear localization deformation in Taylor impact condition. Several dispersive voids distribute along the shear bands, which indicates that the specimen is in the

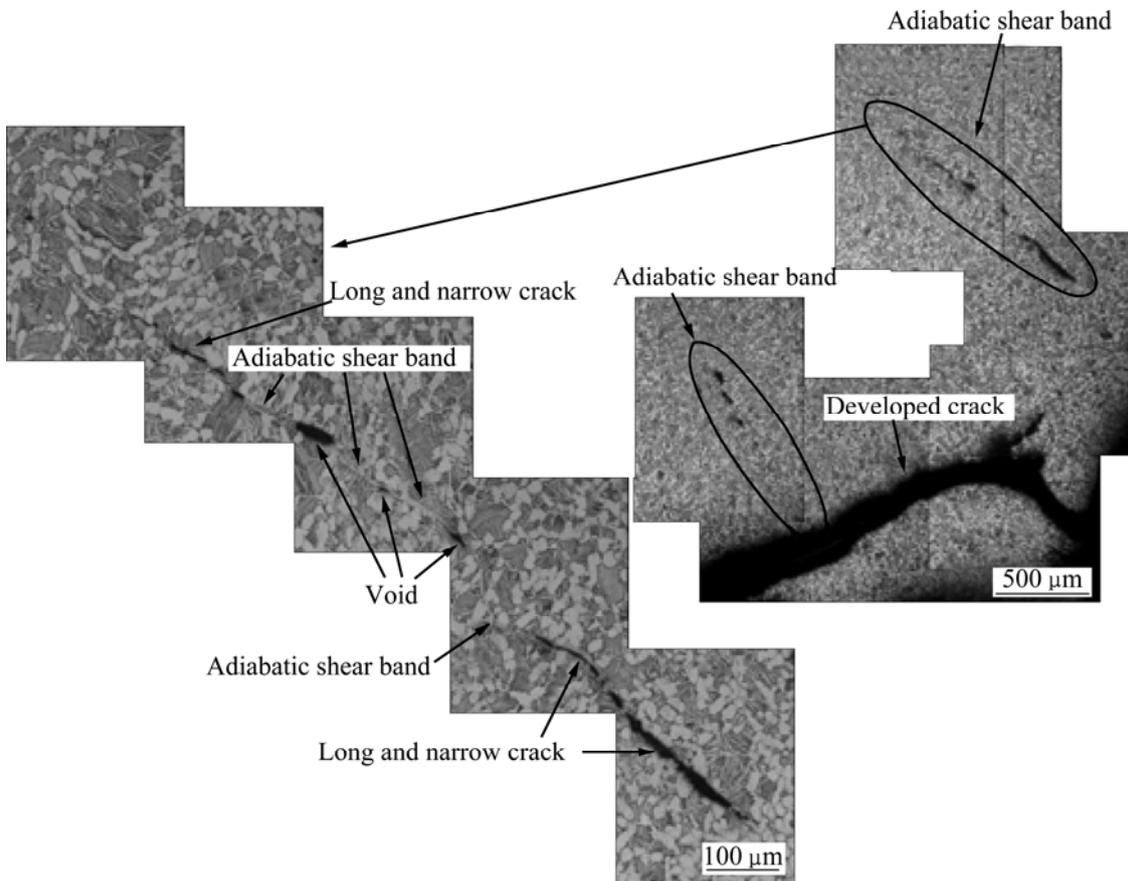
**Fig.11** Optical micrographs of main crack and adiabatic shear bands branching off from main crack at impact velocity of 253 m/s

Fig.11 shows that some developed cracks and more shear bands were observed in the complete fractured stage specimens with increasing impact velocity. These shear bands are longer than those in the critical fractured stage specimens. A few dispersive voids and a series of long and narrow small cracks distribute along the shear

band, which imply the nucleation, growth and coalescence of voids along adiabatic shear bands is the major reason for the fracture of the Taylor projectiles.

When the impact velocity reaches 260 m/s, some interesting phenomena are noticed. Besides developed cracks and relatively small normal cracks with shear bands on the tip of crack, as shown in Fig.11, there are some distinct cracks. Fig.12 presents these special cracks, whose tips are not sharp but arc and smooth, and any evidence of deformation or ASB are not observed in the microstructures surrounding these tips of cracks. A more detailed discussion about these special cracks is given in section 4.

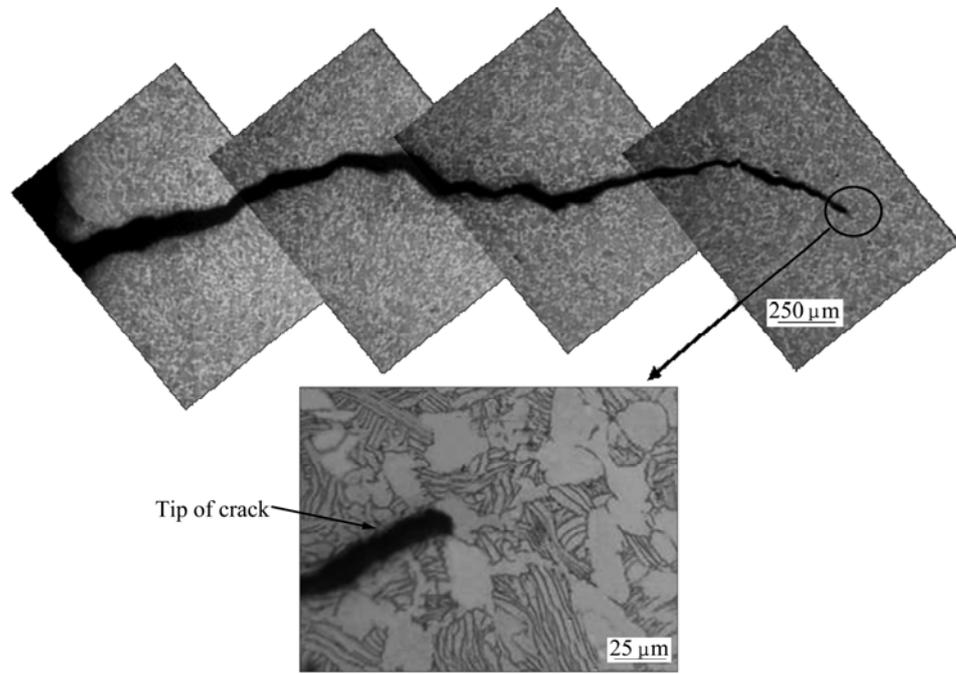
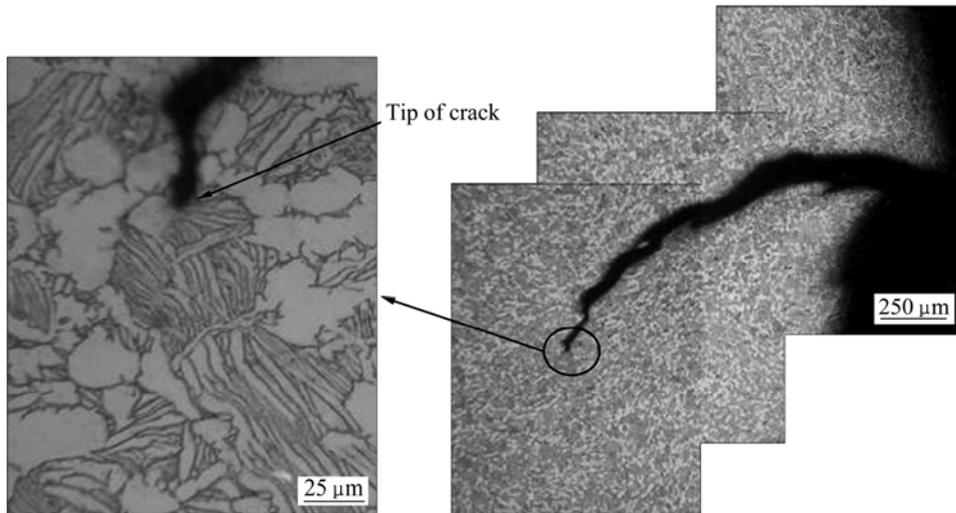
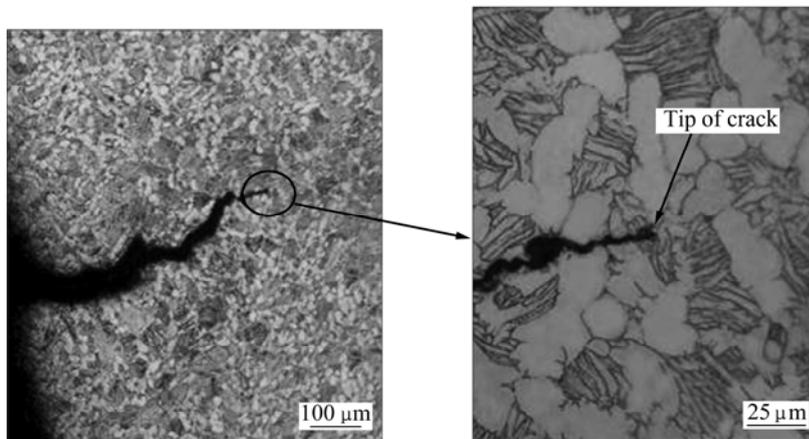
**Fig.12** Optical micrographs of crack without any deformation or ASB surrounding tip of it: (a)  $v=261$  m/s; (b)  $v=267$  m/s; (c)  $v=282$  m/s

The cracks on the impact end surface are actually a cross-section and top-view of the real three-dimensional stagger ridge structure, meantime, the view of the sections is a series of side-view of the real three-dimensional stagger ridge structure. So the single crack on the impact end surface is corresponding to the vertical view of a roof ridge and is the intersection line between the two shear planes practically. Therefore, the “tip” of the crack on the impact end surface is in fact the origination site of another crack (such as crack 2 discussed above). We could not observe any evidence of deformation or ASB in the microstructures surrounding these tips of cracks (see Fig.12) because the crack expands along the opposite direction.

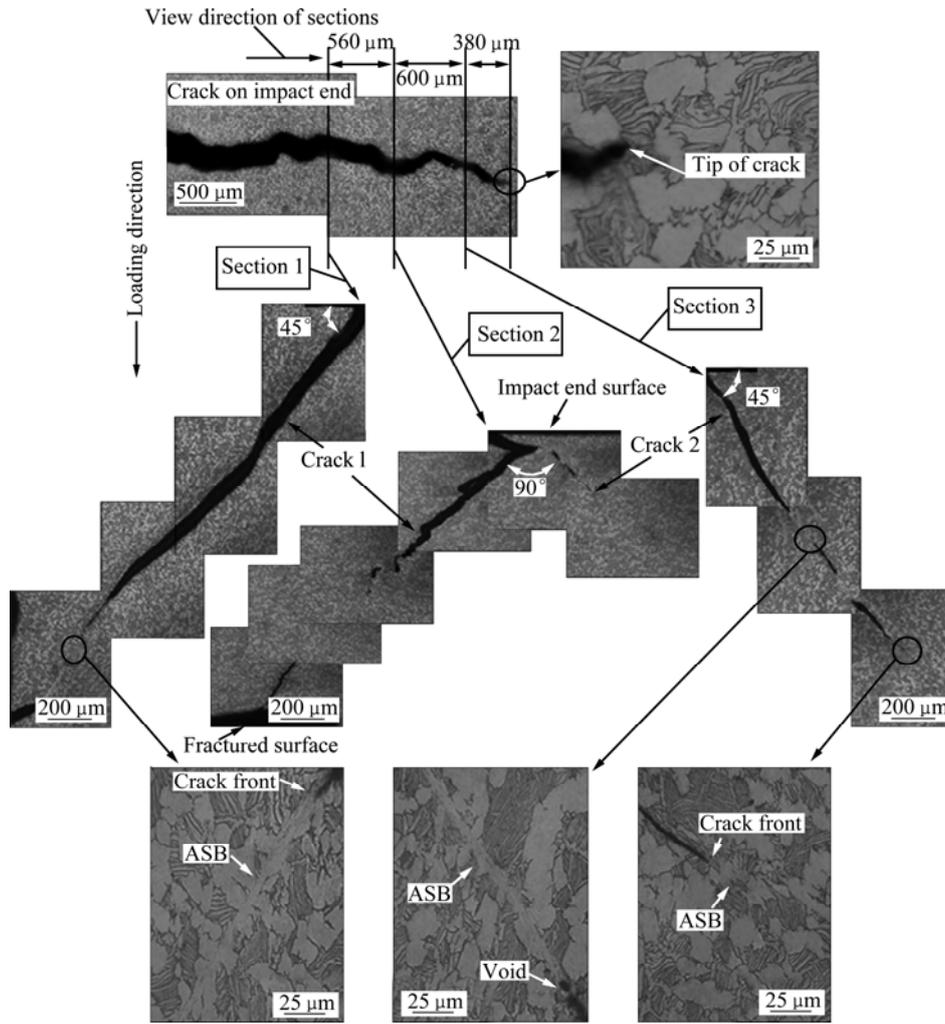
**Fig.13** Optical micrographs of sections of crack on impact end surface at impact velocity of 260 m/s

To investigate the expansion mode of the cracks within the specimens, the longitudinal sections of the fragment splitting away from the projectile were also examined systemically by optical microscope. Fig.13 shows that three sections were cut from one of the cracks on the impact end surface of the specimen along the “expansion direction” of the crack. On section 1, which is far from the crack “tip”, there is a developed crack with an adiabatic shear band in the front of it, and the crack makes an angle of about  $45^\circ$  with the impact end surface, denoted as crack 1. This crack expanded on a shear plane (denoted as shear plane 1) along the direction of the maximum shear stress, as reported in Refs.[12, 14], and linked another crack with the shear band finally. On the section 3 which is the nearest to the crack “tip”, a similar adequately grown crack was observed. But this crack expanded on the opposite direction against the crack 1. According to the uniform view direction of section 1 and section 3, it identifies that this is a new crack, denoted as crack 2, expanding along another shear plane (shear plane 2). There is also an adiabatic shear band in the front of the crack 2 and some long and narrow cracks caused by microvoids connection were observed. On the section 2 which locates between section 1 and section 3, the junction of crack 1 and crack 2 is presented clearly. According to the diverse extension length of crack 1 on the section 1 and section 2, we can make sure that the crack 1 expanded from external and upside to inside and lower side of the specimen, at the same time, the crack 2 expanded from internal and upper to external and downward of the specimen verified by the diverse extension length of crack 2 on the section 2 and section 3. The two shear planes are cuneiform and make an angle of about  $45^\circ$  with the impact end surface. Finally, these two cracks intersected and formed a tridimensional “stagger ridge” structure. The normal

stress forms two maximum shear stresses on the opposite direction with an angle of  $90^\circ$ ; so the two cracks, which expanded respectively along the shear plane 1 and the shear plane 2, intersected even at an angle of about  $90^\circ$ , as shown on section 2 in Fig.13.

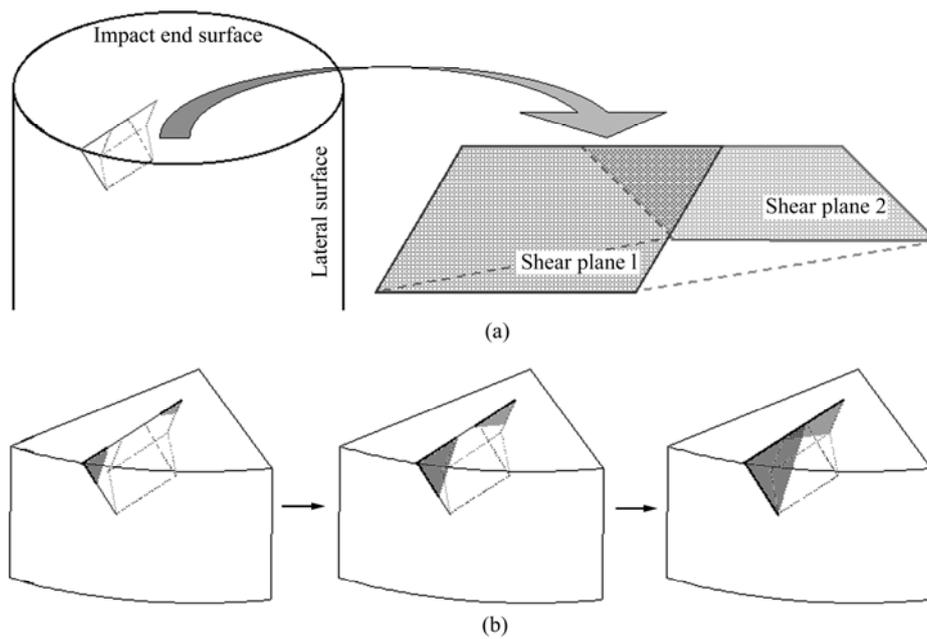
**Fig.14** Schematic diagrams of tridimensional “stagger ridge” structure (a), and expanding process of cracks and forming process of tridimensional “stagger ridge” structure (b)

Fig.14 presents the expansion of cracks and the forming process of the tridimensional stagger ridge structure schematically. As shown in Fig.14(a), the stagger ridge structure consists of two shear planes. These two shear planes intersect at an angle of  $90^\circ$ , and the intersecting sides of these two shear planes are not coincident absolutely. Fig.14(b) shows the expanding process of cracks and forming process of the tridimensional “stagger ridge” structure. Firstly, two cracks nucleate on the two different maximum shear stress planes (marked as shear plane 1 and shear plane 2, respectively). Then, these two cracks expand head-on along the maximum shear stress planes. Finally, these two cuneiform cracks encounter and intersect as a three-dimensional “stagger ridge” structure. And on the impact end surface, the intersecting line looks like a single crack. Based on the above discussion, under certain loading conditions, some “special cracks” without adiabatic shear band on its tip can form due to the complicated stress state. So, we should not simply consider that there is independent between those cracks and adiabatic shearing, and more in-depth studies are required.
