## Properties of dawsonite conversion film on AZ31 magnesium alloy

CHEN Jun, SONG Ying-wei, SHAN Da-yong, HAN En-hou

State Key Laboratory for Corrosion and Protection, Institute of Metal Research,  
Chinese Academy of Sciences, Shenyang 110016, China

**Abstract:** An environmentally friendly method for synthesizing a dawsonite conversion film was developed to improve the corrosion resistance of AZ31 Mg alloy. The film was prepared by two steps: the AZ31 alloy was first immersed in an  $\text{Al}_2(\text{SO}_4)_3$  solution venting  $\text{CO}_2$  gas to form a precursor film, and then the precursor film was treated in a  $\text{Na}_2\text{CO}_3$  solution dissolved with Al to obtain the dawsonite film. The surface morphology of the conversion film was observed with an environmental scanning electronic microscope. The chemical composition of the conversion film was analyzed by energy dispersive X-ray spectroscopy and X-ray diffractometry. Electrochemical and immersion tests were carried out to evaluate the protection effect of the conversion film on AZ31 alloy. There are some network-like cracks on the surface of the film. The conversion film is mainly composed of dawsonite  $\te

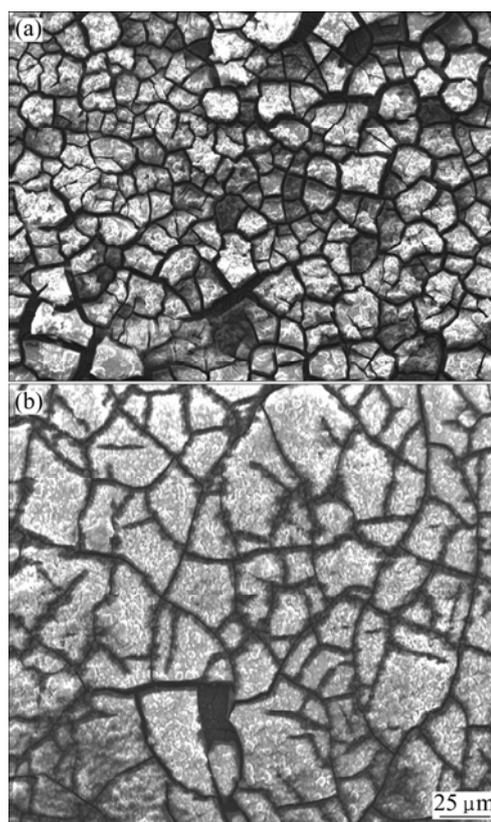
**Fig.1** SEM images of samples with precursor film (a) and final film (b)

Figure 1 shows the SEM micrographs of the samples with precursor and dawsonite film. The SEM morphology of the precursor film on AZ31 alloy shown in Fig.1(a) reveals a continuous coating with cracks. Fig.1(b) depicts the dawsonite film with network-like cracks. Compared with the precursor film, the surface

cracks were reduced and the flaw size was refined due to the post treatment in  $\text{Na}_2\text{CO}_3$  solution containing Al compounds. The chemical composition of the films was determined by EDS and listed in Table 1. It discloses that the precursor film was mainly composed of Al, O and S with a small amount of Mg, whereas the major elements in the final film were Al, O, and C, the content of Mg and S decreased and Na appeared. The variation in C concentration reveals that the precursor film changed to compounds containing C after post treatment.

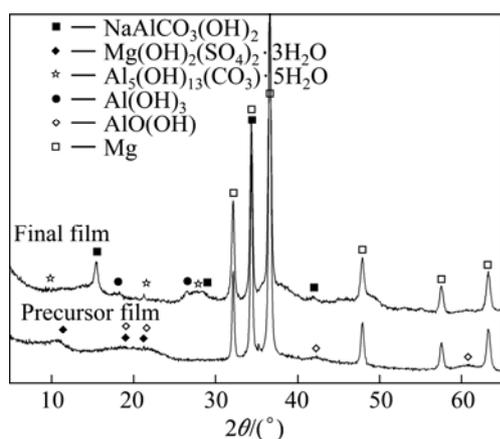
Fig.2 XRD patterns of films formed on surface of AZ31 alloy

The XRD patterns of the precursor and final films formed on the surface of AZ31 alloy are shown in Fig.2. The major phases existing in the precursor film were  $\text{Mg}(\text{OH})_2(\text{SO}_4)_2 \cdot 3\text{H}_2\text{O}$  and  $\text{AlO}(\text{OH})$ . The final film was composed of  $\text{NaAlCO}_3(\text{OH})_2$  dawsonite compound,  $\text{Al}(\text{OH})_3$  and  $\text{Al}_5(\text{OH})_{13}(\text{CO}_3) \cdot 5\text{H}_2\text{O}$ .

1) An environmentally friendly method for synthesizing dawsonite conversion film is developed to improve the corrosion resistance of AZ31 Mg alloy. The film is mainly composed of  $\text{NaAlCO}_3(\text{OH})_2$ ,  $\text{Al}(\text{OH})_3$  and  $\text{Al}_5(\text{OH})_{13}(\text{CO}_3) \cdot 5\text{H}_2\text{O}$ .

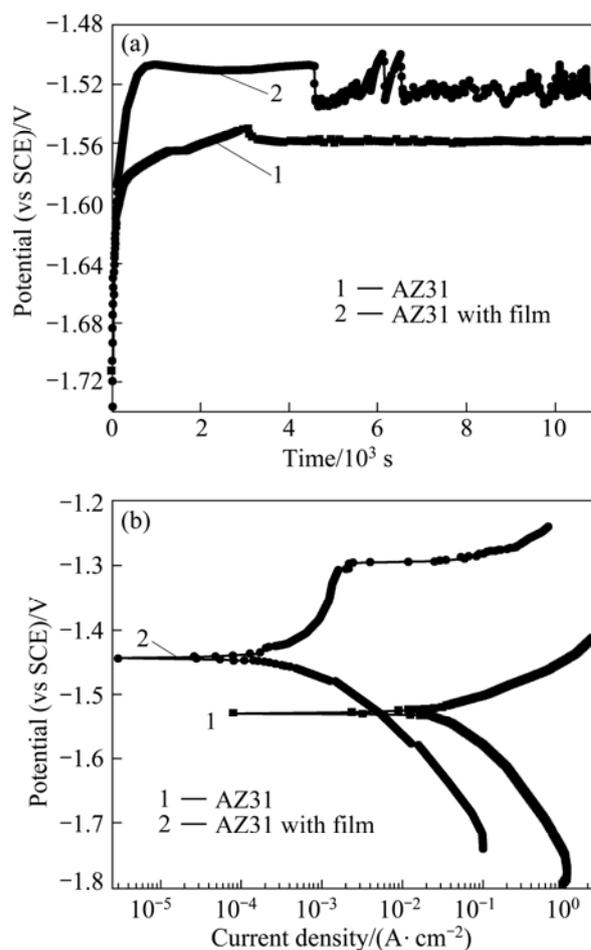
Fig.3 Potential vs time curves (a) and polarization curves (b) of AZ31 alloy with and without film in 0.1 mol/L NaCl solution

Figure 3(a) shows the curves of free corrosion potential ( $\varphi_{\text{corr}}$ ) as a function of time for the AZ31 substrate and its dawsonite film in 0.1 mol/L NaCl solution. The  $\varphi_{\text{corr}}$  of the substrate rose continuously, then slightly sloped down, and finally sustained a stable level of  $-1.558$  V(vs SCE) with increasing immersion time. It implies that a protective  $\text{Mg}(\text{OH})_2$  corrosion product film was formed immediately on the AZ31 substrate, and then the film ruptured after being soaked for 3 115 s. Finally, the rupture and formation of the corrosion products film reached a dynamic equilibrium. The  $\varphi_{\text{corr}}$  of the dawsonite film rapidly increased from  $-1.736$  to  $-1.505$  V(vs SCE) at 730 s in the initial stage of immersion, and then kept stable with a sudden interruption at 4 570 s, and finally fluctuated in a small range, indicating the local failure of the film and the formation of corrosion products. It is obvious that the  $\varphi_{\text{corr}}$  of AZ31 alloy with film was always more positive than that of the substrate, which indicates that the AZ31 substrate became more stable after being deposited with the dawsonite film.

Polarization curves are demonstrated in Fig.3(b). There was great difference at the anodic sides of the two curves. In the case of AZ31 alloy, the corrosion current density quickly increased with increasing potential, indicating the active dissolution of Mg substrate. Differently, the anodic side of the coated alloy exhibited a large passivation region and the breakdown potential  $\varphi_b$  was about  $-1.31$  V( vs SCE). This result indicates that the dawsonite film can greatly inhibit the corrosion of Mg substrate. Once the anodic potential reached the film breakdown potential, the sample corroded quickly, implying that the film is sensitive to pitting corrosion. The electrochemical parameters of the alloy with and without film are listed in Table 2. It is clear that the dawsonite film significantly improves the corrosion resistance of AZ31 alloy in view that  $J_{\text{corr}}$  value was decreased by about two orders of magnitude.

2) The conversion film can increase the corrosion potential ( $\phi_{\text{corr}}$ ) and decline the corrosion current density ( $J_{\text{corr}}$ ) of the substrate by about two orders of magnitude. The anodic polarization curve of the coated alloy exhibits a large passivation region. It is indicated that this film can provide good protection to the Mg alloy.

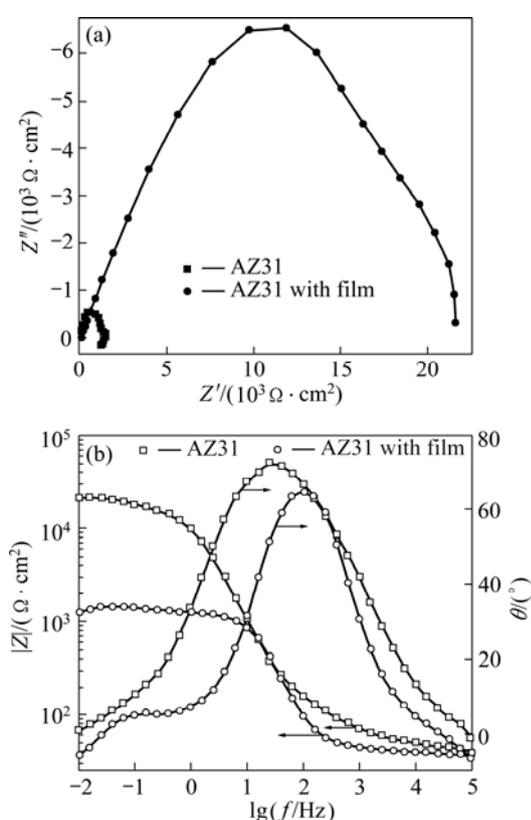
**Fig.4** EIS results of AZ31 alloy with and without film in 0.1 mol/L NaCl solution: (a) Nyquist plots; (b) Bode plots

The corrosion behavior of the AZ31 alloy with and without film was investigated with EIS measurements (Fig.4). The Nyquist plot for the AZ31 substrate consisted of three loops, one high frequency capacitive loop, one medium frequency capacitive loop and one short low frequency inductive loop. The high frequency capacitive loop is due to the contribution of electric double layer at the interface of substrate and solution; the medium frequency capacitive loop relates to the adsorption of corrosion products on the AZ31 surface[23], BARIL et al[24] and ANIK and CELNKTEN[25] also suggested that this loop originates from the diffusion through a porous solid film, and the low frequency inductive loop is attributed to the corrosion nucleation in the initiation stage of localized

corrosion. The existence of inductive loop indicates that there are corrosion pits on the surface of Mg substrate. The plot for the coated sample contains only one capacitive loop. It implies that the coating is compact and undamaged. In addition, the diameter of the plot is much larger than that of the substrate. According to the Bode plot of  $|Z|$  vs frequency, it is found that the  $|Z|$  value changes from  $1.46 \times 10^3$  for the AZ31 substrate to  $2.21 \times 10^4 \Omega \cdot \text{cm}^2$  for the dawsonite film coated sample. Higher  $|Z|$  value represents better corrosion resistance[23]. Thus, the conversion film can enhance the corrosion resistance of AZ31 alloy in 0.1 mol/L NaCl solution.

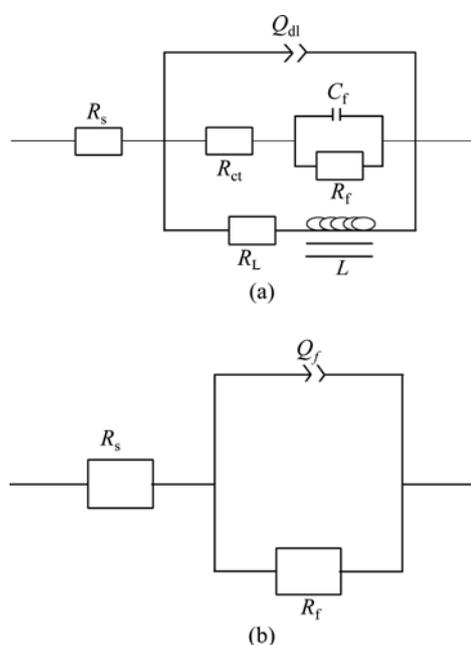
**Fig.5** Equivalent circuits of EIS plots for (a) bare AZ31 alloy and (b) AZ31 alloy with film

EIS plots can be equivalent to the circuits as shown in Fig.5, which can be applied to simulate the impedance plots of the bare AZ31 and coated sample.  $R_s$  is the solution resistance;  $R_{ct}$  is the charge transfer resistance;  $Q_f$  is the capacity of conversion film on AZ31 alloy and  $Q_{dl}$  represents the electric double layer capacity. The constant phase element ( $Q$ ) is used to compensate for

the non-homogeneity in the system[23].  $Q$  is defined by two values,  $Y_0$  and  $n$ . If  $n$  is equal to 1,  $Q$  is identical to a capacitor.  $C_f$  and  $R_f$  represent the capacity and resistance of the corrosion products film on AZ31 alloy, respectively.  $R_L$  and  $L$  represent the inductance resistance and inductance, respectively, and are used to describe the low frequency inductive loop, implying the initiation of pitting corrosion[23]. The capacity and resistance of the conversion film on AZ31 alloy are characterized by  $Q_f$  and  $R_f$ , respectively. The EIS fitting results are listed in Table 3. The  $R_f$  for the coated sample is about two orders of magnitude of the  $R_f$  for the bare alloy, which indicates that the corrosion resistance of the dawsonite film is much better than that of the corrosion products film formed on the AZ31 substrate surface.

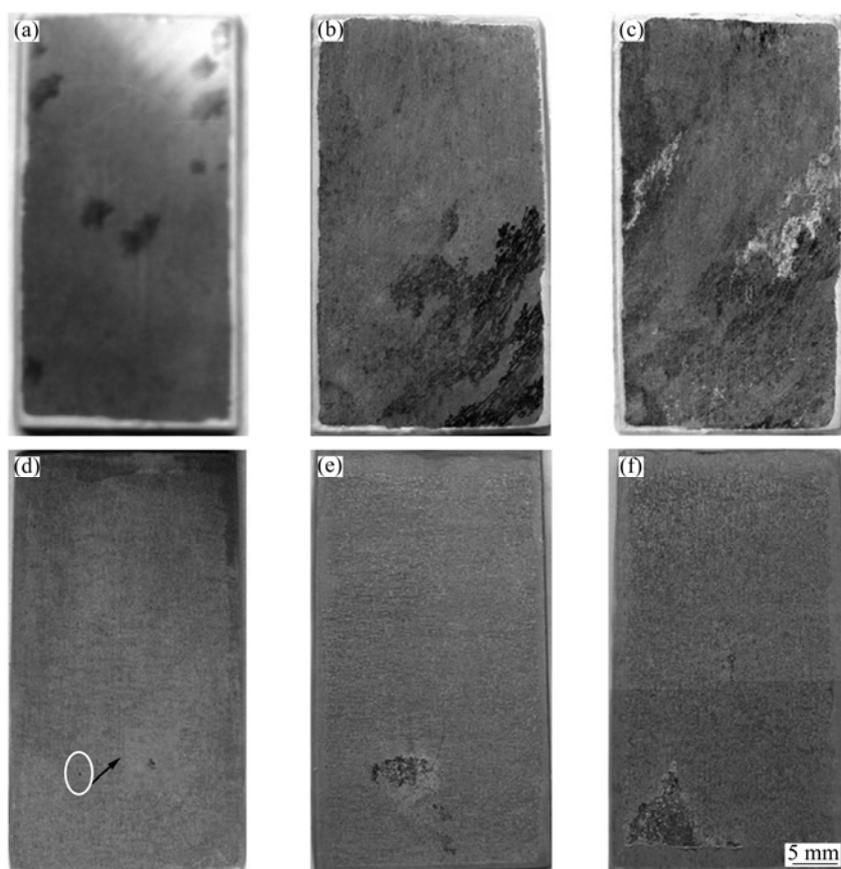
**Fig.6** Optical morphologies of substrates (a, b, c) and coated specimens (d, e, f) after immersion tests for 2.5 h, 24 h and 48 h in 0.1 mol/L NaCl, respectively

Figure 6 shows the optical morphologies of the AZ31 specimens with and without film after 2.5, 24 and 48 h immersion tests, respectively. After 2.5 h, severe pitting corrosion occurred on the bare material, as marked in Fig.6(a). However, the first corrosion pit initiated on the specimen with dawsonite film until 2.5 h later, as shown in Fig.6(d). It can be seen that the corrosion did not present at other areas and only expanded around the initial pits. After 48 h immersion

test, the bare material underwent serious general corrosion (Fig.6(c)), while the majority of the coated sample was not attacked except for the localized narrow areas (Fig.6(f)). It is in accordance with the result of polarization curves that the coated sample is susceptible to pitting corrosion and the bare alloy can not resist to general corrosion. The optical corrosion morphologies also indicate that the corrosion resistance of the coated alloy was superior to that of the Mg substrate.

3) After immersion tests, the film almost keeps intact, except for the localized narrow areas with some corrosion pits, while the bare material undergoes serious general corrosion.

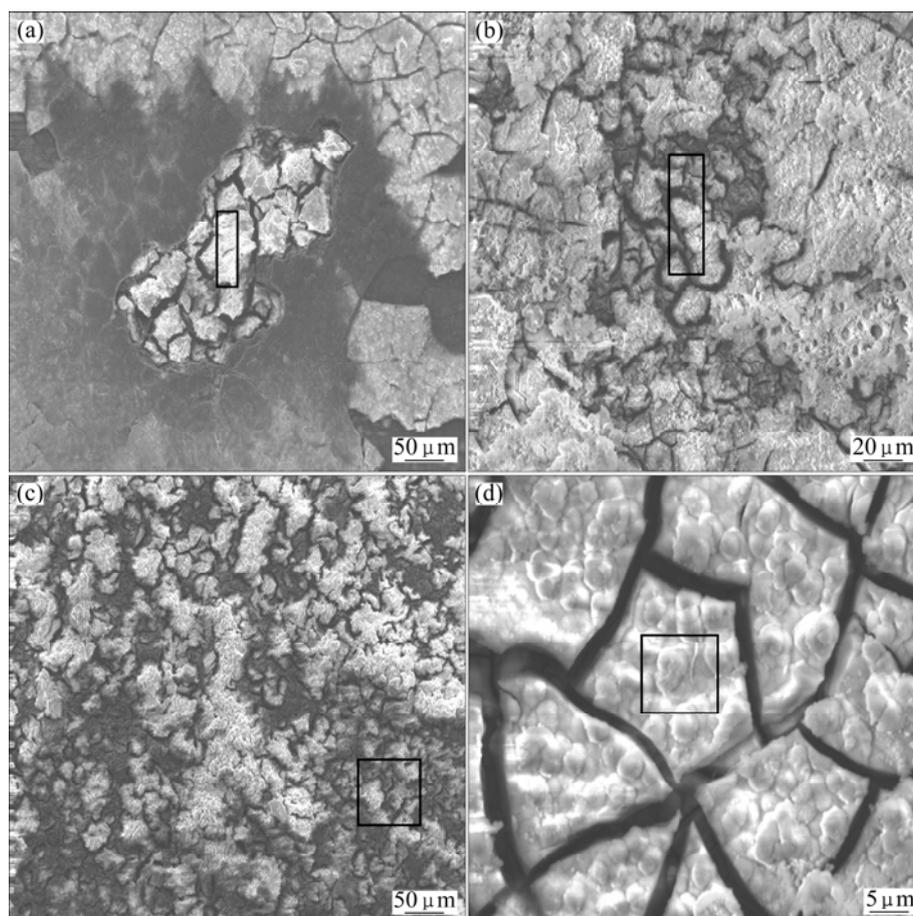
Fig.7 SEM images of coated samples after immersion tests for 2.5 h (a), 24 h (b) and 48 h (c, d)

SEM corrosion morphology of the dawsonite film after immersed in 0.1 mol/L NaCl solution for different time is shown in Fig.7. There was one corrosion pit appearing on the surface of the film after 2.5 h immersion, and the size of the corrosion pit gradually increased with increasing immersion time. The film lost its typical dawsonite film surface morphology after corrosion, and a different layer of insoluble corrosion products was deposited on the pit area. However, other regions still kept intact even after 48 h immersion (Fig.7(d)).

EDS test was carried out in the rectangle regions as marked in Fig.7 to study the chemical composition of the films after immersion test, and the results are listed in

Table 4. It can be observed that there existed slight change in the content of the elements in the intact area of the film, which agrees with the images as shown in Fig.7(d) compared with the film without immersion as listed in Table 1. However, the content of Mg increased greatly in the corrosion pits. Usually, in aqueous solution, the surface layer of magnesium can react with water to form magnesium hydroxide ( $Mg(OH)_2$ ). When the conversion film ruptures and the Mg substrate is exposed, more and more  $Mg(OH)_2$  is deposited in the corrosion pits with increasing immersion time. Correspondingly, the content of Mg increases, while that of C reduces from 20.37% to 13.52%.
