Effect of scratch on corrosion resistance of calcium phosphate conversion coated AZ80 magnesium alloy

Abstract: In order to analyze the effect of scratch on the corrosion behaviour of a calcium phosphate conversion coating (CPCC) on AZ80, the electrochemical testing, scanning vibrating electrode technique (SVET), immersion test and hydrogen evolution experiment were performed to study the corrosion resistance of AZ80, AZ80 with CPCC and coated AZ80 with scratch. The results show that the coating improves the corrosion resistance of the AZ80 from a current density of (85 ± 4) to (4 ± 1) $\mu\text{A}/\text{cm}^2$. When the coating was damaged, its protection on substrate would be reduced. The scratch with a length of around 12 mm on the coating reduced the corrosion resistance to a current density of (39 ± 1) $\mu\text{A}/\text{cm}^2$. In addition, the corrosion occurred initially in the scratch area and the corrosion site first occurred at the junction of the scratch and the coating. Besides, the micro corrosion mechanism of the specimen containing scratch was clarified.

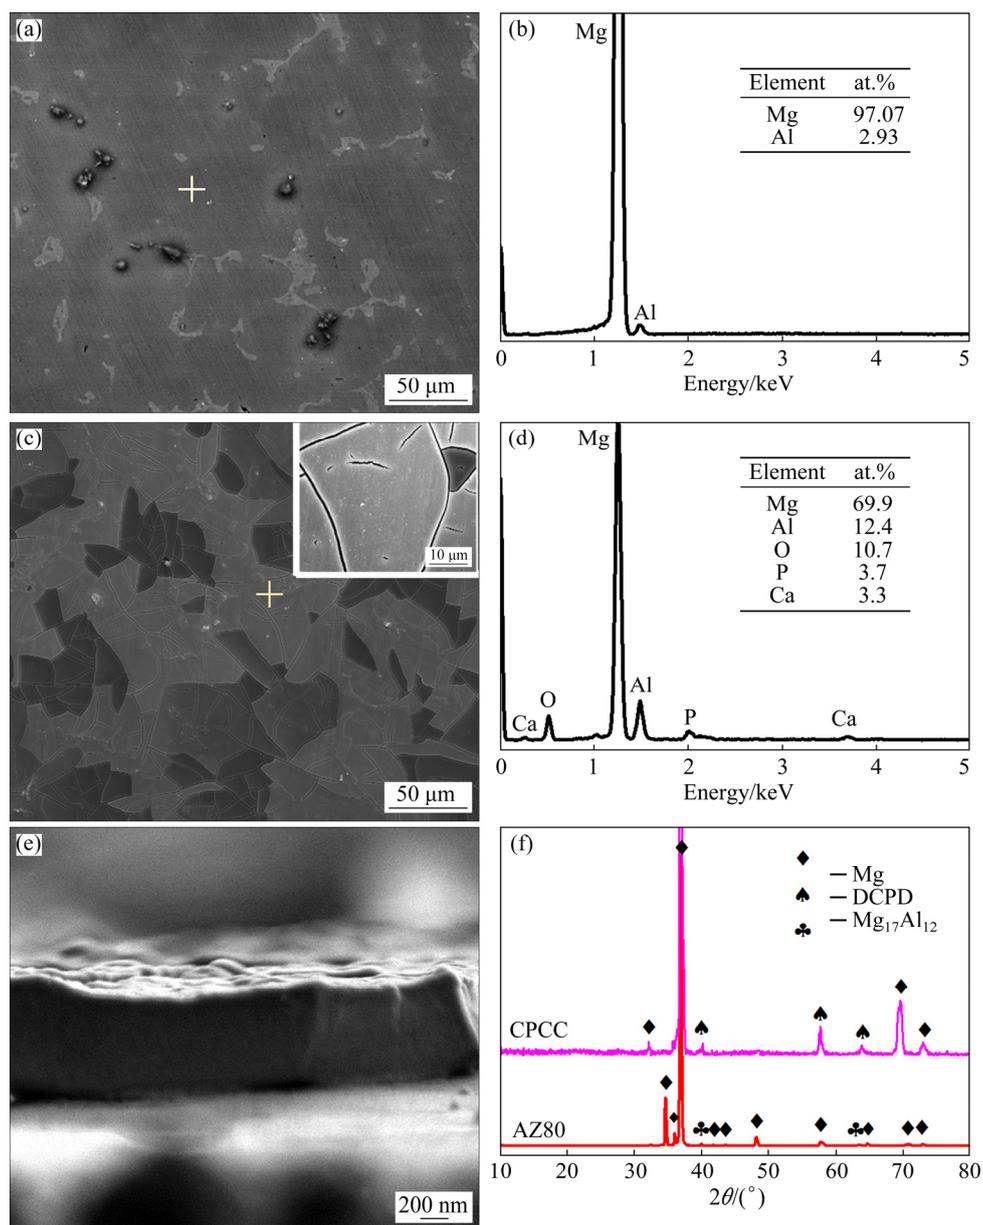
Fig. 1 SEM images and EDS analyses of AZ80 (a, b), CPCC (c, d), cross-section image of CPCC (e), and XRD patterns of AZ80 and CPCC (f)

Figure 1 displays the SEM images, EDS and XRD analyses of AZ80 and CPCC. The second phase in AZ80 magnesium was identified as Mg₁₇Al₁₂ (Fig. 1(f)). It is reported that the second phase will induce galvanic corrosion, resulting in poor corrosion resistance of the AZ80 magnesium alloy [26–28]. The CPCC on AZ80 exhibited a micro-cracked structure (Fig. 1(c)) with a thickness of about 800 nm (Fig. 1(e)). The microcracks are common on the surface of chemical conversion coated magnesium alloys [29,30]. The formation of micro-cracks is likely owing to the reduced molar volume of the conversion coating from dehydration process [31]. The entrapped hydrogen-induced coating cracking mechanism could also lead to the formation of cracks [32]. The EDS results (Fig. 1(d)) of CPCC showed that CPCC was composed of Mg (69.9%), Al (12.4%), O (10.7%), P (3.7%) and Ca (3.3%). The molar ratio of Ca to P was about 1.0, which was close to that of dicalcium phosphate dihydrate (DCPD). The XRD results (Fig. 1(f)) revealed that the main component of CPCC was DCPD, which was consistent with the EDS results.

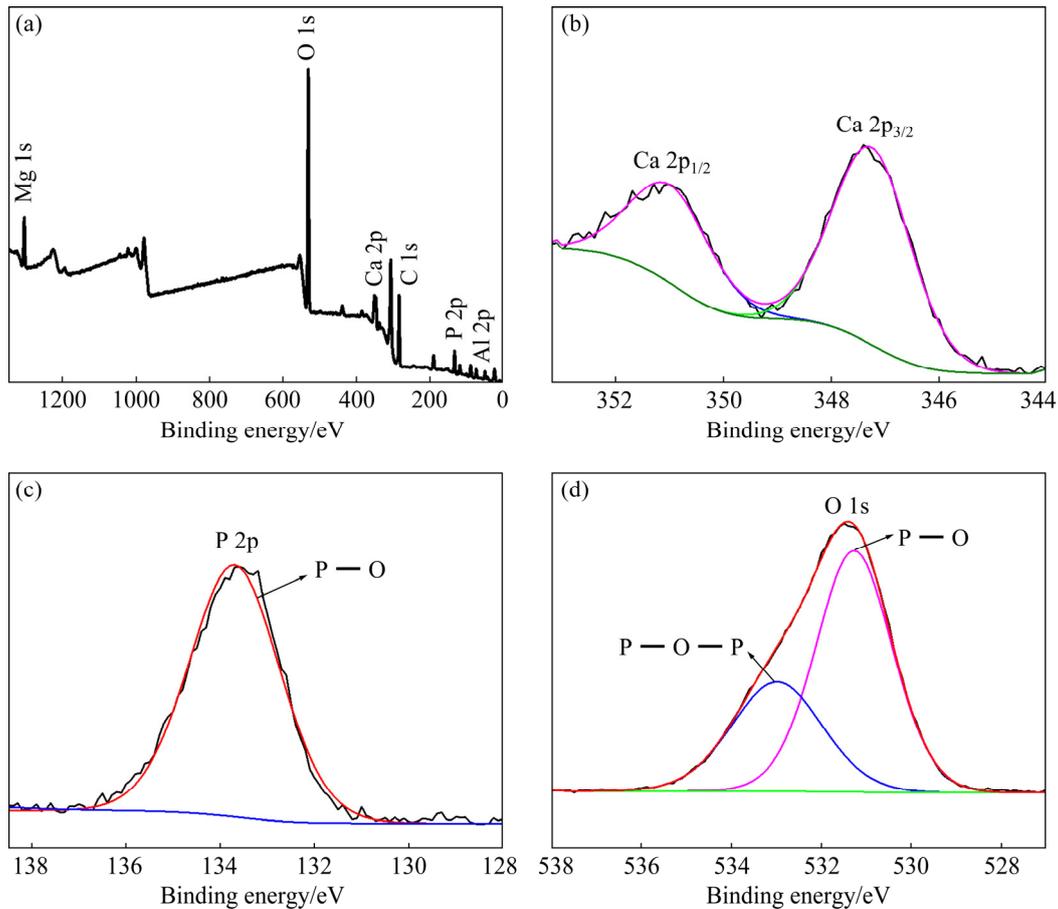
Fig. 2 XPS spectra of CPCC: (a) Survey scanning spectrum; (b) High-resolution spectrum of Ca 2p; (c) High-resolution spectrum of P 2p; (d) High-resolution spectrum of O 1s

The chemical states of the surface elements on the CPCC were measured using XPS. The XPS survey spectra contained peaks of O, P, Ca, Mg, Al and C (Fig. 2(a)), and the element contents are shown in Table 2. The C peak is commonly seen

in XPS results because of the extraneous hydrocarbons in the environment [22]. The Mg and Al peaks were from the AZ80 substrate because the CPCC was thin with a micro-cracked structure. The peaks of O, P, Ca reflected the composition of CPCC. The high-resolution XPS spectra of the Ca 2p, P 2p and O 1s are depicted in Figs. 2(b)–(d), respectively. Two prominent peaks of Ca 2p_{3/2} (347.3 eV) and Ca 2p_{1/2} (350.9 eV) were detected, which were generally assigned to the Ca—P compound [33–35]. The P 2p at binding energy of 133.7 eV was attributed to the HPO₄²⁻ radical of CaHPO₄ [36]. The high-resolution O 1s showed two

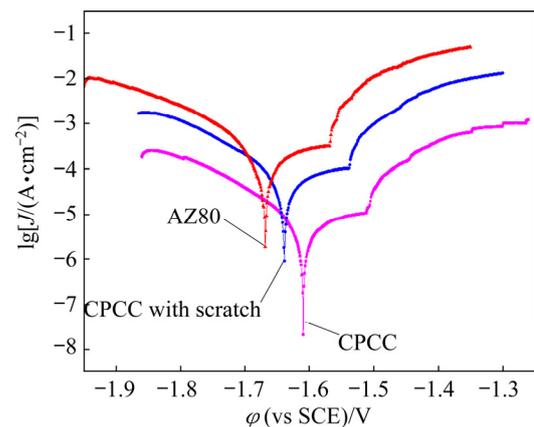
Fig. 3 Potentiodynamic polarization curves of AZ80, CPCC and CPCC with scratch measured in 3.5 wt.% NaCl solution

Figure 3 and Table 3 show the potentiodynamic polarization curves of all specimens after immersion in 3.5 wt.% NaCl solution. The results show that the corrosion current density of CPCC ($(4\pm 1) \mu\text{A}/\text{cm}^2$) was over an order of magnitude lower than that of AZ80 ($(85\pm 4) \mu\text{A}/\text{cm}^2$), demonstrating that CPCC improved the corrosion resistance of AZ80. When the CPCC was damaged to a certain extent, the current density (J_{corr}) of the CPCC with scratch increased to $(39\pm 1) \mu\text{A}/\text{cm}^2$ from $(4\pm 1) \mu\text{A}/\text{cm}^2$ for CPCC. The increased corrosion rate was attributed to the scratch of the coating shortening the mass

transfer channel of the corrosion process, so that the solution directly reached the substrate. However, the corrosion current density of scratched coating was still lower than that of AZ80, indicating that the damaged coating still has a protective effect on the magnesium alloy.

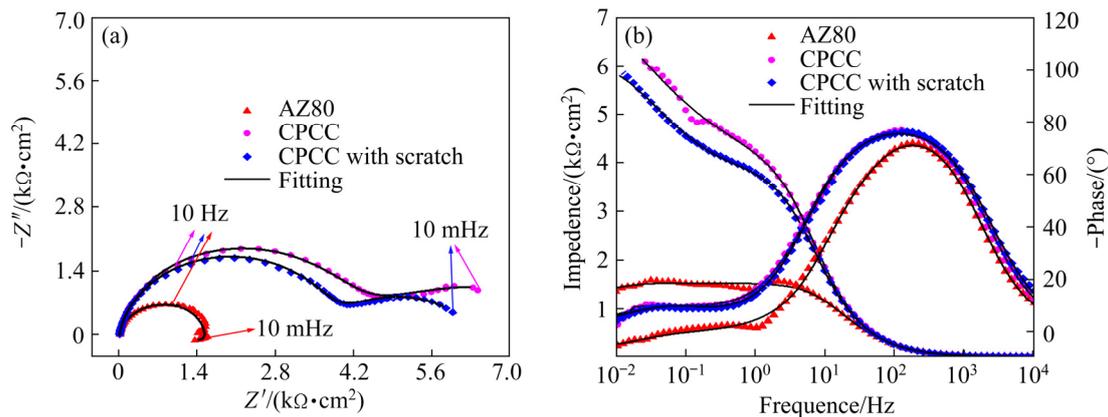
**Fig. 4** Nyquist diagram (a) and Bode diagram (b) of AZ80, CPCC and CPCC with scratch measured in 3.5 wt.% NaCl solution

EIS can effectively reflect the corrosion performance of the specimens. Nyquist diagrams of AZ80, CPCC and CPCC with scratch measured in 3.5 wt.% NaCl solution are presented in Fig. 4(a) and Bode diagrams are presented in Fig. 4(b). The overall corrosion resistance of the specimens can be evaluated by the impedance modulus at low-frequency and the radius of the Nyquist curves. In general, the higher the impedance modulus, the larger the radius of the Nyquist curves, and the better the corrosion resistance [38–40]. Therefore, the corrosion resistance order of the specimens is:

CPCC > CPCC with scratch > AZ80, which is consistent with the potentiodynamic polarization results.

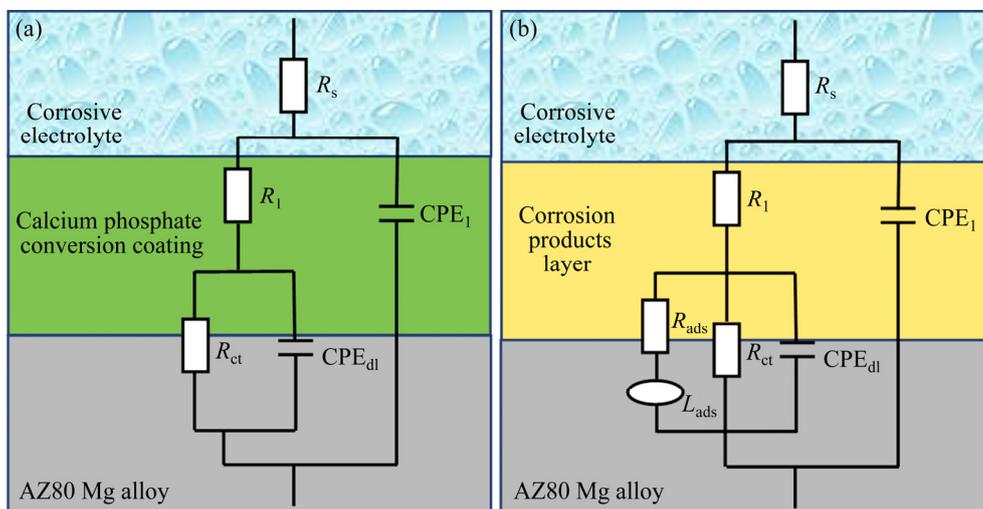
**Fig. 5** Equivalent circuit diagrams for CPCC and CPCC with scratch (a) and AZ80 (b)

The equivalent circuit diagrams for EIS of AZ80, CPCC and CPCC with scratch are presented in Fig. 5. In the equivalent circuits, R_s corresponds to the electrolyte solution resistance. As for CPCC and CPCC with scratch specimens, R_1 describes the phosphate conversion coating resistance, R_{ct} represents the charge transfer resistance, CPE_1 corresponds to the constant phase element of the coating, and CPE_{dl} represents the double-layer constant phase element. For AZ80 specimens, R_1 and CPE_1 correspond to the loose corrosion products layer resistance and constant phase element, respectively; R_{ct} and CPE_{dl} represent the charge transfer resistance and the double-layer constant phase element, respectively; R_{ads} and L_{ads} represent the low frequency (LF) inductive loop. The EIS spectra (Fig. 4) of CPCC and CPCC with

scratch consisted of two capacitive loops at high frequency (HF) and middle frequency (MF). The equivalent circuit diagram of CPCC and CPCC with scratch is presented in Fig. 5(a). Generally, the capacitive loops at HF and MF reflect the physicochemical process of the coating and their specific structural features or electrochemical properties [31,41,42]. The EIS of AZ80 immersed in NaCl solution consisted of two capacitive loops at HF and MF and an inductive loop at low frequencies (LF), which is consistent with the equivalent circuit shown in Fig. 5(b). The additional inductive loop for AZ80 is attributed to the adsorption and desorption of the corrosion products such as $Mg(OH)_2$, demonstrating the formation of a thin film of $Mg(OH)_2$ during the period for building a stable OCP in 3.5 wt.% NaCl solution before EIS test. The formation of $Mg(OH)_2$ indicates slow corrosion reaction on the surface of AZ80 [43–45].

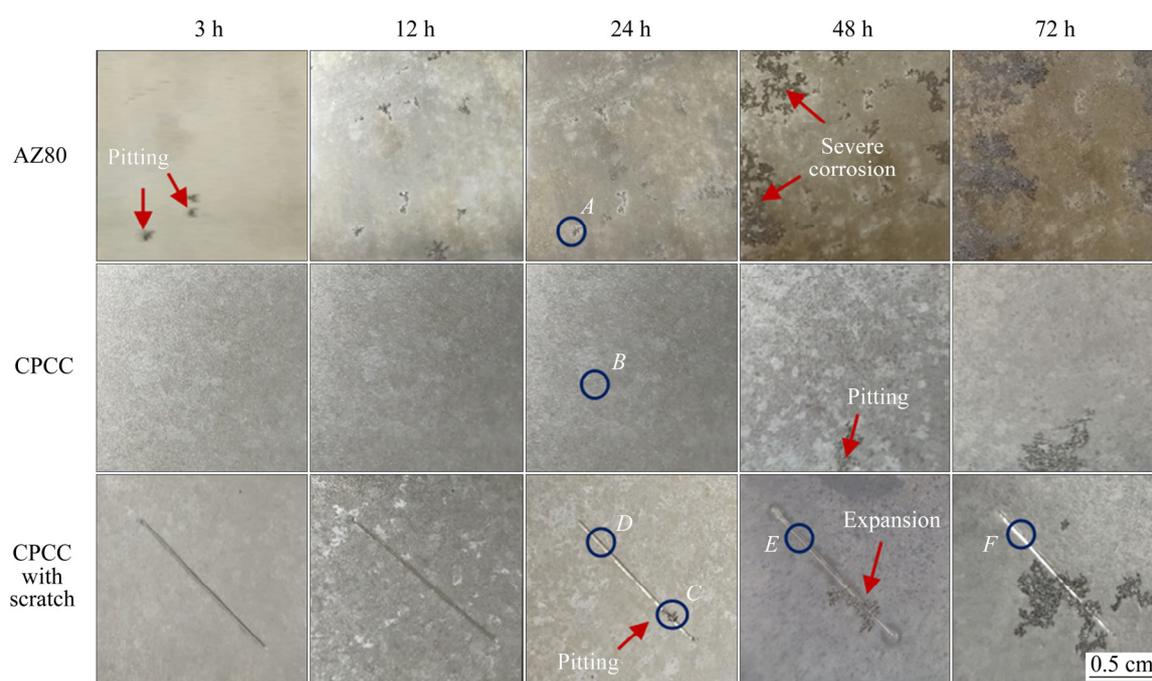
Fig. 6 Morphologies of AZ80, CPCC and CPCC with scratch immersed in 3.5 wt.% NaCl solution for different time

The corrosion morphologies of the specimens immersed in 3.5 wt.% NaCl solution for different time are shown in Fig. 6. After immersing for 3 h, there was obvious localized corrosion on the surface of AZ80, which is attributed to the microgalvanic acceleration of the corrosion of the matrix phase by the adjacent second phase particle. As the immersion time increased, the corrosion proceeded more deeply. After 48 h immersion, the

surface of AZ80 underwent severe corrosion. Pitting corrosion initiated on CPCC after 48 h immersion, indicating an enhanced corrosion resistance. In the case of CPCC with scratch, pitting corrosion firstly occurred after being immersed for 24 h. In addition, as the immersion time increased, the corrosion expanded from the scratch to the surroundings.

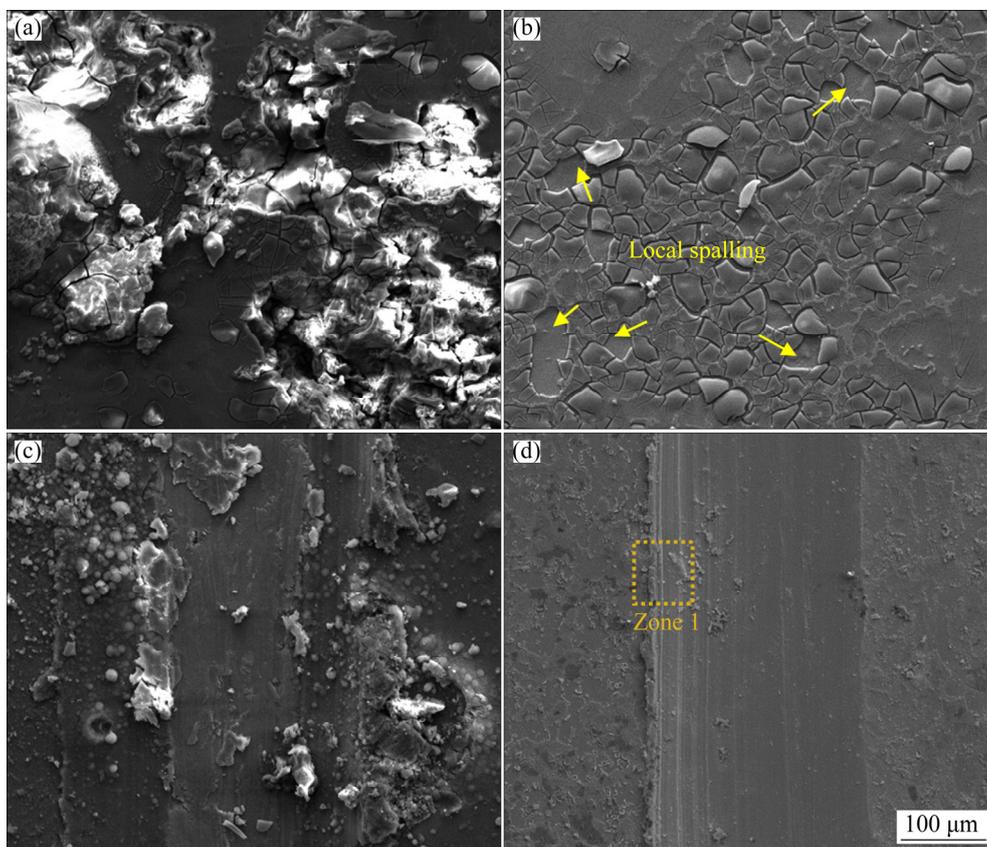
Fig. 7 SEM images of specimens immersed in 3.5 wt.% NaCl solution for 24 h at different zones in Fig. 6: (a) AZ80 (Zone *A*); (b) CPCC (Zone *B*); (c) CPCC with scratch (Zone *C*); (d) CPCC with scratch (Zone *D*)

In order to further analyze the corrosion characteristics, the microstructures of the specimens immersed for 24 h were selected for comparison. The microstructures observed at zones *A*, *B*, *C* and *D* in Fig. 6 are shown in Fig. 7. AZ80 had obvious corrosion (Fig. 7(a)) and the CPCC had local spalling (Fig. 7(b)). In the case of the scratched coating, there was some pitting corrosion in some scratch areas, as shown in Fig. 7(c). However, the appearance at Zone *D* (Fig. 7(d)) indicated that corrosion was not remarkable in other scratched areas.

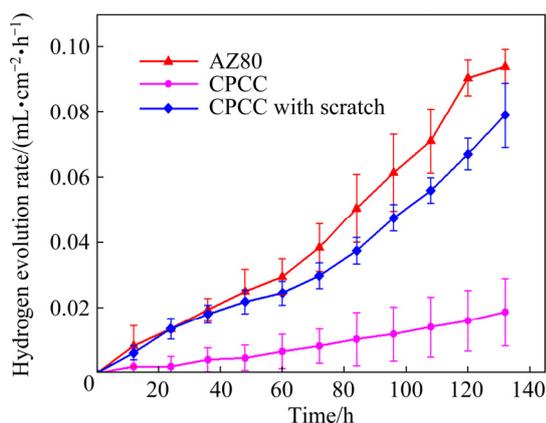
Fig. 8 Hydrogen evolution rate of AZ80, CPCC and CPCC with scratch immersed in 3.5 wt.% NaCl solution

experiments were carried out in the 3.5 wt.% NaCl solution. The results (Fig. 8) show that the hydrogen evolution rate of AZ80 is the fastest. After phosphating, the hydrogen evolution rate of the alloy decreased and the corrosion resistance was improved. The hydrogen evolution rate of CPCC with scratch was higher than that of CPCC, but still lower than that of AZ80, which is consistent with the results of electrochemical testing.

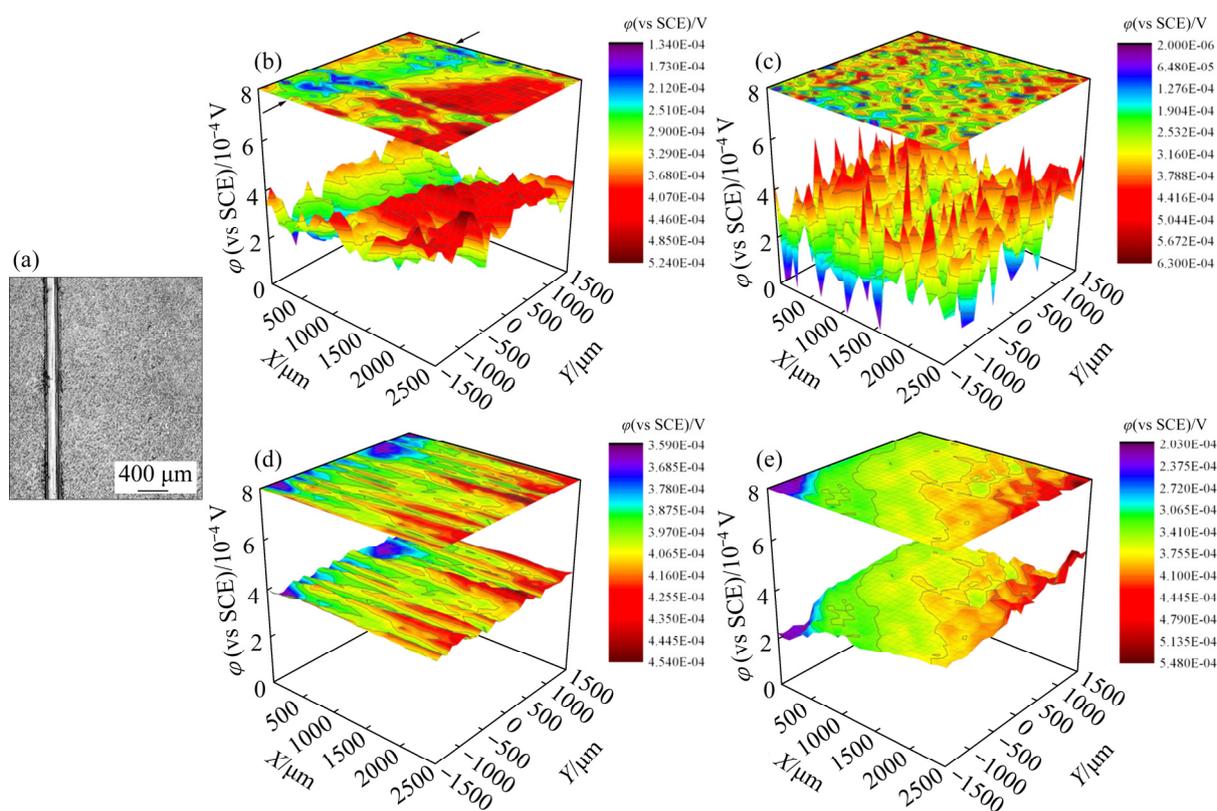
Fig. 9 Optical image of CPCC with scratch before immersion in 3.5 wt.% NaCl (a), and SVET maps after immersion for 15 min (b), 1 h (c), 3 h (d) and 6 h (e)

the corrosion behaviour of CPCC with scratch for different immersion time. The optical microstructure of the scratched coating before the test and the SVET maps after 15 min, 1 h, 3 h and 6 h immersion in corrosive solution are presented in Fig. 9. The SVET map after 15 min immersion (Fig. 9(b)) shows that the potential of the scratch area (as pointed by the black arrows) was lower than that of non-scratch area, indicating that the anodic region occurred initially at the scratch area.

The strong corrosion in the scratch area occurred because of the direct contact between the exposed magnesium alloy substrate at the scratch and the NaCl corrosive solution. When the immersion time increased to 1 h (Fig. 9(c)), there was small potential difference between the scratch area and the non-scratch area. This indicated that there was no obvious local corrosion in the scratch area. It is assumed that the accumulated film of corrosion products caused the reduction of the corrosion rate [40]. With the further increase of the immersion time to 3 and 6 h, affected by the edge effect, no obvious corrosion was found in the scratch areas, and the whole test areas exhibited mainly global corrosion. Hence, it was concluded from the SVET that the scratch mainly affected the initial stage of corrosion by inducing local corrosion.

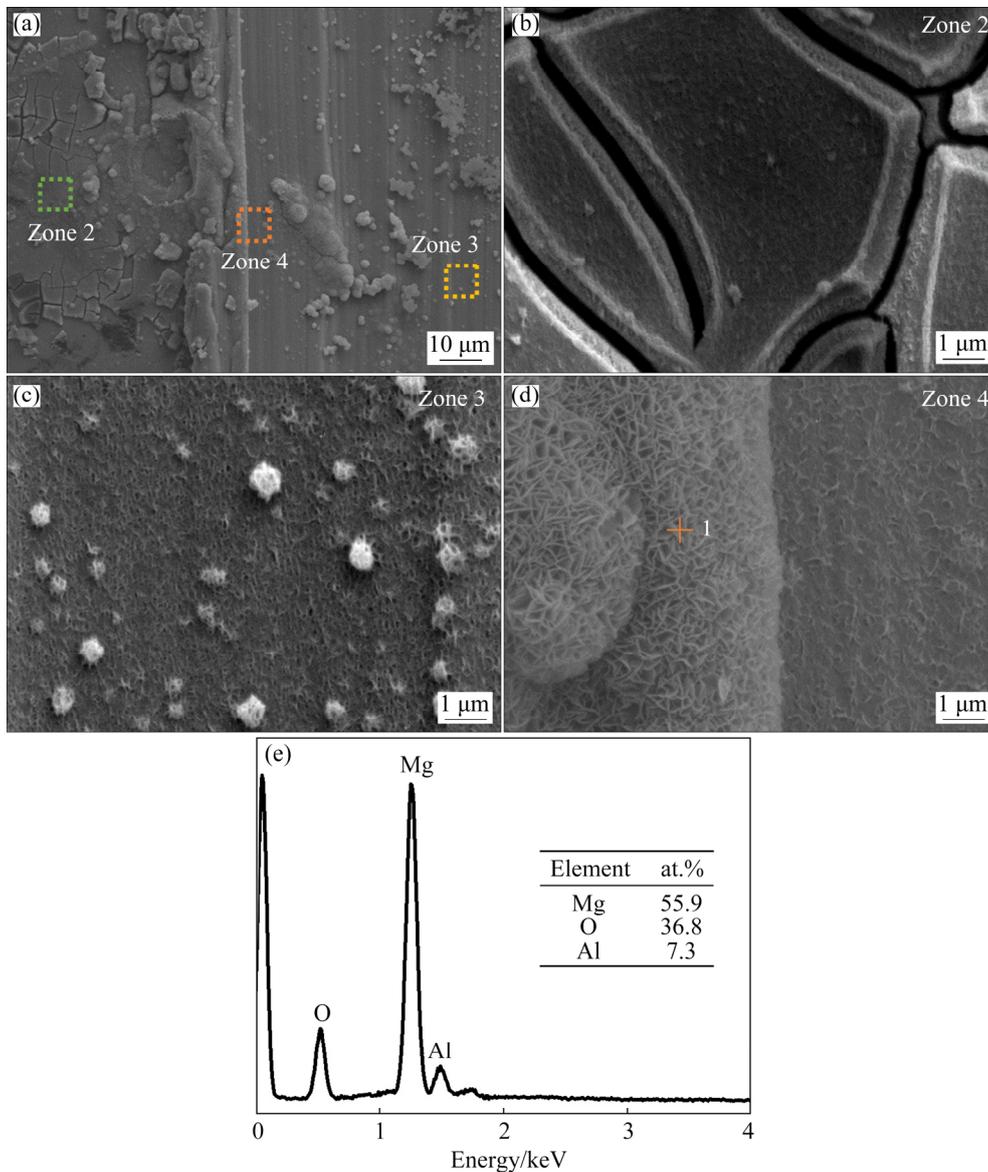
Fig. 10 SEM images of CPCC with scratch immersed in 3.5 wt.% NaCl solution for 24 h: (a) Overall morphology (Zone 1 in Fig. 7(d)); (b) Zone 2 for CPCC; (c) Zone 3 for substrate; (d) Zone 4 for junction of coating and substrate; (e) EDS spectrum of Point 1 in (d)

The image of CPCC with scratch immersed in 3.5 wt.% NaCl solution for 24 h at Zone 1 in Fig. 7 is shown in Fig. 10(a). Figures 10(b)–(d) are local

enlarged images of Fig. 10(a), which represent the area of the coating, the AZ80 substrate area and the bonding area between the coating and the substrate, respectively. After immersion in NaCl solution for 24 h, a small number of particles and flocs were formed on the CPCC (Fig. 10(b)). The evenly distributed flower-like clusters and some granular products were formed on the substrate (Fig. 10(c)). At the same time, the obvious lamellar corrosion products were formed in the scratch (Fig. 10(d)). The result of EDS (Fig. 10(e)) showed that the lamellar corrosion products were mainly composed of Mg, O and Al. Generally, the corrosion reaction of magnesium alloy in NaCl solution is usually

It was observed that corrosion occurred initially at the scratch. Such phenomenon may be due to the potential difference between the AZ80 substrate and the coating, resulting in galvanic corrosion in the NaCl solution [48,49]. Furthermore, the corrosion firstly occurred at the junction between the scratch and the coating rather than in the scratch groove. We speculate that this may be

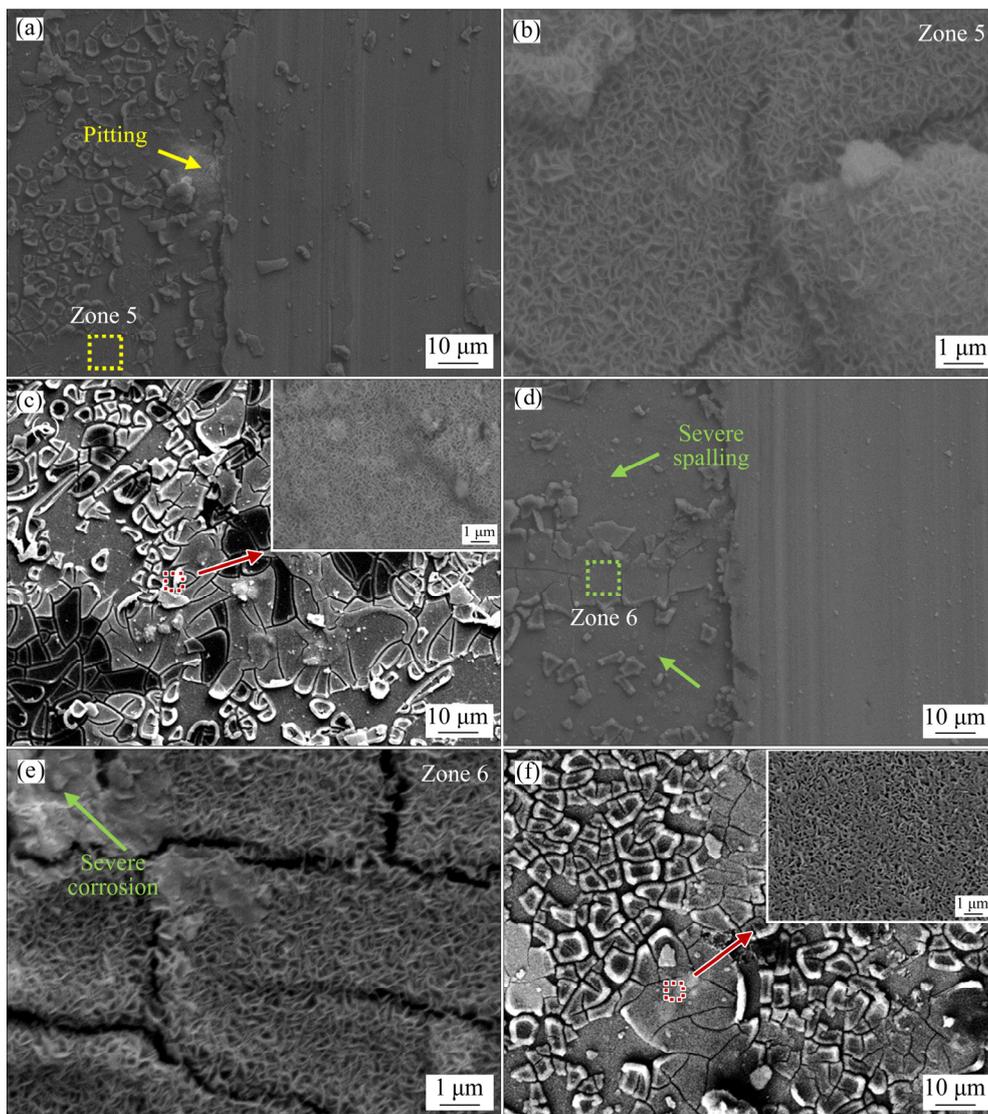
Fig. 11 SEM images of CPCC with scratch immersed in 3.5 wt.% NaCl solution for 48 h (a, b) (Zone E in Fig. 6) and 72 h (d, e) (Zone F in Fig. 6), and coating without damage immersed in 3.5 wt.% NaCl solution for 48 h (c) and 72 h (f)

without scratch were observed after immersion for 48 and 72 h, as shown in Fig. 11. As for the scratched specimens, after immersion in NaCl solution for 48 h, the accumulation of corrosion products occurred on the AZ80 substrate, compared with immersion for 24 h (Fig. 10(c)), and the CPCC was cracked and spalled (Fig. 11(a)). In addition, the lamellar corrosion products $Mg(OH)_2$ were found on the CPCC (Fig. 11(b)). This is because chloride ions in the solution are more likely to reach the magnesium alloy matrix through the cracks and then cause corrosion [53]. After immersion in NaCl solution for 72 h, most of the CPCC detached (Fig. 11(d)). In addition, there were corrosion products and large cracks on the remained coating (Fig. 11(e)), indicating that the specimen exhibited severe corrosion even for the coating. For the

specimens without scratch, the chemical conversion coating peeled off locally, and fine layered corrosion products were found on the coating after immersion for 48 h, as shown in Fig. 11(c). When the immersion time increased to 72 h, the coatings seriously cracked and partially peeled off. The flocculent corrosion products formed on the surface of coating (Fig. 11(f)). Obviously, the corrosion degrees of the specimens without damage were lower than those of the scratched specimens. Therefore, the scratch had a great influence on the corrosion behavior of the specimens which would accelerate the corrosion of the specimens because of the opened corrosion channel.

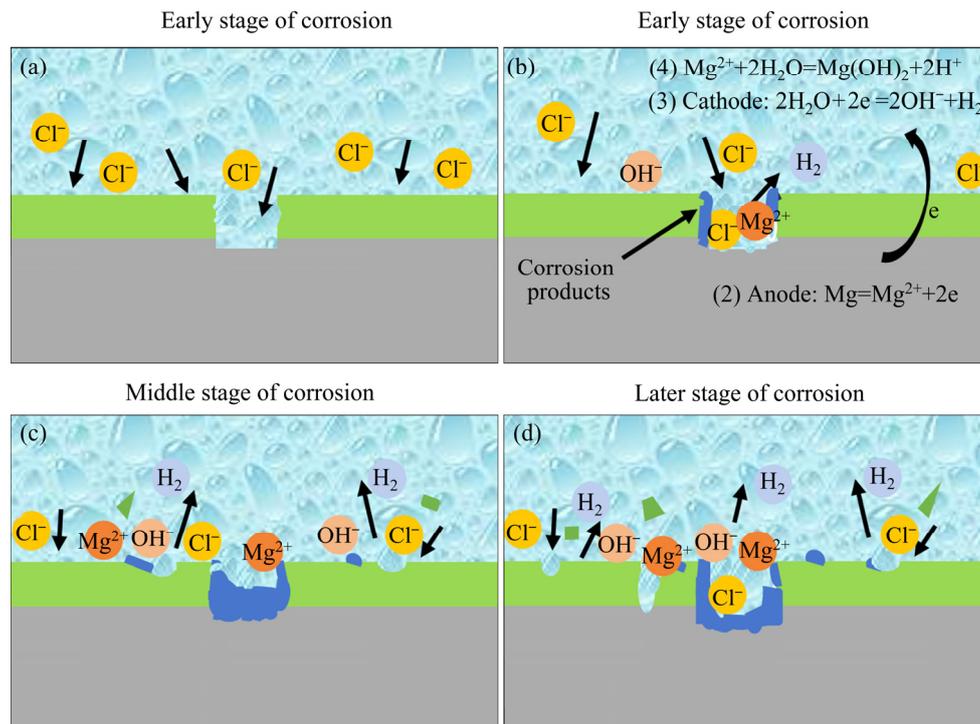
Fig. 12 Schematic showing corrosion process and mechanism of CPCC with scratch in 3.5 wt.% NaCl solution at various immersion time

Based on the clarification of corrosion mechanism of AZ80, CPCC and CPCC with scratch, a schematic model was established, as shown in Fig. 12. In the early corrosion stage, the scratched coating was immersed in the 3.5 wt.% NaCl solution rich in corrosive ions (Fig. 12(a)). The corrosion firstly occurred at the junction of the scratch and the CPCC (Fig. 12(b)). This is because a corrosion channel was built resulting from the scratch to the CPCC, which was associated with the NaCl solution directly arriving at the AZ80

magnesium alloy substrate through the scratch. The Cl^- reached the Mg alloy substrate and induced the chemical reactions (Reactions (2)–(4)). Furthermore, the tensile stress from the scratching process accelerated the local corrosion at the junction of the scratch and the CPCC. In the middle corrosion stage, the brittle and hard coating began to detach from the AZ80 substrate (Fig. 12(c)). A few local corrosion pits also occurred on the CPCC. At the same time, the generated corrosion products mainly deposited on the scratch area. As the immersion time further increased, a large corrosion channel was formed (Fig. 12(d)). The CPCC was also significantly corroded. As a result, the corrosion resistance of the coating began to decline.
