Trans. Nonferrous Met. Soc. China 24(2014) 806-815

Fracture evolution around pre-existing cylindrical cavities in brittle rocks under uniaxial compression

Abstract: The development of fracture around pre-existing cylindrical cavities in brittle rocks was examined using physical models and acoustic emission technique. The experimental results indicate that when granite blocks containing one pre-existing cylindrical cavity are loaded in uniaxial compression condition, the profiles of cracks around the cavity can be characterized by tensile cracking (splitting parallel to the axial compression direction) at the roof–floor, compressive crack at two side walls, and remote or secondary cracks at the perimeter of the cavity. Moreover, fracture around cavity is size-dependent. In granite blocks containing pre-existing half-length cylindrical cavities, compressive stress concentration is found to initiate at the two sidewalls and induce shear crack propagation and coalescence. In granite blocks containing multiple parallel cylindrical cavities, the adjacent cylindrical cavities can influence each other and the eventual failure mode is determined by the interaction of tensile, compressive

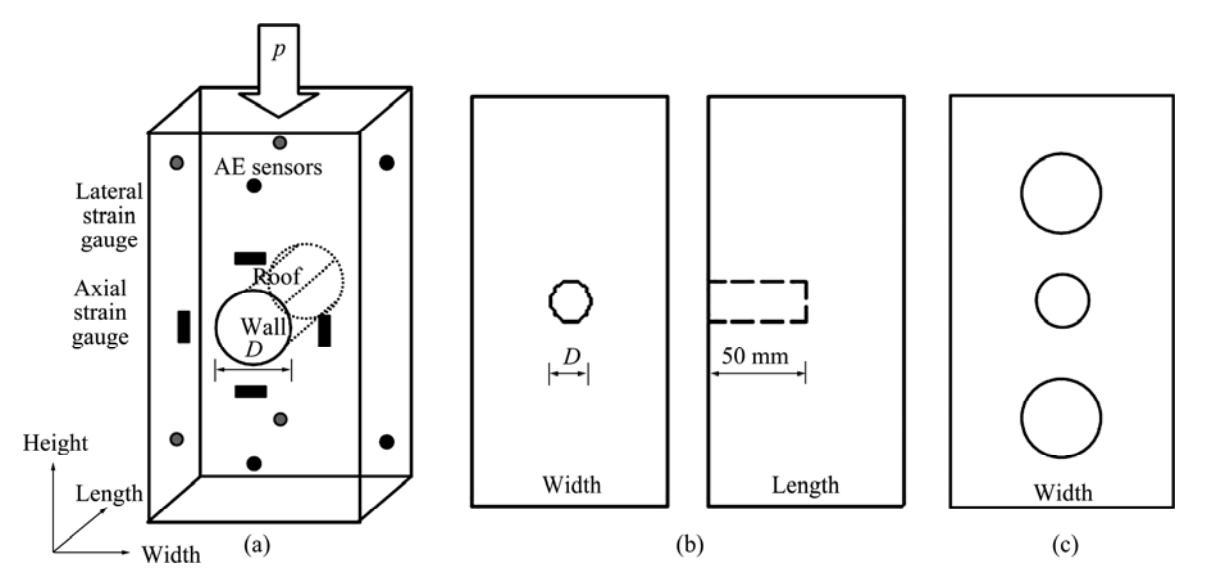
Fig. 1 Specimen with different cylindrical cavities in diameters of 20, 28 and 38 mm, strain gauges, acoustic emission monitoring system and loading conditions (a), cuboid granite samples consisting of half-length cylindrical cavity with 20 mm in diameter and 50 mm in length (b), and cuboid granite samples containing three cylindrical cavities with diameters of 28 mm (top and bottom) and 20 mm (center) (c)

Twenty five medium-grained brittle hard granite blocks with dimensions 100 mm×100 mm×200 mm were cut and ground to accurate size based on the recommendation of the ISRM [17]. All the specimens have a height-to-width ratio of 2. Parallelism between top and bottom faces of each specimen is within an error of 0.02 mm. The fracture evolution in granite samples with pre-existing single cylindrical cavities was experimentally modeled to examine the influence of cavity diameter on crack evolution behavior. Fifteen blocks of granite, divided into 3 groups of 5 blocks each, were prepared with cylindrical cavities with diameters of 20, 28 and 38 mm. This was the uniform of the fifteen rock samples. The compressive strength averaged 112 MPa while the tensile strength averaged 12 MPa. All of the specimens with cylindrical cavities were loaded under uniaxial compression. Each cuboid granite specimen was equipped with four axial and lateral strain gauges attached on the surface of the specimens and positioned directly in direction of tensile/ compressive stress concentration areas (Fig. 1).

To investigate workplace failure behavior of an underground cavity under uniaxial compression, another group of five granite specimens containing pre-existing half-length cylindrical cavities were considered. In this case, the diameter and length of cavities were 20 mm and 50 mm, respectively, as shown in Fig. 1(b). The vertical load was applied at a rate of 20 kN/min and showed a uniaxial compressive strength of 98 MPa, a P-wave velocity of 3850 m/s and a Poisson ratio of 0.24. The AE system was used to monitor the failure process during the total testing process.

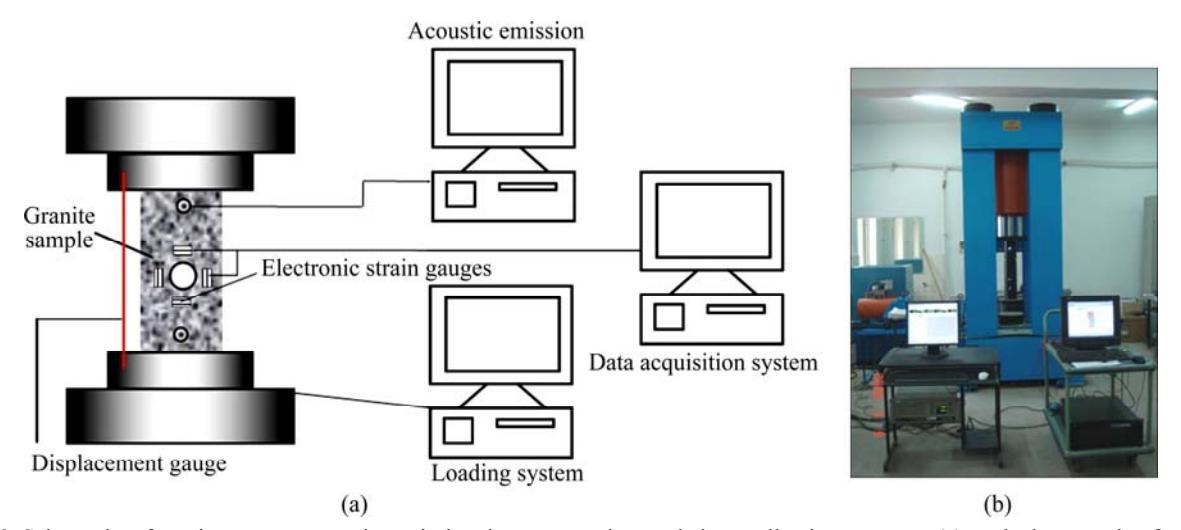
Fig. 2 Schematic of strain gauge, acoustic emission instrumentation and data collection systems (a) and photograph of testing apparatus (b)

The uniaxial compression tests were carried out with a 3000 kN capacity testing machine (Fig. 2), which used displacement control featuring electromechanical controllers with three control channels. The loading system recorded the values of the load and displacement

and drew the curve of load-displacement instantaneously. The specimens were loaded to fail at a minimum loading speed of 0.05 mm/min. Eight acoustic emission (AE) transducers were glued to different points along the outer surface of specimens.

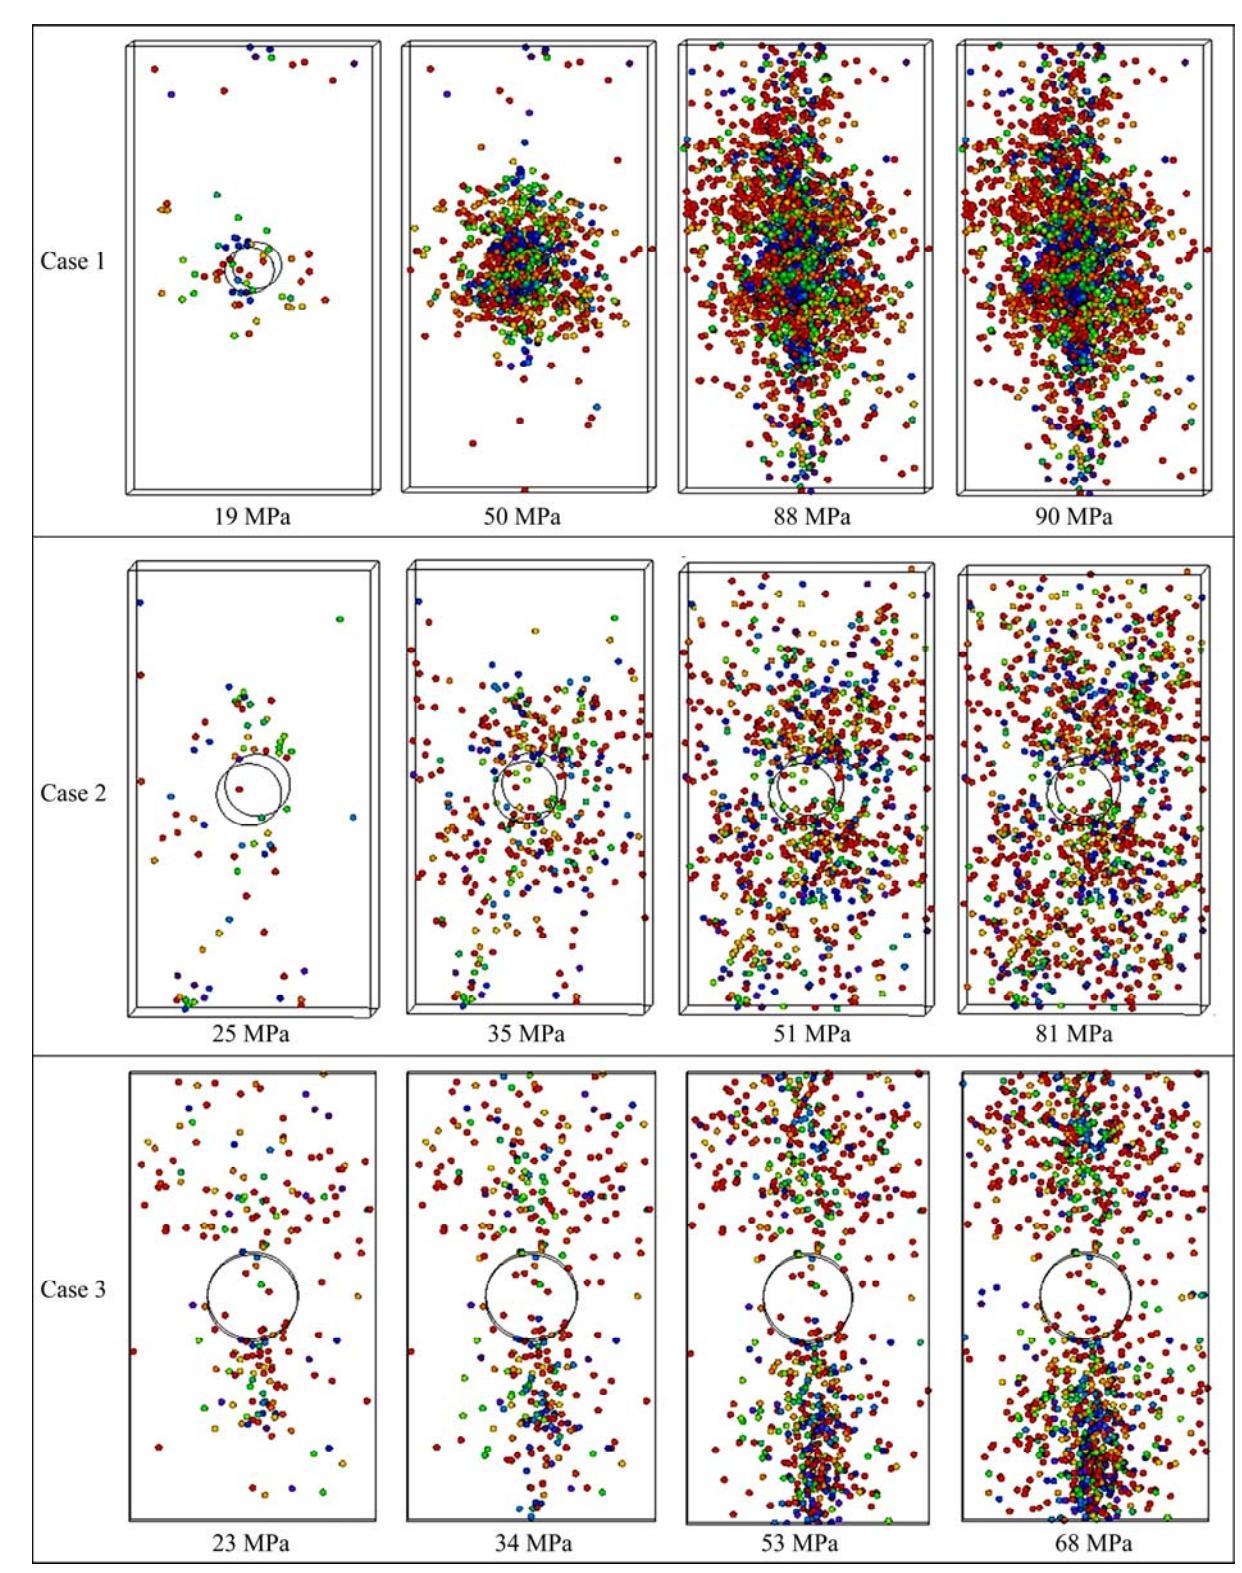
Fig. 3 Distribution of acoustic emission location in granite specimens with pre-existing cylindrical cavities

The AE events locations during the failure process are presented in Fig. 3. Only the AE events that could be located with an error less than 5 mm were selected for the source characterization. In case 1, it can be clearly seen that many AE events were concentrated around the potential tensile damage zones. Therefore, the compliant behavior of the rock was responsible for the initiation of the cracks that developed in the roof-floor of the cavity. The tensile fracture zones eventually reached the vertical upper and lower boundaries. In case 2, it can be clearly seen that the AE events were mainly concentrated around the perimeter of the cylindrical cavity when the vertical stress reached 35 MPa. The AE events, mainly concentrated at the roof-floor, gradually formed clusters, thereby initiating the tensile fracture and slabbing. Although many AE events were recorded outside the zone of rock mass surrounding the cavity, these AE events were not the active micro-cracks, which were significant because of their effect on the mechanical properties of the rock. At initial stage, it was difficult to predict where the macro-crack would begin in the loading process, because the AE events were discrete in the specimen. When the vertical stress reached 81 MPa, the AE events occurred around certain clusters, and were in a distinct AE active zone that developed in the rooffloor of the cylindrical cavity and the nucleation zone in

the specimen. In case 3, the AE active zones were connected to form a large active AE zone that was consistent with the site of the macro-cracks. In contrast, very few localized AE events occurred in the region near the vicinity of cavity wall during the total loading process. With the influence of strong interaction between isolated micro-cracks, these isolated micro-cracks progressively propagated in an unstable manner, and eventually coalesced to form a splitting macro-crack failure.

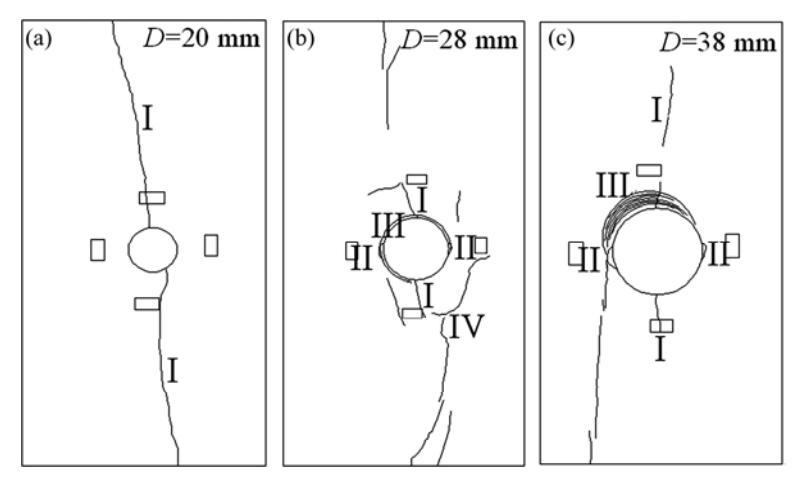
Fig. 4 Fracture distribution of cuboid granite samples containing cylindrical cavities with different diameters (I: Tensile fracture; II: Compressive fracture; III: Slabbing; IV: Remote fracture)

Figure 4 presents the failure patterns of the specimen containing the smaller pre-existing cylindrical cavity, which failed in a splitting mode (Fig. 4(a)), and its cleavage paralleled the direction of the maximum

axial stress [22], whereas the other two specimens failed because of cracks initiated in a shear stress zone. When the diameter of the cylindrical cavity was 28 mm, the failure pattern (Fig. 4(b)) was the remote or secondary fracture at the rock abutment and the side wall slabbing at the compressive stress concentration due to the tensile fracture initiation at the roof-floor [23]. In contrast to the failure pattern of the specimens with a cylindrical cavity of 28 mm in diameter, the specimens with a cylindrical cavity of 38 mm in diameter had failure patterns (Fig. 4(c)) that occurred as tensile cracking in the roof-floor and the V-shaped notch in the side wall. However, their similarity was not perfect. In general, the slabbing occurring in the periphery of the 38 mm diameter cylindrical cavity was much more serious than in the cavity with 28 mm in diameter, and no crack-remote damaged zone in a compressive area can be seen in Fig. 4(c). Whether the deformation induced instability problem in the cylindrical cavity is dependent upon the ratio of the diameter of the cylindrical cavity to the width of the cuboid granite sample, it was demonstrated in the previous detailed description. The fracture nucleation stress and fracture types for all three granite types were size-dependent with size sensitivity being most prominent in the different size ranges.

crack, when axial stress exceeded the compressive strength of the granite specimens, compressive damage was initiated and grew; the damage was also observed at the sidewalls. The resulting damage zone occurring [24] is commonly referred to as a breakout or V-shaped notch (Figs. 4(b) and (c)). The failure around the cavity observed in the granite samples is depicted in Figs. 4(b) and (c), which reveals that the V-shaped notch occurred in a manner similar to that observed in previous studies [25,26]. As the distance from the cavity face increased, the failure zone became wider and deeper. As the axial stress increased, slabbing was first observed in the periphery near the cylindrical cavities with diameters of 28 mm and 38 mm under high stress conditions [27] and then collapsed, leaving dust and small particles (see Figs. 4(b) and (c)) [10,23]. However, the slabbing failure in the case of a cavity diameter of 28 mm at these compressive stress concentrations was no more obvious than that in a 38 mm-diameter cavity. The specimens lost their loading capacity. The remote failure, either tensile or primary, and the sidewalls fractures around a cylindrical cavity of 28 mm in diameter are shown in Fig. 4(b), whereas no remote failure was observed, as shown in Fig. 4(c). Fracture development beyond the stages of the primary tension and normal shear fracture was usually responsible for the eventual collapse of the cylindrical cavities in the specimens.

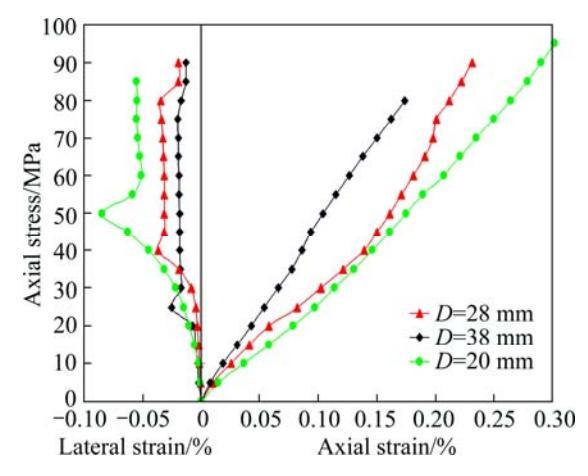
Fig. 5 Axial stress vs axial/lateral strain behavior of specimens with cylindrical cavities

Figure 5 shows the stress-strain curves of granite specimens with cylindrical cavities of different diameters. Tensile stress concentration and the damage initiation were measured by the strain gauges attached along the direction of the fracture with the increasing uniaxial load. The lateral strain was increased with the increase of the cavity size. For specimens with cavity diameter of 20 mm, the tensile stress concentrated at the roof-floor and the compressive stress concentrated at the two sidewalls (Fig. 5). When the axial stress was 50 MPa (with a maximum axial strain of 0.17%), the tensile crack initiated in the roof-floor of the cylindrical cavity. With

the increase of axial loading, the tensile crack gradually propagated, nucleated and coalesced, thus leading to instability of the granite samples. The failure pattern was slightly different from previous experimental results [6], which showed no compressive damage at the sidewalls and remote cracks (case 1 in Fig. 3). The pattern of the macroscopic fracture observed at the roof-floor was generally parallel to the direction of the uniaxial compressive load.

For specimens with cavity diameter of 28 mm and 38 mm, when the axial stresses were 40 MPa and 25 MPa with the maximum axial strains of 0.14% and 0.058%, respectively, the tensile cracks initiated and developed from the roof and floor. With the increase of compressive stress, cracks were initiated approximately adjacent to the termination of the tensile fractures and at some distance from the cylindrical cavity at the roof and floor and the propagation of cracks paralleled to the direction of axial stress. However, the crack did not fulfill the coalescence criterion in the tensile stress concentration. During the propagation of the tensile

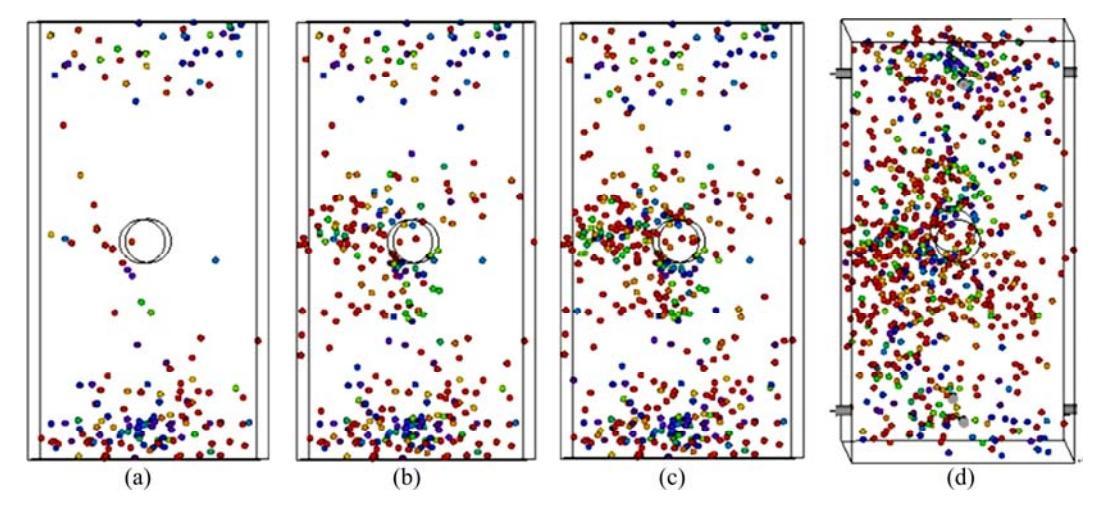
Fig. 6 Distribution of acoustic emission location in cuboid granite sample containing half-length cylindrical cavity with 20 mm in diameter and 50 mm in length: (a) 16 MPa; (b) 60 MPa; (c) 90 MPa; (d) 98 MPa

The AE events location distributions are presented in Fig. 6. It can be seen that before the vertical stress reached 16 MPa, the AE events were mainly distributed in the upper and bottom boundaries. With loading the tensile and compressive stress increasing, concentrations were located in the roof-floor and two sides of cylindrical cavity. After the axial stress reached 90 MPa, a distinct AE active zone developed in the specimen. Although a few of AE events occurred through the whole specimen, most AE events were clustered near the nucleation zone on the left-hand side of the specimen. The final AE events showed that the AE active zones were connected to form the macro-cracks of the V-shaped notches in the two sidewalls and the shear fracture in the panel. It is likely the damage in the notches and, therefore, the compliant behavior of the rock in this region was responsible for the initiation of the cracks. These rupture zones eventually reached the vertical boundaries [16].

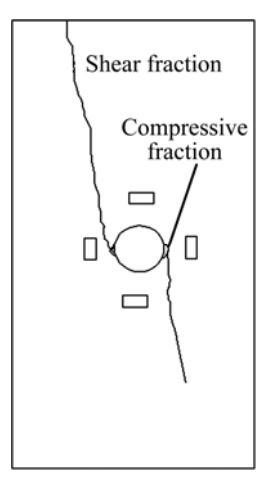
Fig. 7 Fracture distribution of cuboid granite sample containing half-length cylindrical cavity with 20 mm in diameter and 50 mm in length

The primary crack and shear fracture of the granite specimens with half-length cylindrical cavities are illustrated in Fig. 7. The most prominent failure zone observed around the cylindrical cavities in the brittle rocks was the region of breakout. This zone formed as a V-shaped notch and was caused by microcracking. The compressive stress damage zone was larger in the area of the side walls than in the roof-floor area of the cylindrical cavities. Under tangential stress conditions, the breakouts occurred in the region of maximum tangential stress around the boundary of the cylindrical opening. One important characteristic of the shear fracture was that it was not a single fracture, but a fracture zone caused by shear damage. In addition to the

failure patterns on the surface, the shear fracture at the two side walls could also be observed ahead of the face of the half-length cylindrical cavities.

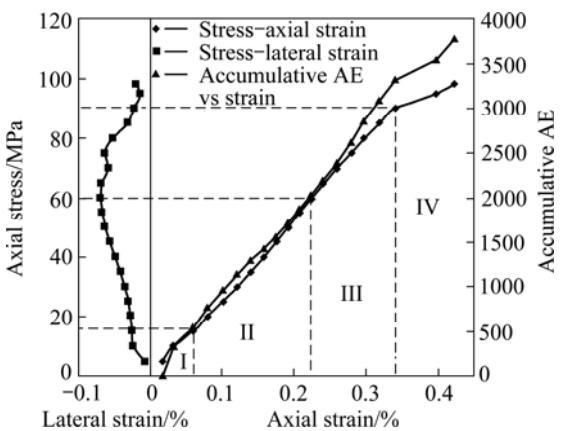
Fig. 8 Axial stress vs strain, accumulative acoustic emission and lateral strain behaviors of cuboid granite samples containing half-length cylindrical cavity with 20 mm in diameter and 50 mm in length

The axial stress vs axial/lateral strain and the accumulative AE events curves are shown in Fig. 8. Before the axial stress reached 16 MPa, the stress (tensile in the roof-floor; compressive in the side walls) was concentrated on the periphery of the cylindrical cavity [28,29], and observed through the data provided by the strain gauges. The lateral strain began to increase more rapidly than the axial strain. Existing micro-cracks closed to the point where nearly all the strains could not be recovered upon unloading (Stage I). Tensile failure was first noticed in the roof-floor region, whereas compressive damage was first initiated in the side walls of the five testing granite specimens when the axial stress exceeded the uniaxial compressive strength of the specimens. Subsequently, more compressive damage was observed in the two side walls, which eventually led to the primary (compressive) failure in two sides of the cylindrical cavity (Stage II). The increase in axial stress and the high compressive stress were concentrated at the side walls when the axial stress reached 90 MPa. V-shaped (in echelon) fractures caused by microcracking (Stage III) resulted in localized failure and occurred extensively in the side walls. After the propagation of the primary compressive fracture, any increase in the axial stress led to continuous initiation and propagation of shear fractures. Shear fracture was observed in locations remote from the perimeter of the cylindrical cavity. These shear fractures were associated with the redistribution of tensile stress towards the side walls of the cavity. The axial and lateral strains caused unstable changes. Shear fractures propagated from the V-shaped notch to the macroscopic fracture and they propagated away from the cylindrical cavity (Stage IV). From Fig. 8, it can be inferred that the remote fracture was also caused by the tensile fracture. The granite specimen lost its strength, and the main crack broke. The eventual collapse of the circular cavities in the specimens was caused by the concentration, initiation, propagation and coalescence of the shear stress.

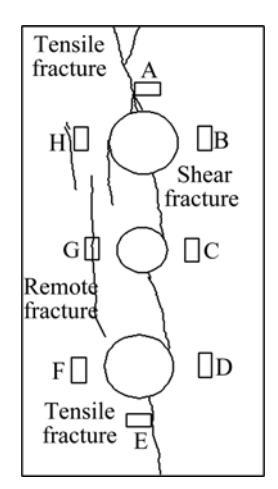
Fig. 9 Axial stress vs axial/lateral strain behavior of granite samples with three pre-existing cylindrical cavities

To study the influence of the interaction between cavities close to each other, the specimens containing an array of three circular cavities arranged in vertical lines were tested. Five granite specimens with three circular cavities (the diameters of two pre-existing cylindrical cavities were 28 mm at the top and bottom of the specimens and one pre-existing cylindrical cavity was 20 mm in diameter in the center (Fig. 1(c)) were loaded under uniaxial compression. Sixteen electric strain gauges with serial numbers A–H were instrumented on the specimens to measure the axial and lateral strains (Fig. 9).

Figure 9 shows the ultimate failure patterns and fracture distribution for the granite specimens containing multiple pre-existing cylindrical cavities. The coalescence stress was 96 MPa. At first, the cracks grew quickly. When the tips of the cracks were near the ends of the specimen, the propagation then slowed down, or sometimes stopped, because of the boundary effect. When the shear stress in the area between the cavity and the free boundary of the specimen was sufficiently high, shear failure occurred between the cavity and the free boundary (Fig. 9). It is interesting to note that no cracks nucleated from the central cylindrical cavity arranged in the vertical line. The tensile stress decreased around the central cavity, which may have been caused by the presence of the free specimen boundaries. The crack growth can be seen more clearly in the following loading stage in the specimens containing multiple cylindrical cavities. The interaction between cavities and their coalescence was more complicated than that discussed above, and the central, smaller cavity became the direction of the splitting failure.

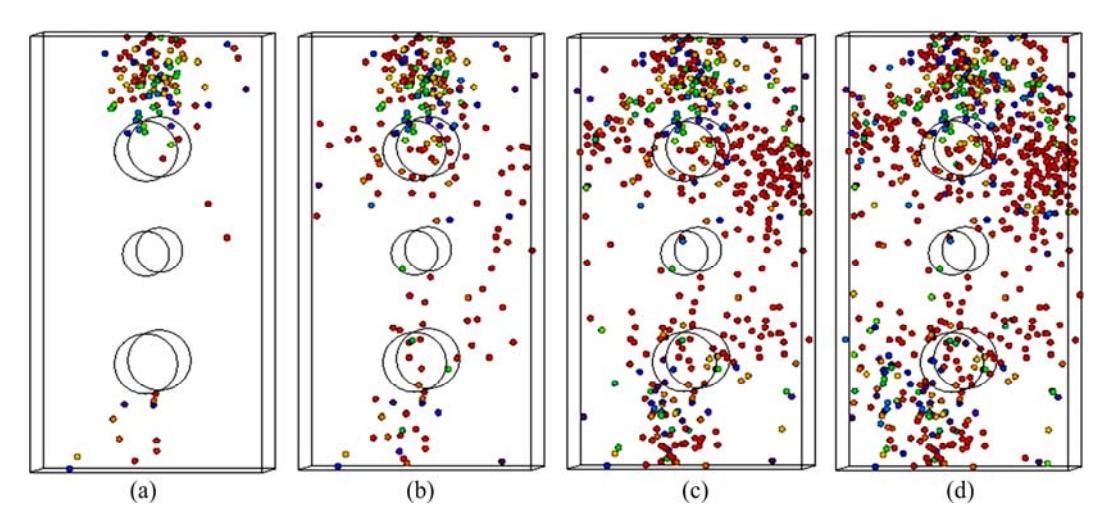
Fig. 10 Distribution of acoustic emission location in granite specimens with pre-existing cylindrical cavities: (a) 30 MPa; (b) 38 MPa; (c) 47 MPa; (d) 62 MPa

Figure 10 shows the AE events location distribution during the total loading process. From Fig. 10, it is clear that very few localized AE events occurred at the upper edge of the granite specimens during the early stage of loading when the vertical stress reached 30 MPa. The results showed that the tensile crack initiated in the roof of the pre-existing cylindrical cavity. With load increasing, more of the AE occurred, and the AE active zones were connected to form a larger AE active zone. It was found to be consistent with the occurrence of macro-cracks.

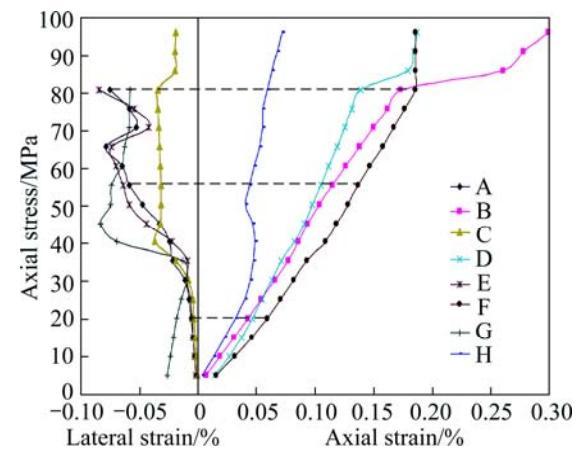
Fig. 11 Axial stress vs axial/lateral strain behavior of granite samples with three pre-existing cylindrical cavities

Figure 11 shows the curves of axial stress vs axial/lateral strain of granite specimens with pre-existing cylindrical cavities. As shown in Fig. 11, when the specimens were subjected to a uniaxial compressive

stress, the axial strain contracted and the lateral strain extended. At low stresses (less than 32 MPa), the axial and lateral strain steadily propagated, but the axial strain increased more rapidly than the lateral strain. As a result of the changing axial/lateral strain, the tensile stress was concentrated in the roof-floor and the compressive stress was concentrated at the side walls. With the axial stress increasing, the lateral strain changed more than the axial strain ratio. When the tensile stress exceeded the tensile strength of specimens, tensile cracks initiated in the rooffloor. These cracks were usually manifested by small changes in the position and orientation of fracture surfaces at the roof of the top cavity and the floor of the bottom cavity; however, no damage initiation could be observed surrounding the central smaller cavity. When specimens were subjected to a higher stress (σ =66.5 MPa), the lateral strain at the roof-floor of the pre-existing cylindrical cavity attained the maximum value, and the propagation of the tensile crack started to stabilize. Meanwhile, high compressive stresses were concentrated at the sidewalls, where some small flakings could be observed at the sidewalls of the upper and central cavities. After the axial stress reached 82 MPa, the slight compressive stress increased the number of tensile fracture "breakthrough" from the upper and lower cavity to the top and bottom faces, and the shear fractures closed at the sidewalls and floor of the central cavity. Although the compressive failure was initiated purely by local fracture, the cracks still appeared to propagate, yet the compressive cracks could not affect the failure patterns of the specimens. The remote cracks appeared in the compressive stress zones and were parallel to the axial stress direction. The failure was not localized in the circular cavity, but was instead within finite regions determined by the geometry. The fracture evolution was influenced more and more by the presence of the adjacent cylindrical cavities and the orientation of their crack propagations relatively to another. The eventual failure patterns were created by the interaction of tensile and shear stress.
