Trans. Nonferrous Met. Soc. China 24(2014) 1750-1757

Formability of aluminum-silicon coated boron steel in hot stamping process

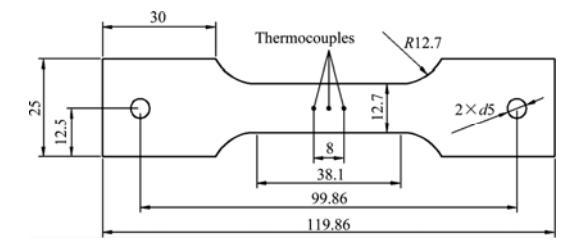
Fig. 1 Dimension properties of tensile test sample (unit: mm)

Uniaxial tensile tests carried out by Gleeble–3500 were performed to evaluate the thermo-mechanical behavior of the Al–Si coated and uncoated boron steels under different deformation conditions. Dimension properties of the tested samples are shown in Fig. 1. The thermal–mechanical procedure is illustrated Fig. 2. Each sample was heated to 920 °C with a heating rate of 10 °C/s, and austenitized for 5 min. Then the samples were cooled down to 850, 800, 750 and 700 °C at a speed of 30 °C/s, kept at the temperature for 3 s to attain a uniform temperature region. Strain rates of 0.01, 0.1 and 1 s⁻¹ were selected as the forming process parameters.

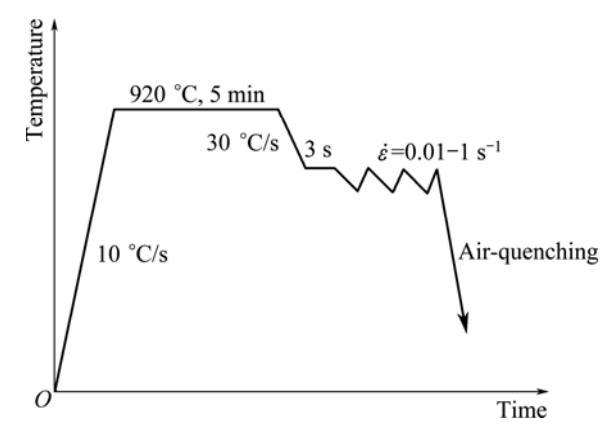
Fig. 2 Illustration of heat treatment and deformation process

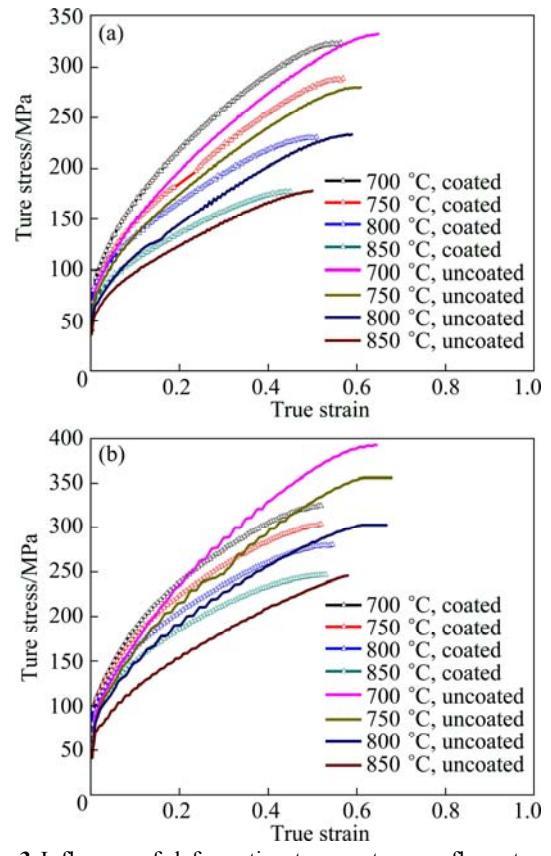
Fig. 3 Influence of deformation temperature on flow stress of uncoated and coated boron steels: (a) $\dot{\varepsilon} = 0.1 \text{ s}^{-1}$; (b) $\dot{\varepsilon} = 1 \text{ s}^{-1}$

Examples of the true strain-stress curves of the coated and uncoated boron steels obtained from the hot

tensile tests are shown in Fig. 3. It could be found that the effect of the deformation temperature on the flow stress is significant. The flow stress exhibits a dynamic flow softening behavior at higher deformation temperatures, whereas with the decreasing deformation temperature, a work hardening behavior is obviously observed for the flow stress. During the tensile test, it is also seen that the flow stress and the maximum stress increase with the decreasing temperature at a constant strain rate. Moreover, the maximum stress value also increases with the strain rate increasing from 0.01 to 1 s^{-1} .

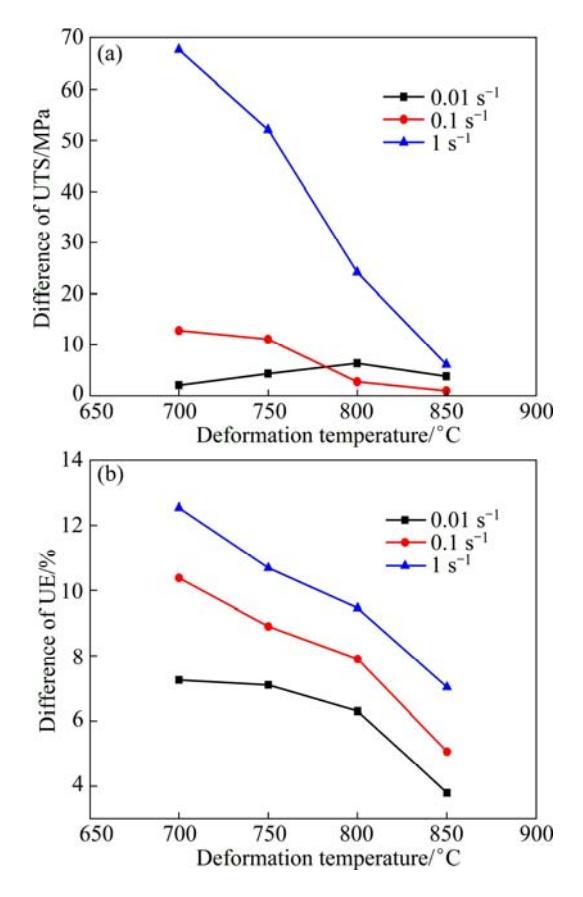
Fig. 4 Comparisons of indexes of coated and uncoated boron steels: (a) UTS; (b) UE

Figure 4 shows the comparison of thermomechanical behavior between the Al–Si coated and the uncoated boron steels. The ultimate tensile strength (UTS) and uniform elongation (UE) were selected as evaluation indexes. The differences were calculated by subtracting the index values of the uncoated samples from the coated one, and the positive value means that the index of the uncoated sample is higher than that of the coated one.

It can be seen that the UTS difference between the coated and uncoated samples are very small under low stain rates of 0.01 s^{-1} and 0.1 s^{-1} (Fig. 4(a)), thus the two could be regarded as having similar ultimate tensile strength. A glimpse of this phenomenon can also be

caught from the test results of JANG et al [15]. However, no attentions were put on it. PANAGOPOULOS et al [19] also found a drop in mechanical behavior of the Zn–Fe alloy coated mild steel in cold forming operation with a strain rate of 1.1×10^{-3} s⁻¹. As the strain rate comes up to 1 s⁻¹, the difference becomes remarkable. Especially under a lower deformation temperature, it comes up to 67.7 MPa at 700 °C. Moreover, the UTS difference decreases with the increasing temperature given a constant strain rate. Another observation can be found that the Al–Si coated samples have a significantly lower ductility than the uncoated ones (Fig. 4(b)). The difference of UE increases with the decreasing temperature at a constant strain rate. In addition, it also increases with the strain rate from 0.01 to 1 s⁻¹.

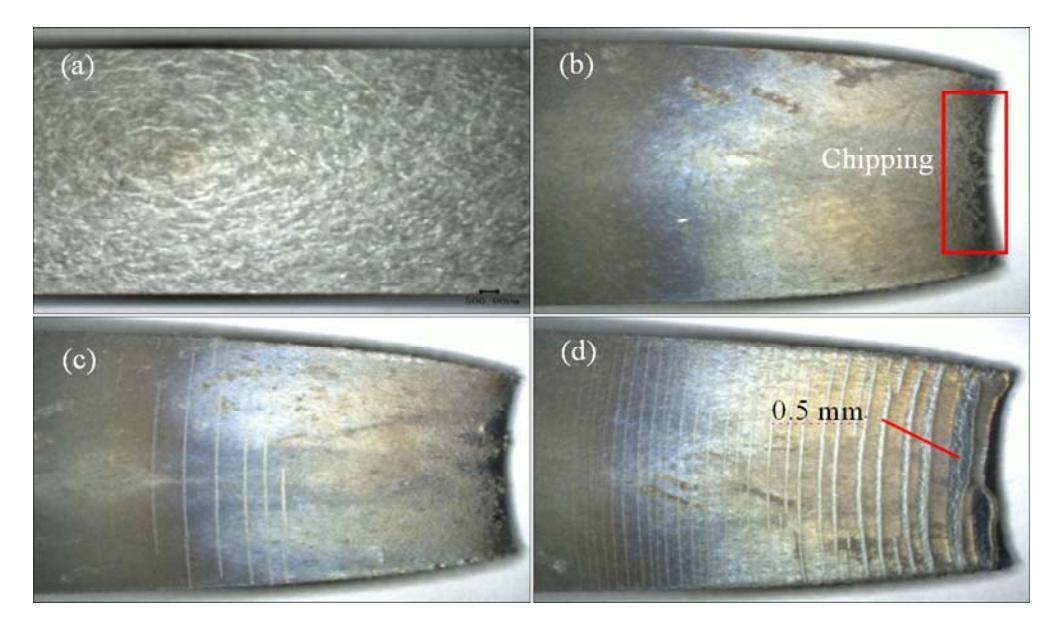
Fig. 5 Optical graphs of surface morphology of coated samples under different stain rates ($t_{\text{forming}}=850 \text{ °C}$): (a) As-coated; (b) 0.01 s⁻¹; (c) 0.1 s⁻¹; (d) 1 s⁻¹

The forming process can induce crack initiation and propagation in the coatings. Once cracks advance, their openings provide passages for air and moisture that lead to adverse oxidation reactions and corrosion in both the coatings and the steel substrate. The sections next to the fracture surface of the coated samples after tensile deformation are shown in Figs. 5 and 6.

It is found that at the strain rate of 0.01 s^{-1} , only partial chipping of the coating occurs near the fracture (Fig. 5(b)). The coating cracks obviously when the strain rate reaches 0.1 s^{-1} , but the width and density of the crack are relatively narrow and small (Fig. 5(c)). A sharp increase in the crack width and density is found as the strain rate comes up to 1 s^{-1} , and the maximum crack width about 0.5 mm occurs near the fracture (Fig. 5(d)). The crack width and density of the coatings have been boosted significantly with the increasing strain rate. The cracks formed in all Al-Si coatings propagate nearly perpendicular to the tensile axial. The cracks observed on the surface of the coatings are believed to form due to the inability of the brittle coating to accommodate the strain generated in the ductile substrate [22,24]. At a lower strain rate, there is more time for the coating to

coordinate with the substrate, but not vice versa. The above results indicate that the strain rate should be lowered in hot stamping of the Al–Si coated boron steel, which is declared by punching speed in the actual forming process. The higher punch speed will lead to ascending crack tendency of the coating. However, it facilitates the production efficiency. Considering practical efficiency and final properties of the hot-stamped components [25], the punch speed needs to be optimized.

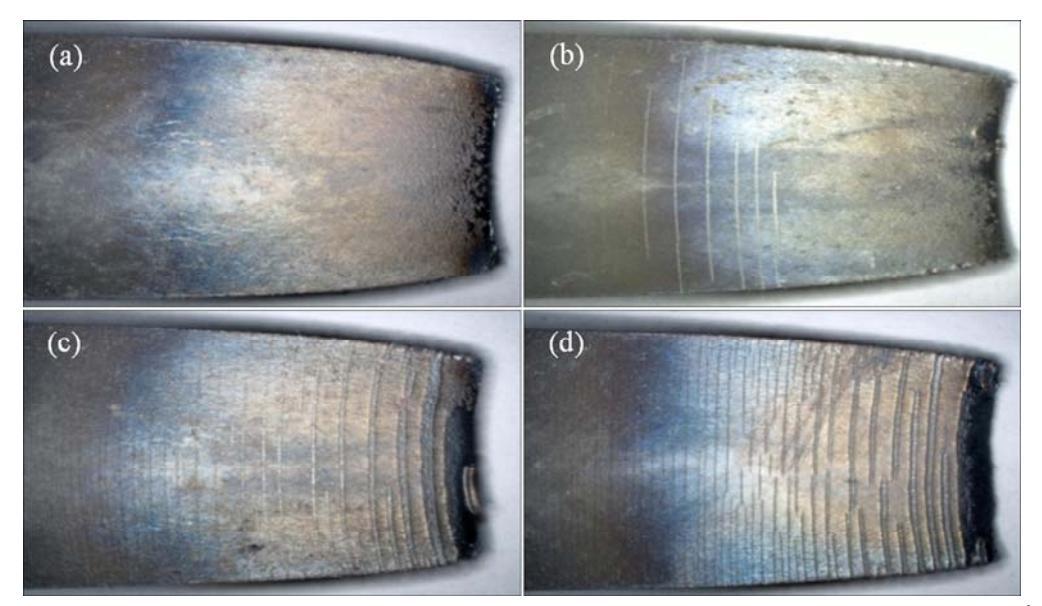
Fig. 6 Optical graphs of surface morphology of coated samples under different deformation temperatures ($\dot{\varepsilon} = 0.01 \text{ s}^{-1}$): (a) 850 °C; (b) 800 °C; (c) 750 °C; (d) 700 °C

Another observation is that the crack width and density of the coatings have been increased significantly with the decreasing deformation temperature (Fig. 6). The orientation of the crack propagation in relation to the tensile axial still holds. Cracking of the coating occurs at the deformation temperature of 800 °C, but the density of cracks is samll, and almost no pieces of the coating are delaminated from the substrate. However, as the deformation temperature drops to 700 °C, the density of the cracks increases substantially. The cracks are wider

and deeper. This could be attributed to the influence of temperature on the mechanical properties of both the coating system and the steel substrate. It is suggested the lower the temperature is, the wider and the denser the cracks are. A high crack density is favorable for the partial fracture and delamination of the coated components, and decreases weldability, paintability and corrosion resistance of the hot-stamped components during post operations and service. It is of great interest to avoid such a high crack density in the Al–Si coating. Consequently, a higher deformation temperature should be applied to the hot stamping of Al–Si coated steel. Moreover, it is benefit for an enhancement in the tensile strength of the hot-stamped components [26].

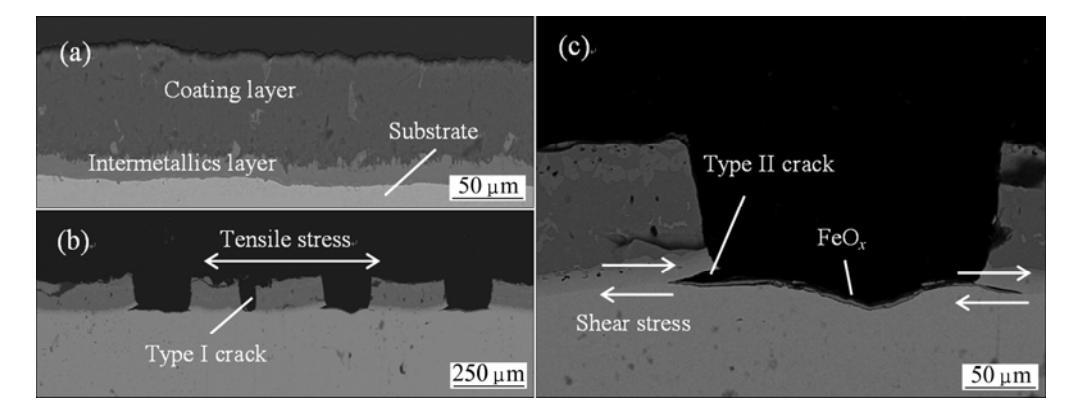
Fig. 7 Cross-sectional morphology of coated samples: (a) As-coated; (b) Hot deformed $(t_{\text{forming}}=800 \text{ °C}, \dot{\epsilon}=0.1 \text{ s}^{-1})$; (c) Higher magnification of (b)

Figure 7 shows the cross sectional surfaces of the coated samples before and after hot tensile tests. It could be seen that the Al–Si coating after hot dipping keeps dense, integrated and continuous (Fig. 7(a)). During the deformation at a elevated temperature, the coating heavily cracked and broke into segments but still adhered

to the substrate (Fig. 7(b)). The forming process causes large deformation in steel substrate, and elastic mismatch of the coating and the substrate induces the crack initiation and propagation in the coatings [22]. Moreover, the microcracks occurring in the coating due to austenitizing heat treatment act as nucleation sites for coating cracking and propagate under tensile stress [27]. The cracks propagate in direction perpendicular to the coating/substrate interface and form Type I crack due to the tensile stress (Fig. 7(b)). Since the interfacial bonding strength between the coating and the substrate is lower than the substrate yield strength, as the crack reaches the interface, the propagation is hindered by the substrate, and turns to parallel the coating/substrate interface. In addition with the shear stress, Type II crack forms (Fig. 7(c)). The cracked coating peels off from the steel substrate. The cracks become wider following the increasing strain. Bare steel is exposed between the separate segments of the coating. The opening provides passages for air and leads to appearance of a thin FeO_x layer on the steel surface. Apparently, delamination also occurs along the interface between the oxides and the Al-Si coating. So, it is reasonable to conclude that the existence of the oxide decreases adhesion of the Al-Si coating.

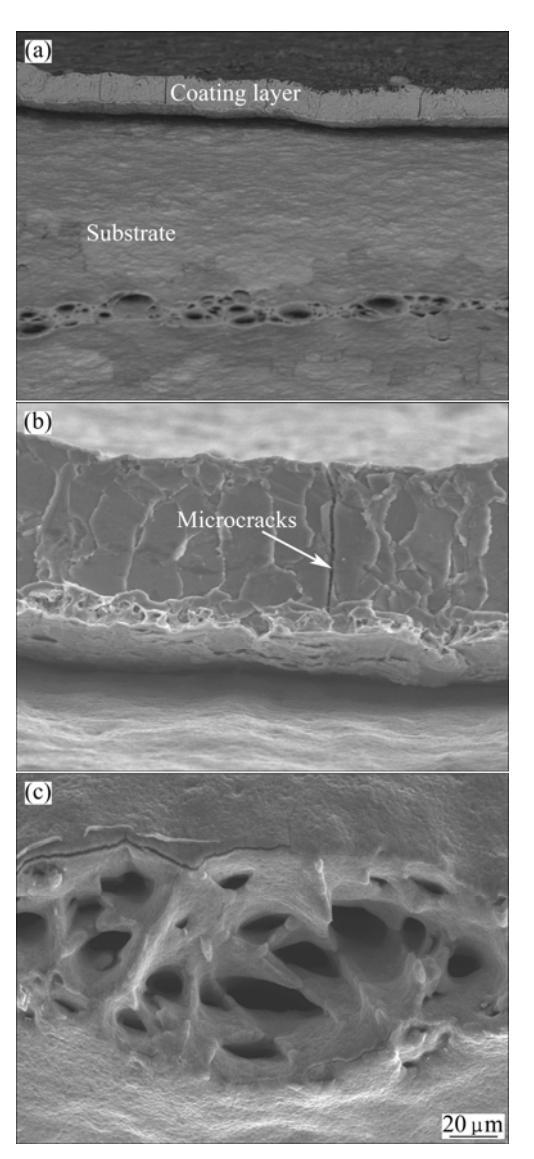
Fig. 8 SEM images of coated sample: (a) Coating system; (b) Higher magnification of fracture surface of cracked coating; (c) Higher magnification of fracture surface steel substrate

Figure 8 shows the facture surfaces of the coated samples. The cracked coating surface is faceted due to brittle fracture and microcracks are found to initiate from the coating surface, and go through the coating layer (Fig. 8(a)). The brittleness and thermal expansion mismatch of the Fe_xAl_v intermetallic compounds result in coating microcracks. The Al-rich intermetallic compounds exhibiting low fracture toughness promote formation and propagation of cracks in the coating microstructure [28]. While the facture surface of the steel substrate shows nearly equiaxed dimples, which indicate the ductile fracture. It is confirmed that there is a remarkable difference between the formability of the coating layer and the substrate. The coating is expected to be more compatible to the deformation of the substrate and fully deform plastically without brittle fracture.

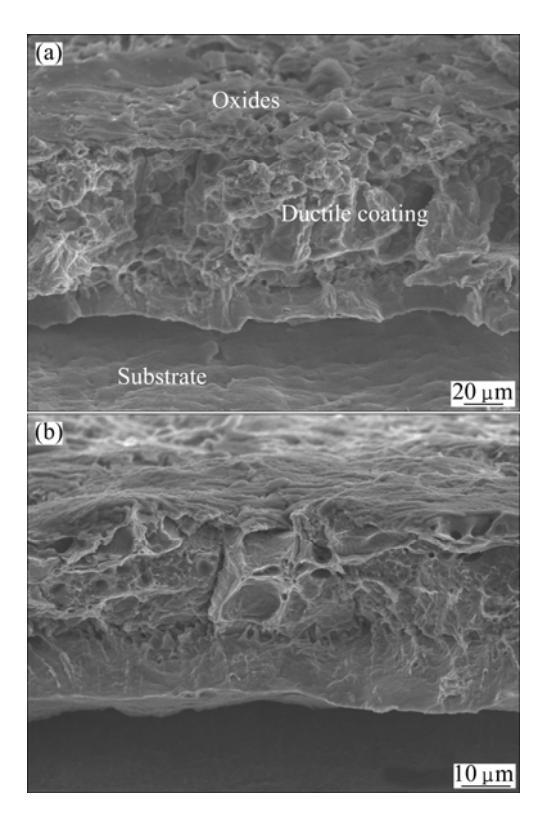
Fig. 9 SEM images of optimized cracked coating (t_{forming} =800 °C, $\dot{\varepsilon} = 0.1 \text{ s}^{-1}$): (a) 920 °C, 20 min; (b) 1050 °C, 5 min

oxidation resistance, corrosion resistance and specific strength properties. KOBAYASHI and YAKOU [28] identified that the formation and growth of Fe-Al intermetallic compounds is controlled by the diffusion of Fe atoms into the coating layer. As a result of the diffusion processes, the Al-rich intermetallic compounds in the coating transform to more Fe-rich intermetallic compounds, supporting the formation of the ductile FeAl intermetallic compounds [9,10]. Therefore, a longer dwell time or higher austenitizing temperature will promote the Fe diffusion into the Al-Si coating. Figure 9 shows the experimental results. The cracked coating presents the ductile fracture surface. This therefore suggests that the austenization, which influences the phase transformation in the coating layer, can serve as an important parameter for tailoring the formability of the Al-Si coatings.
