Trans. Nonferrous Met. Soc. China 25(2015) 1525–1532

Microstructure and high temperature tribological behavior of laser cladding Ni60A alloys coatings on 45 steel substrate

Abstract: The crack-free Ni60A coating was fabricated on 45 steel substrate by laser cladding and the microstructure including solidification characteristics, phases constitution and phase distribution was systematically investigated. The high temperature friction and wear behavior of the cladding coating and substrate sliding against GCr15 ball under different loads was systematically evaluated. It was found that the coating has homogenous and fine microstructure consisting of γ (Ni) solid solution, a considerable amount of network Ni–Ni₃B eutectics, M₂₃C₆ with the floret-shape structure and CrB with the dark spot-shape structure uniformly distributing in interdendritic eutectics. The microhardness of the coating is about 2.6 times as much as that of the substrate. The coating produces higher friction values than the substrate under the same load condition, but the friction process on the coating keeps relatively stable. Wear rates of the coating are about 1/6.2 of that of the substrate under the higher load

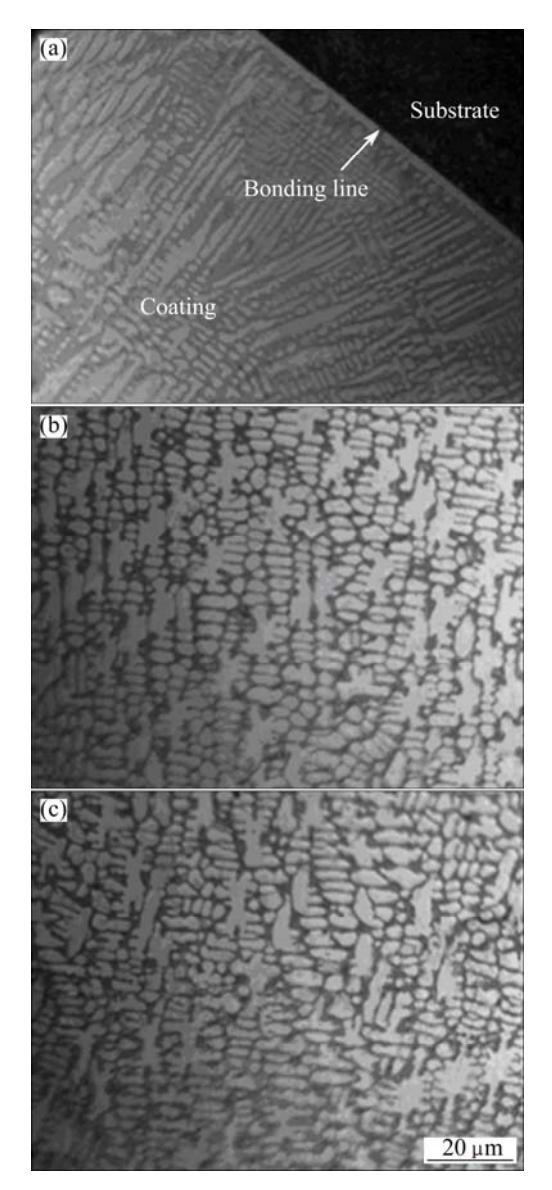
Figure 1 shows cross-sectional OM morphologies of the Ni60A coating. It can be seen that a white bonding line (zone) with a thickness of 5 μ m is found at the coating/substrate interface and the coating is metallurgically bonded with 45 steel substrate. It also exhibits that the microstructure of coating is typical rapid

Fig. 1 Cross-sectional OM morphologies of Ni60A coating: (a) Ni60A coating near to interface; (b) Ni60A coating near to middle zone; (c) Ni60A coating near to top surface

solidification structure [4,15]. It can be seen that a planar growth with a thickness of 5 um and relatively coarse cellular are found at the coating/substrate interface (Fig. 1(a)). With an increase in distance from the surface of substrate, the columnar dendrites are observed in the middle of coating (Fig. 1(b)) and the equiaxed grains are observed at the top of coating (Fig. 1(c)). The result of the XRD analysis shown in Fig. 2 indicates that Ni60A coating is mainly composed of $\gamma(Ni)$, FeNi₃, M₂₃C₆ (M=Fe, Ni, Cr), CrB, and Ni₃B. Moreover, Cr-rich precipitates with different shapes distributed in the matrix are not found by OM. They are likely to precipitate in an intergranular network of the coarse matrix and are enclosed by interdendritic eutectics. Meanwhile, a considerable amount of interdendritic eutectics also precipitate in an intergranular network of the coarse matrix. The previous studies have also shown the similar microstructure, and this microstructure is not only helpful for improving the toughness of coatings but also easily to prepare large-area crack-free coating under the condition of no preheating [8,9]. Based on previous studies, the formation mechanism of this microstructure may be explained. Under high laser power and low scanning speed, molten pool liquid retention time is longer and the cooling rate is relatively low, which results in a high Fe content of coating because of the substantial dilution of the steel substrate. In such a condition, excessively high Fe contents modify the solidification path of the alloy, suppress the primary boride and carbide phases at the beginning and diminish the interdendritic eutectics at the end of the solidification as it can be seen in microstructure of Fig. 1, such precipitates with different shapes distributed in the matrix are not found by OM. Meanwhile, the absence of porosity and microcracks shows that the process parameters selected in this work have ensured a high quality coating and the microstructure has a low crack sensibility.

1) The cladding Ni60A coating is metallurgically bonded to the substrate. It has homogenous fine microstructure consisting of γ (Ni) solid solution, a considerable amount of network Ni–Ni₃B eutectics, M₂₃C₆ with the floret-shape structure and CrB with the dark spot-shape structure uniformly distributing in interdendritic eutectics. With increasing distance from the surface of substrate, γ (Ni) solid solution with a planar growth, column dendrites and the equiaxed grains are formed.

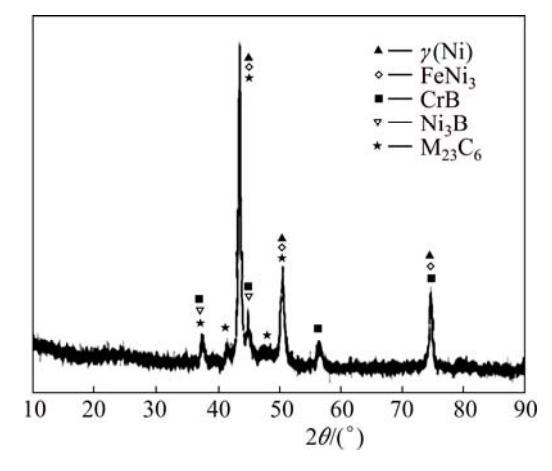
Fig. 2 XRD pattern of Ni60A coating

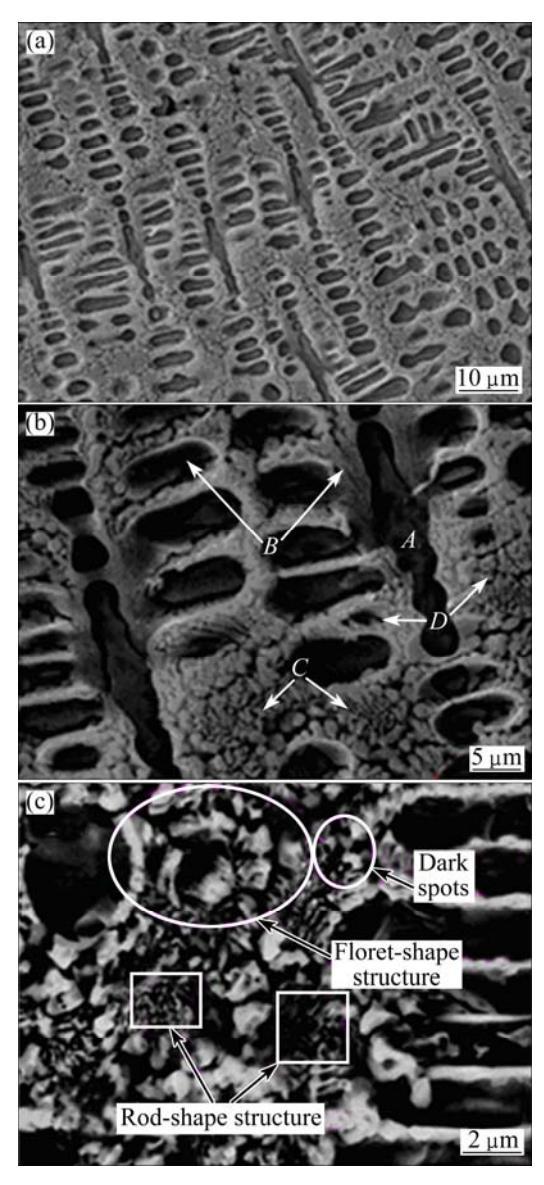
Although OM could provide a general overview of the microstructures, details of the constituent phases and their micro-morphologies could only be revealed by SEM. The microstructure shown in Fig. 3 is the typical feature of the Ni60A coating crystallized in hypoeutectic crystal mode under SEM, a considerable amount of network eutectics and Cr-rich precipitates locate in a large number of intergranular positions of the primary matrix. The structure of the coating is fine, uniform and close. Figures 3(b) and (c) show the magnified cross-sectional SEM images of the coating. It can be more clearly seen in Fig. 3(b) that the microstructure of the Ni60A coating contains two different zones respectively described as dendritic solid solution matrix (marked with A) and interdendritic precipitates. In addition, interdendritic precipitates contain at least three

Fig. 3 Cross-sectional SEM micrographs of Ni60A coating: (a) General view of microstructure; (b) Magnified cross-sectional micrograph of (a); (c) Detail view

components: interdendritic eutectics with the rod-shape structure (marked with B), many flower-shape precipitates (marked with C) uniformly distributed in interdendritic eutectics and several dark spot-shape precipitates (marked with D) scattered in the flower-shape precipitates. Figure 3(c) exhibits details of interdendritic precipitates, where the rod-shape structure interdendritic eutectic phase with a length of $0.2-1 \mu m$, the floret-shape structure precipitates with a size of $0.5-3 \mu m$, and the dark spot-shape structure precipitates with a diameter of 0.1 µm are better observed. The chemical compositions of various phases by SEM/EDS analysis are given in Table 3. According to the EDX measurements and the above mentioned XRD analysis, the matrix (marked with A in Fig. 3(b)) is a γ (Ni) solid solution with small quantities of Cr and Si, and rich in Fe, showing that a higher Fe content of coating can influence microstructure of the cladding coating [9]. The interdendritic eutectics (marked with *B* in Fig. 3(b)) may be identified as Ni–Ni₃B eutectics with significant quantities of B. The floret-shape precipitates (marked with *C* in Fig. 3(b)) are identified as carbides $M_{23}C_6$ (*M*=Fe, Ni, Cr) with significant quantities of Ni and Fe. The dark spot-shape precipitates (marked with *D* in Fig. 3(b)) are identified as borides CrB with fewer quantities of Ni and Fe.

Table 3 Chemical composition analysis of marked location in Fig. 3(b) (mass fraction, %)

0.1.(1)(1)		3)				
Location	Ni	Cr	Fe	С	В	Si
Α	60.66	5.00	29.23	2.52	-	2.59
В	62.26	6.13	15.79	2.22	12.39	1.21
С	19.47	50.42	17.47	11.57	-	1.07
D	7.42	77.94	6.50	0.12	7.30	0.76

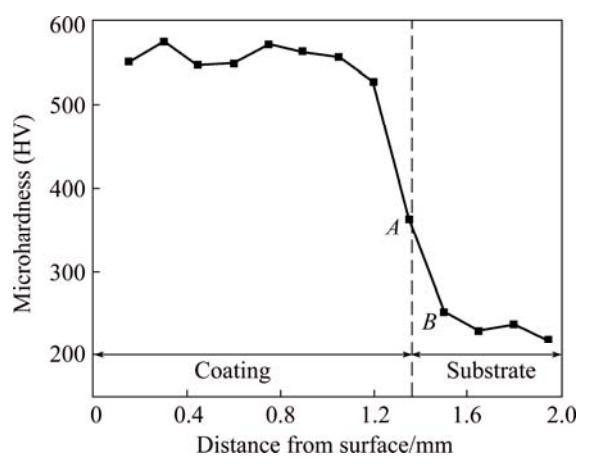
Figure 4 shows the microhardness profile along the depth direction of the Ni60A coating. It is seen that the average microhardness of the coating (approximately HV 530-580) is about 2.6 times as much as that of the 45 steel substrate (approximately HV 220), which is attributed to the formation of hard phases such as $Cr_{23}C_{6}$, CrB, Ni₃B, and FeNi₃ during laser cladding process [15]. But this microstructure prepared by optimizing process parameters has lower average microhardness than that of previous studies [9,12,16]. The main reason is that quantities of precipitates with different shapes distributed in the matrix are suppressed by high Fe contents, due to the dilution between coating and substrate. In particular, this microstructure helps to improve the toughness of the laser deposited coatings, to decrease the crack sensitivity, and crack-free laser cladding Ni60A coating will be easy to be obtained without preheating conditions [9]. The transition from the high values of the coating to the small values of substrate is a smooth gradient distribution, this

Fig. 4 Microhardness profile of Ni60A coating

is because a small region which is accordingly described as the binding zone interface (BZ, marked with A) and the heat affected zone (HAZ, marked with B) exists between the coating and substrate. Due to the dilution between the substrate and the coating, the hardness value (HV 363) of BZ is lower than that of the coating. Due to the occurrence of phase transformation on the surface of substrate, the hardness value (HV 260) of HAZ is higher than the initial one of substrate material.

2) The average microhardness of the Ni60A coating is about 2.6 times as much as that of the substrate. The friction coefficients of the substrate and the coating decrease with increasing the applied loads. And the coating produces higher friction values than the substrate under the same load condition, but the friction process on the coating keeps relatively stable, while the friction process on the 45 steel substrate keeps relatively intensive.

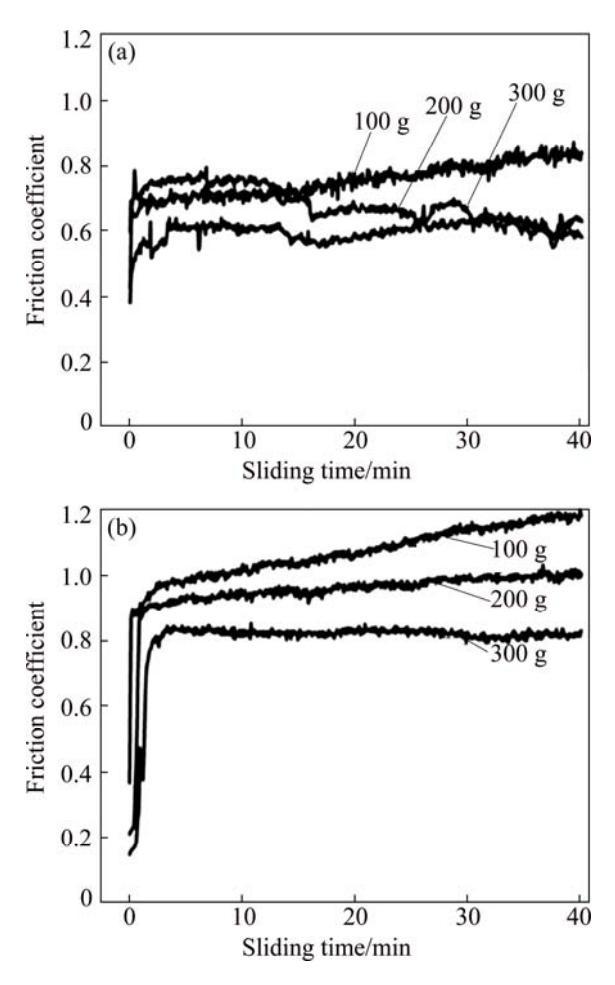
Figure 5 illustrates the friction response as a function of sliding time for the substrate (Fig. 5(a)) and the Ni60A coating (Fig. 5(b)). The 45 steel substrate keeps intensive and the instant friction response curve fluctuates rapidly. Especially, under applied loads of 200 g and 300 g, friction coefficients fluctuate rapidly for sliding against the 45 steel substrate. The friction pairs are composed of GCr15 steel ball and 45 steel substrate or the Ni60A coating. It can be observed that the friction coefficients of the substrate and the coating decrease with the increasing applied loads under the different load conditions. It is well known that in the investigated sliding systems, an increase in load caused a decrease in friction, which is attributed to the oxides produced under the higher load condition [16-19]. The contact surfaces of the substrate and the coating against GCr15 steel balls are easily oxidized to form oxides, due to dry sliding wear test conducted at high temperature, especially under the higher load. Oxides are known to reduce the critical shear stress at the contact points, thereby reducing friction in the sliding system. The presence of oxides is also confirmed in the subsequent studies. Sliding against the Ni60A coating produced higher friction coefficients than sliding against the 45 steel substrate under the same load condition, but the friction process on the Ni60A coating keeps relatively stable and the instant friction response curve is smooth, while the friction processingin wear phase evolves into the severe wear phase during the whole wear process, while the Ni60A coating presents that the running-in wear phase evolves into the steady wear phase. It can be attributed to the fact that the Ni60A coating has a dense and uniform microstructure (Fig. 1 and Fig. 3) and a high microhardness (Fig. 4) as well as good high-temperature property, leading to the relatively stable friction coefficient during the friction and wear test. Under the same load condition, sliding against the 45 steel substrate produces lower friction values, it can be explained by the following reason, the 45 steel substrate has a much lower hardness than the Ni60A coating and thus is easily plastically deformed under the harder material (GCr15 ball), resulting in the

Fig. 5 Friction response as a function of sliding time for substrate (a) and Ni60A coating (b) under different loads

formation of the smooth contact surface which helps to decrease the contribution of the ploughing component to friction [18].

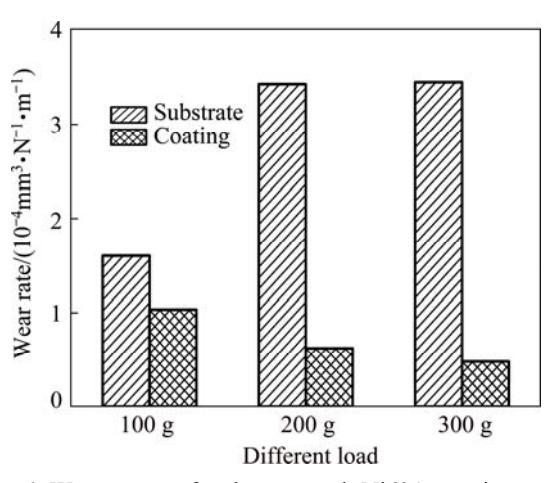
The wear rates of the 45 steel substrate and the Ni60A coating are shown in Fig. 6. It indicates that the Ni60A coating has much smaller wear rates than the 45 steel substrate under the same load condition, and wear rates of the Ni60A coating $(4.8 \times 10^{-5} \text{mm}^3/(\text{N} \cdot \text{m}))$ are about 1/6.2 of that of the 45 steel substrate (3.45×10^{-4}) $mm^{3}/(N \cdot m)$) under the higher load (300 g). This indicates that the coating has excellent wear resistance than the substrate. Besides, the wear rates of the Ni60A coating decrease with the increasing applied loads, while the opposite is observed for the 45 steel substrate. The excellent wear resistance of the coating was primarily attributed to its microstructure, phase constitution, phase distribution and the friction and wear process. A considerable amount of carbides M23C6 and small amount of borides CrB uniformly distributed in the interdendritic eutectics rather than $\gamma(Ni)$ matrix effectively reduce the number of wear debris formation at the contact zone, owing to the fracture of hard phases

Fig. 6 Wear rates of substrate and Ni60A coating under different loads

of boride and carbide under high stress, resulting in the stable friction process and the low wear rates. Meanwhile, uniform tough phases of $\gamma(Ni)$ solid solution also help to depress dual actions which hard phases suffer from the inherent residual strain and the shear stress generated in the friction process. In this case, the total stress centralized on the hard phase is difficult to exceed its strength, resulting in the fracture of hard phases and the excessive wear debris formation in the contact zone. Combining the preceding friction analysis (Fig. 5), the wear rates of the 45 steel substrate follow the typical trend of increased loads, leading to the increase of wear rates [18], and the wear rates of the Ni60A coating follow the trend of increased friction coefficient, leading to the increase of wear rates. This results from the increased loads, leading to the acute fluctuation of the friction coefficients and the instability friction process for the 45 steel substrate. Thus, sliding against substrate suffered from the severe wear, resulting in higher wear rates of the substrate. For the Ni60A coating, although the load is increased from 100 g to 300 g, the friction coefficients of coating decrease and friction process keeps relatively stable. Thus, sliding against coating suffered from the steady wear, resulting in lower wear rates of the substrate.

3) The Ni60A coating has much smaller wear rates than the substrate under the same load condition, wear rates of the coating are 1/6.2 of that of the substrate under the higher load (300 g). Besides, the wear rates of the coating decrease with the increase of applied loads, while the opposite is observed for the substrate. High temperature wear mechanism of the substrate includes adhesion wear, abrasive wear, severe plastic deformation and oxidation wear, while the coating merely suffers from mild abrasive wear and moderate oxidation wear.

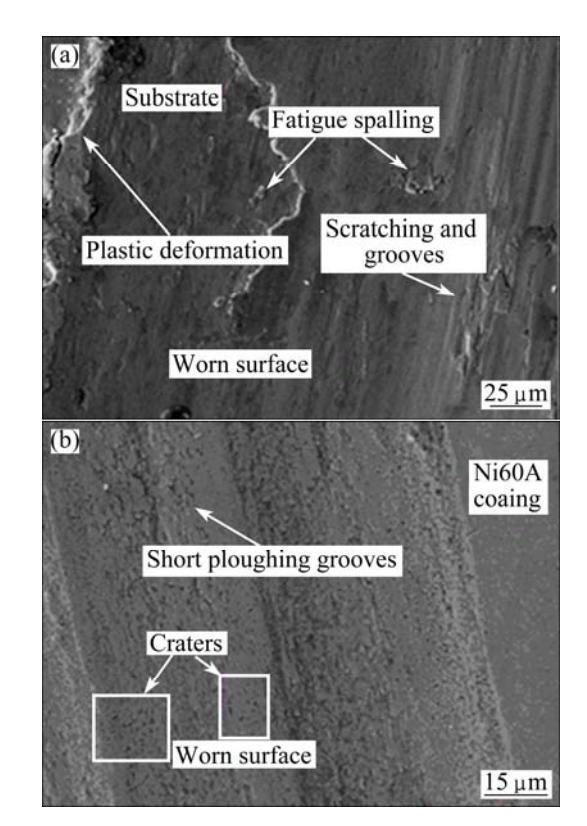
The SEM images of the worn surfaces of the substrate and the Ni60A coating in Fig. 7 indicate the different levels of surface deterioration experienced which are consistent with the wear rates results. It can be observed that the worn surface of the 45 steel substrate shows signs of fatigue spalling and scratching as well as some tiny grooves and severe plastic deformation on the edges of the wear scar, indicating that the 45 steel substrate experienced adhesion wear, abrasive wear, and severe plastic deformation (Especially, severe plastic

deformation on the edges of the wear scar). Scratching and grooving are initially caused by the initial deformation of asperities on the contact surfaces. Subsequent scratching and grooving are caused through an abrasive wear mechanism by wear debris fragments and the surface of the GCr15 ball [18]. No sign of fatigue spalling and plastic deformation are visible on the worn surface of the Ni60A coating, and only a large amount of deep adhesive craters and fairly short continuous ploughing grooves, showing typical characteristic of abrasive mechanism [17]. This well corresponds to the better wear resistance of the Ni60A coating than that of the 45 steel substrate.

Fig. 7 SEM images of worn surfaces of substrate (a) and Ni60A coating (b) under applied load of 300 g
