Trans. Nonferrous Met. Soc. China 25(2015) 2718–2724

# Function of microorganism and reaction pathway for carrollite dissolution during bioleaching

**Abstract:** The function of microorganism and dissolution reaction pathway of carrollite in the bioleaching process were investigated. The results showed that both indirect and contact mechanisms influenced the leaching process. The dissolution of carrollite was significantly accelerated when bacteria were adsorbed on the mineral surface, indicating that the contact mechanism significantly affected the dissolution of carrollite. During bioleaching, the sequence of oxidation state of the sulfur moiety of carrollite was as follows:  $S^{-2} \rightarrow S^0 \rightarrow S^{+4} \rightarrow S^{+6}$ . Elemental sulfur precipitated on the mineral surface, indicating that the dissolution of carrollite occurred via the polysulfide pathway. The surface of carrollite was selectively corroded by bacteria, and oxidation pits with different sizes were observed at various sites. Elemental sulfur, sulfate and sulfite were present on the surface of carrollite during the leaching process, and may have formed a passivation layer on mineral surface.

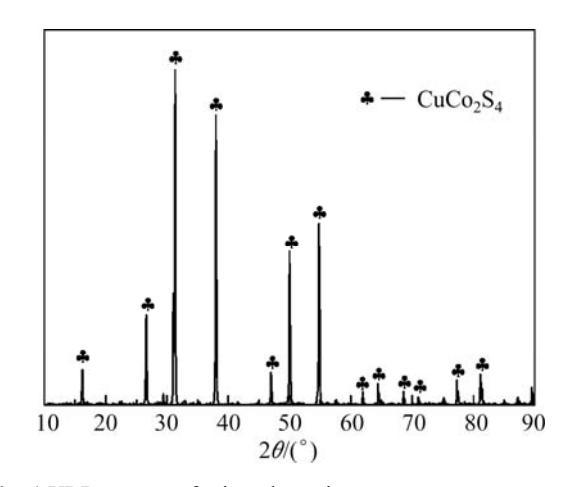
Fig. 1 XRD pattern of mineral specimen

The pure natural carrollite crystal sample was provided by the Luanshya Mine in Zambia. The chemical and XRD (D/MAX-RB, Rigaku Company, Japan) analysis results of the mineral specimens are shown in Table 1 and Fig. 1, respectively. The chemical formula of carrollite is CuCo<sub>2</sub>S<sub>4</sub>. The crystal structure of the mineral belongs to the isometric system. The crystal forms of carrollite are mainly cubic, rhombic dodecahedron, octahedron and trapezohedron. Carrollite is a hypidiomorphic crystal. The formal oxidation states of the constituent elements in CuCo<sub>2</sub>S<sub>4</sub> have been controversial for many years, with no clear consensus  $Cu^{+1}Co^{+3}-Co^{+4}S_4^{-2}$ ,  $Cu^{+1}Co_2^{+3}-S_3^{-2}S^{-1}$ , between  $Cu^{+2}Co_2^{+3}S^{-2}$  or  $Cu^{+1}Co_2^{+3}S_4^{-7}$  [13,14].

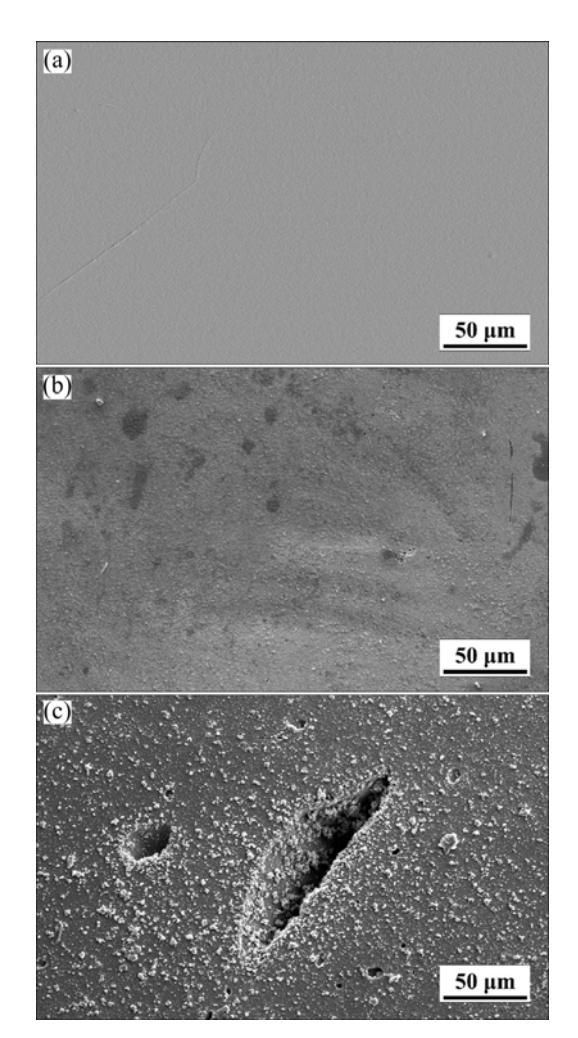
**Fig. 2** Surface micromorphologies of carrollite samples after leaching for 96 h: (a) Original sample; (b) Non-contact; (c) Contact

Figure 2 shows the surface micromorphologies of carrollite samples after leaching for 96 h. Figure 2(a) indicates that the surface of the original sample is metallic luster and clean. In the case of non-contact of bacteria and mineral, the sample shows signs of corrosion after leaching for 96 h, as shown in Fig. 2(b). But only a few tiny etch pits and particles are observed on the specimen surface. The finding indicates that the oxidation of carrollite can occur via an oxidative attack by  $Fe^{3+}$  ions. In the case of contact of bacteria and

mineral, in contrast, the surface of specimen is seriously corroded. Some etching pits with different sizes and particles are observed on the surface, as shown in Fig. 2(c). By comparing Fig. 2(b) with (c), it is obvious that the dissolution of carrollite is significantly accelerated in the case of contact between bacteria and mineral. During leaching process, an ion-exchange between  $Fe^{3+}$  ions in solution against protons of glucuronic acid within EPS occurs, then a stable  $Fe(Glu)^{2+}$  complex is produced, as shown in Eq. (1):

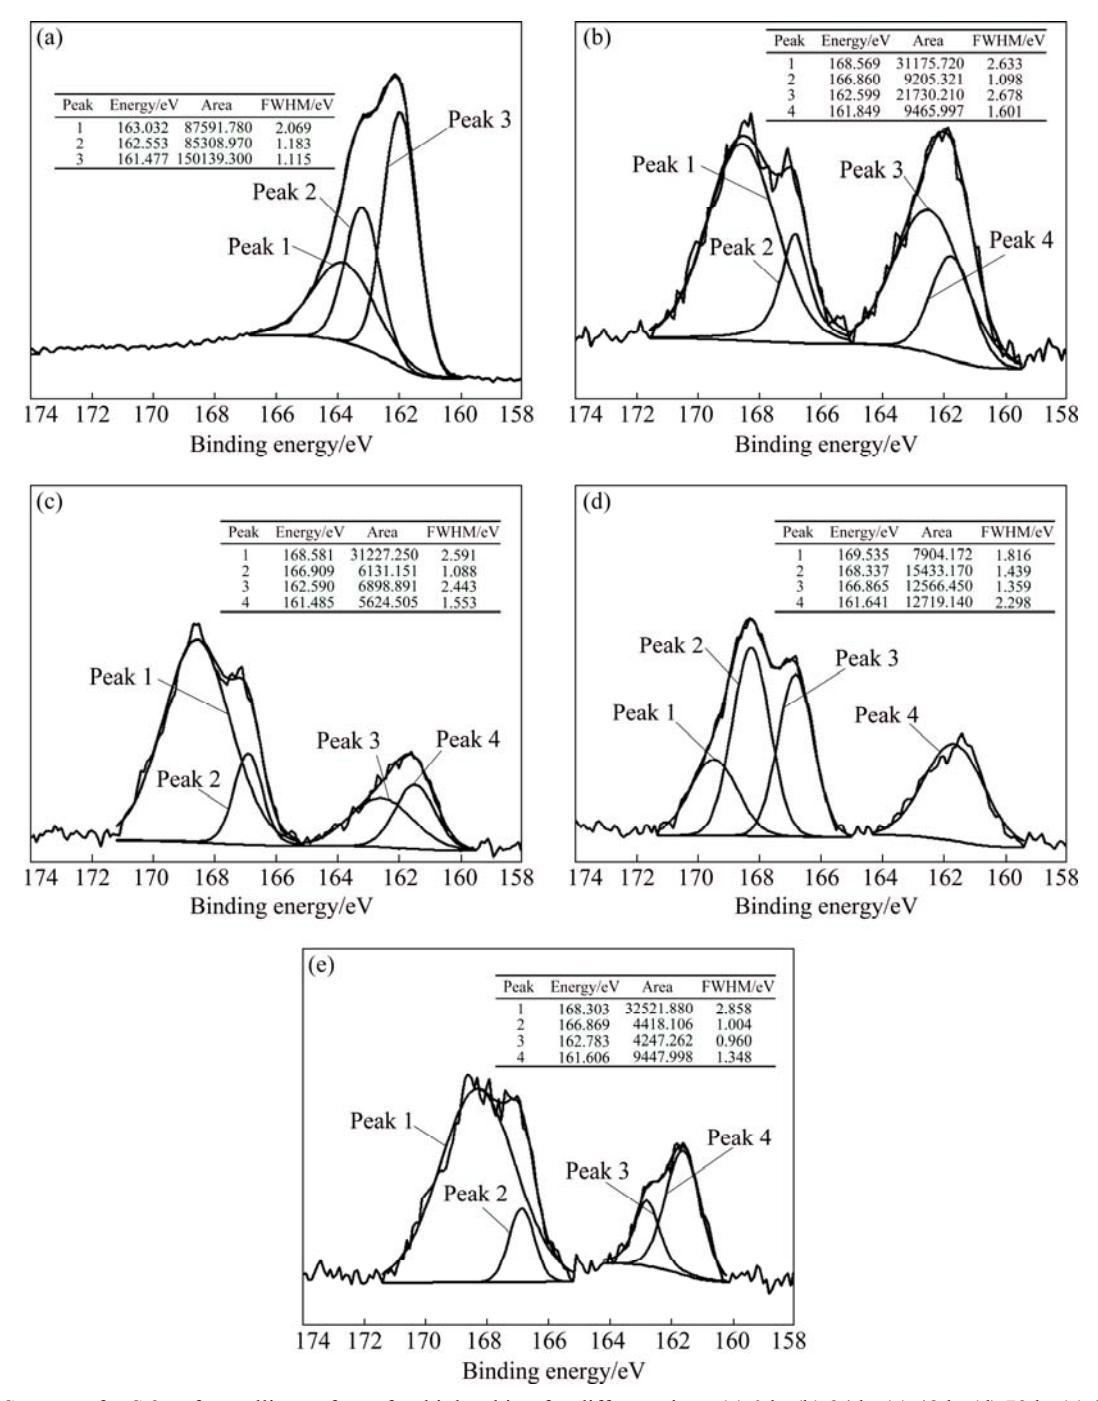
Fig. 3 XPS spectra for S 2p of carrollite surface after bioleaching for different time: (a) 0 h; (b) 24 h; (c) 48 h; (d) 72 h; (e) 96 h

In order to follow the oxidation of the sulfur moiety of carrollite during bioleaching, XPS analyses for elemental sulfur were conducted. The S 2p spectra from the carrollite surface after leaching with bacteria are shown in Fig. 3, and the peak parameters fitted to the spectra are listed in Table 2. Three peaks at 163.032, 162.553 and 161.477 eV fit to the spectrum of the original sample, as shown in Fig. 3(a), which are all assigned to  $S^{-2}$ . This finding indicates that the oxidation state of the sulfur moiety of carrollite is  $S^{-2}$ , which coincides with Refs. [13,14]. After leaching for 24 h, four peaks at 161.849, 162.599, 166.860 and 168.569 eV fit to the spectrum of the specimen, as shown in Fig. 3(b). The first two peaks are assigned to  $S^{-2}$ , whereas the latter two peaks are assigned to  $S^{+4}$  and  $S^{+6}$ , respectively. This indicates that sulfite and sulfate (such as jarosite) are present on the sample surface. After leaching for 72 h, four peaks at 161.641, 166.865, 168.337 and 169.535 eV fit to the spectrum of the sample (Fig. 3(d)). These peaks are assigned to  $S^0$  (161.641 eV),  $S^{+4}$  (166.865 eV), and S<sup>+6</sup> (168.337 and 169.535 eV). This indicates that element sulfur is also present on the mineral surface, besides sulfite and sulfate during the leaching process.

According to the XPS analyses, it can be concluded that the oxidation state of the sulfur moiety of carrollite is transformed as follows:  $S^{-2} \rightarrow S^{0} \rightarrow S^{+4} \rightarrow S^{+6}$ , because elemental sulfur, sulfites and sulfates are defecated. Therefore, it can be concluded that the dissolution of carrollite proceeds through polysulfide pathway, as shown in Fig. 4. The mechanism can be further explained by Eqs. (6)–(10).

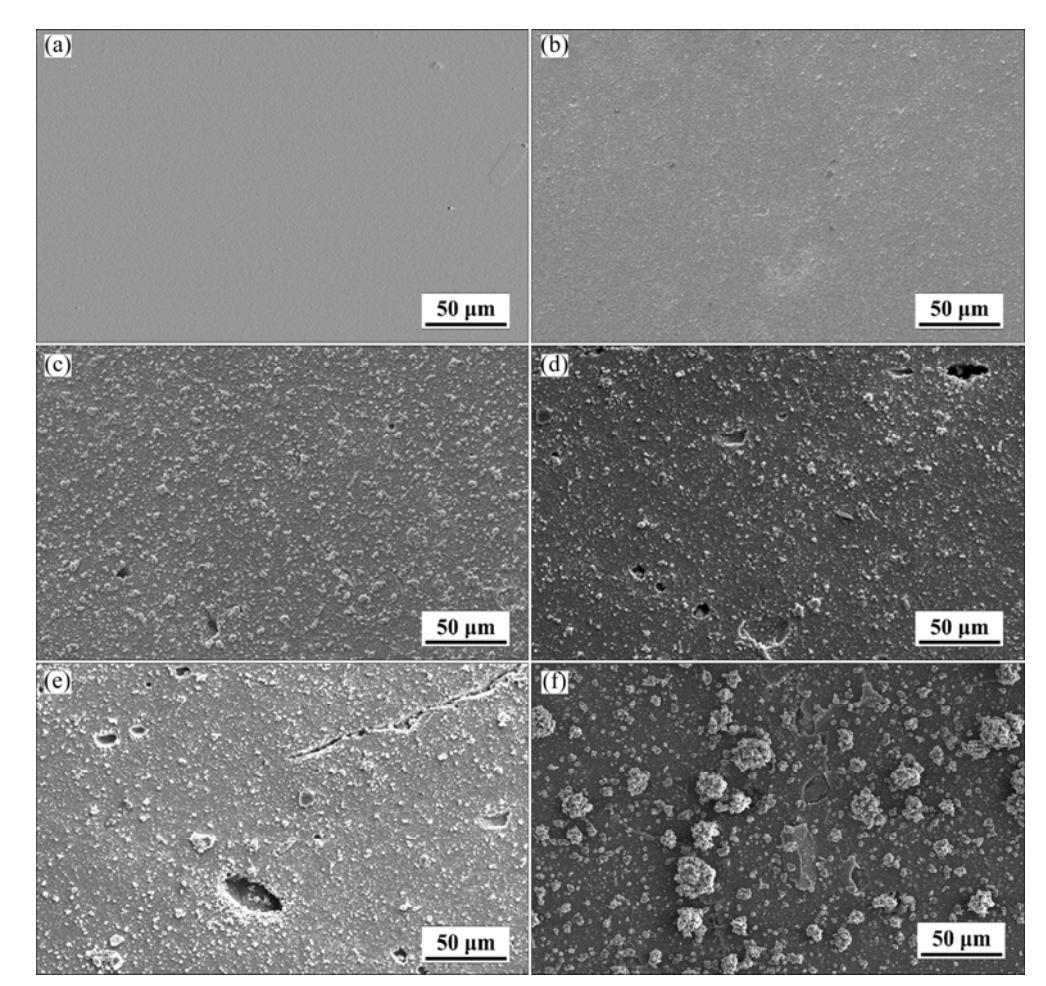
**Fig. 4** Surface micromorphologies of carrollite samples after bioleaching for different time: (a) 0 h; (b) 24 h; (c) 48 h; (d) 72 h; (e) 96 h; (f) 144 h

The changes in the surface micromorphology of carrollite samples during bioleaching are shown in Fig. 4. Figure 4(a) indicated that the surface of the original sample was metallic luster and clean. After leaching for 24 h, the carrollite was corroded, and a few particles were adhered to the surface (Fig. 4(b)). After 48 h, the corrosion became more severe, and the amount of particles increased. Some etching pits with different sizes were observed on the surface (Fig. 4(c)). With increasing leaching time the corrosion faces continued to increase,

and more pits and particles on the surface became visible (Figs. 4 (d) and (e)). The size of etch pit and microcracks gradually increased. The maximum size was 0.04 mm  $\times$  0.02 mm. After 144 h, the particles increased, and a precipitate layer formed on the surface of the sample (Fig. 4(f)).

SEM images demonstrated that the carrollite surface is selectively corroded in the presence of bacteria. Some etched pits with different sizes are observed at various sites. Moreover, some etched pits are seemingly a ranged line, as shown in Figs. 4(d) and (e). There are indications from Refs. [6,16] that the attachment of bacteria on the surface of metal sulfides does not occur randomly. Bacteria preferentially attach to sites with visible surface imperfections such as scratches and low crystallization. The attachment to areas with low crystallization is favored and the sessile bacteria seem to orient along crystallographic axes.

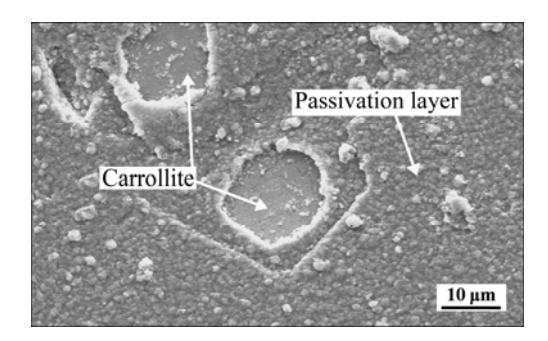
Fig. 5 SEM image of carrollite surface after bioleaching

From the data of XPS, SEM and EDS analyses, elemental sulfur, sulfate and sulfite were detected on the surface of carrollite during bioleaching. If more of these compounds adhere to the mineral surface, they can form a passivation layer on the surface of carrollite, as shown in Fig. 5. The passivation film may hinder the dissolution
