Trans. Nonferrous Met. Soc. China 27(2017) 1071-1080

# Effect of N-ion implantation and diamond-like carbon coating on fretting wear behaviors of Ti6Al7Nb in artificial saliva

Abstract: The tribology behaviors of Ti6Al7Nb, its alloy with N-ion implantation, and its alloy with diamond-like carbon (DLC) coating were investigated in artificial saliva. Fretting wear tests of untreated, N-ion implanted and DLC coated Ti6Al7Nb alloys plate against a  $Si_3N_4$  ball were carried out on a reciprocating sliding fretting wear test rig. Based on the analysis of X-ray diffraction, Raman spectroscopy, 3-D profiler, SEM morphologies and frictional kinetics behavior analysis, the damage behavior of surface modification layer was discussed in detail. The results indicated that the fretting wear behavior of Ti6Al7Nb alloy with N-ion implantation was increased with the dose increase of the implanted nitrogen ions. Moreover, the DLC-coated Ti6Al7Nb alloy with low ion implantation could improve the fretting wear behavior greatly. In addition, the Ti6Al7Nb with DLC coating had better wear resistance due to the special compact structure. All results suggested that the Ti6Al7Nb with DLC coating had be

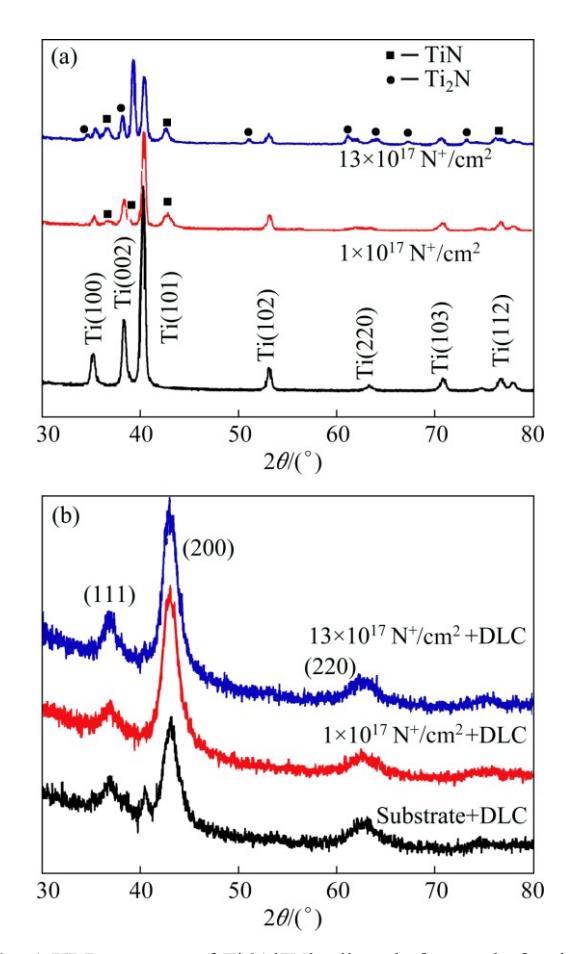
XRD was performed on the implanted surface of the specimens by Xpert PRO MPD) made diffractometer using Cu K<sub>a</sub> radiation with incident angle of  $0.5^{\circ}$ , with a scanned range from 20° to 80°. The diffraction patterns of the specimens are shown in Fig. 1. The pattern showed a single  $\alpha$  peak before ion implantation. At the nitrogen dose of  $1 \times 10^{17} \text{ N}^+/\text{cm}^2$ , there were growing peaks at  $2\theta$  values of 37.4° and 43° compared to un-implanted specimen, resulting from TiN. As nitrogen dose increased to 13×10<sup>17</sup> N<sup>+</sup>/cm<sup>2</sup>, several new peaks appeared at  $2\theta$  values of  $39^{\circ}$  and  $52.7^{\circ}$ , which were detected as Ti<sub>2</sub>N. The transformation process was Ti-TiN-Ti<sub>2</sub>N, in which the first step was the transformation of Ti to TiN by changing the stacking sequence from ABAB, in the HCP structure to ABCABC in the FCC structure of TiN. The nitrogen atoms could stay at octahedral interstitial sites during this process. The second step was the transformation of TiN to Ti<sub>2</sub>N, in which the nitrogen atoms were harmonized in octahedral interstitial sites during this transformation. The XRD patterns of the DLC (Cr-CrN-CrSiN) of three

substrates (un-nitrided Ti6Al7Nb and nitrogen doses of  $1 \times 10^{17}$  N<sup>+</sup>/cm<sup>2</sup> and  $13 \times 10^{17}$  N<sup>+</sup>/cm<sup>2</sup>) were given in Fig. 1(b). The CrSiN composite film was face-centered cubic structure consisting (111), (200) and (220) diffraction peaks [33]. It could be seen that the structures of CrSiN composite film were almost the same, although the substrate was different.

**Fig. 1** XRD patterns of Ti6Al7Nb alloys before and after iron implantation and DLC: (a) Substrate and iron implantation; (b) Iron implantation and DLC

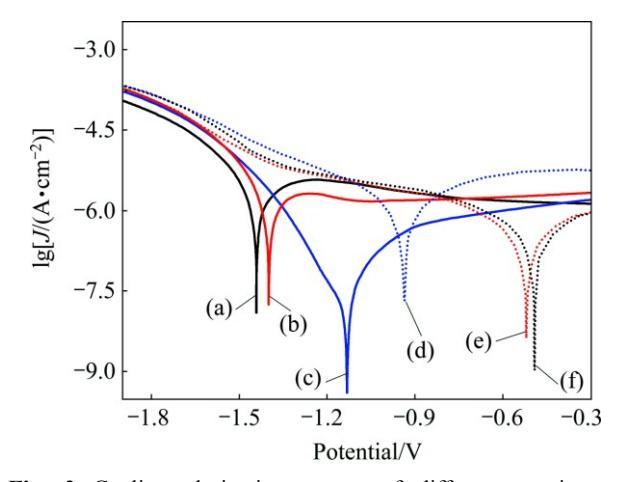
The cyclic polarization curves of the Ti6Al7Nb alloy with different treated ways are shown in Fig. 2. The corrosion potential ( $\varphi_{corr}$ ), corrosion current density ( $J_{corr}$ ), and polarization resistance ( $R_p$ ) can be obtained by corresponding analogy computing program. Compared with implanted and un-implanted Ti6Al7Nb alloys, the polarization curve of DLC exhibited a high positive potential, and its corrosion current density decreased significantly. In addition, the increasing nitrogen dose resulted in the decrease in the passive current density and the positive potential, which indicated that the stability of the passive film against dissolution decreased. However, the DLC on the un-implanted specimen possessed the highest positive potential. Based on the aforementioned results, it can be concluded that the diamond-like carbon

(DLC) coating had better corrosion resistance compared to the two different surface modifications.

Fig. 2 Cyclic polarization curves of different specimens: (a) Substrate; (b) Implanted at dose of  $1 \times 10^{17}$  N<sup>+</sup>/cm<sup>2</sup>; (c) Implanted at dose of  $13 \times 10^{17}$  N<sup>+</sup>/cm<sup>2</sup>; (d) DLC coated after implanted at dose of  $13 \times 10^{17}$  N<sup>+</sup>/cm<sup>2</sup>; (e) DLC coated after implanted at dose of  $1 \times 10^{17}$  N<sup>+</sup>/cm<sup>2</sup>; (f) DLC coated on substrate

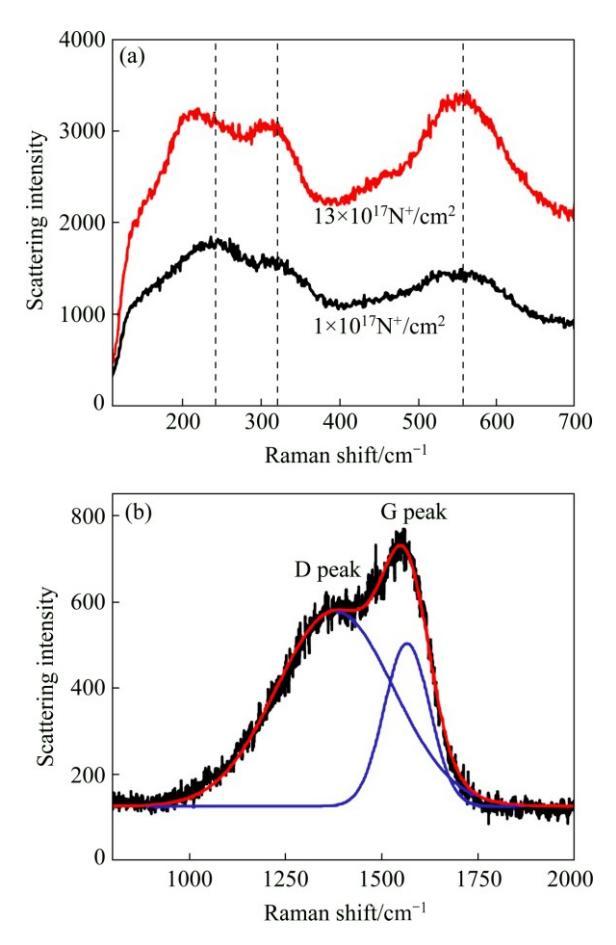
Figure 3 showed the Raman spectra of nitrogen ion implantation layer acquired between 100 and 700 cm<sup>-1</sup> and DLC (Cr-CrN-CrSiN) coating acquired between 800 and 2000 cm<sup>-1</sup>, which could be deconvoluted into two sub-peaks: G band (graphitic) around 1565 cm<sup>-1</sup> and D band (disorder) at approximately 1348  $cm^{-1}$ , which are typical characteristics of diamond-like carbon coatings [34,35]. It could be seen that the implanted Ti6Al7Nb alloy had three apparent positions of the peaks, which were located at 210-250, 310-350 and 550-600 cm<sup>-1</sup>. These peaks were corresponding to the first-order peak of the Ti-N. The three peaks were relatively flat and low-frequency peaks were located at the vicinity of 240 and 330 cm<sup>-1</sup>, when the implantation dose was  $1 \times 10^{17} \text{ N}^{+}/\text{cm}^{2}$ . As the implantation dose increased, the two peaks with low frequency trended to be stable near  $215 \text{ cm}^{-1}$  by moving to a low wave. The frequency peak position had no obvious changes substantially, while the peak intensity was significantly enhanced. Based on the above results, there was a positive correlation between the number of nitrogen atoms in Ti-N and the increase in the nitrogen ion dose.

**Fig. 3** Raman spectra of specimens: (a) Ion implantation; (b) Ion implantation and DLC

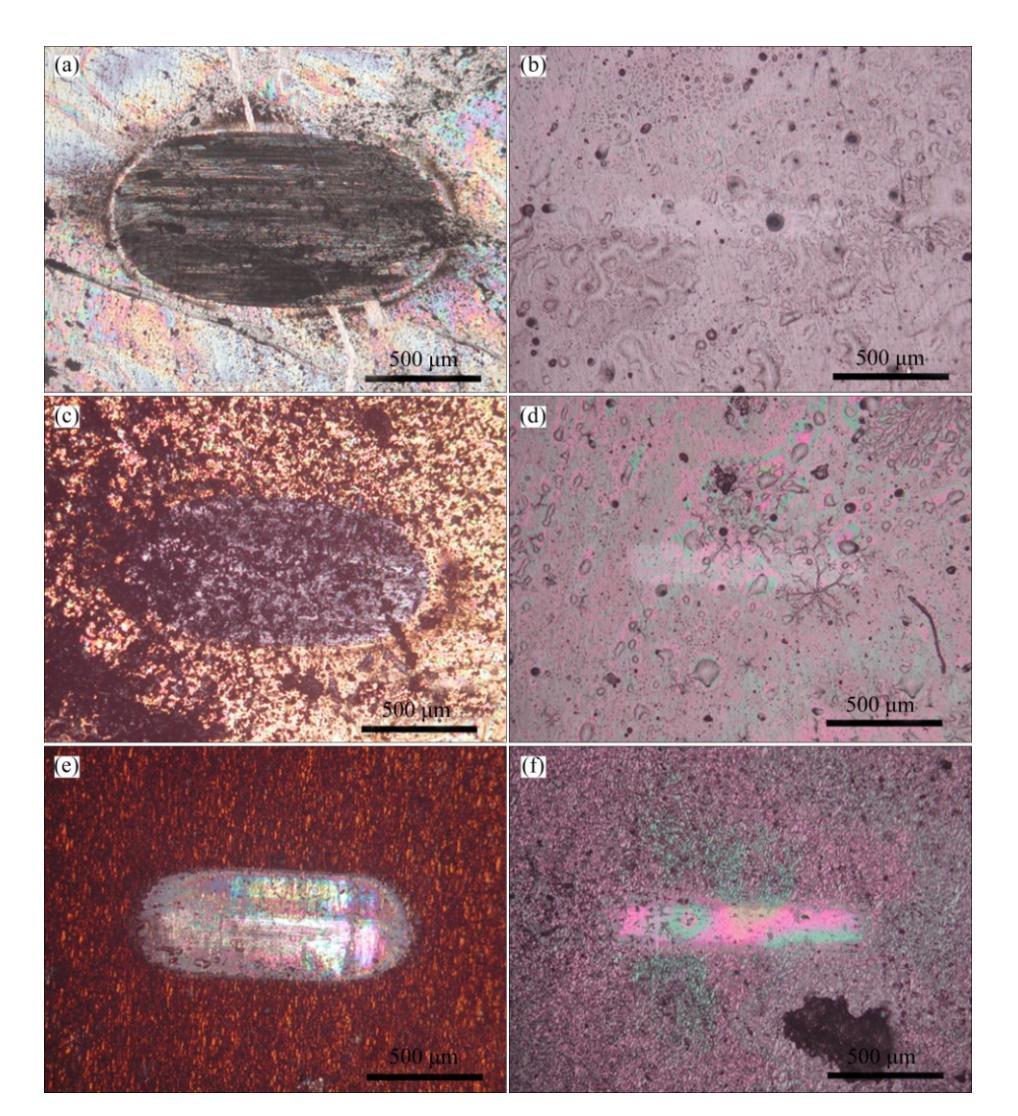
The typical morphologies of worn surfaces of the samples against a  $Si_3N_4$  ceramic counter face under the normal loads of 10 N and 50 N carried out on a flat-on-ball contact on an improved reciprocating sliding fretting are shown in Figs. 4 and 5, respectively. It was found that the shape of wear scars was oval. The wear

scar after implantation became small and slight compared with that of the un-nitrided samples (Figs. 4 and 5), which were worn seriously with wide and deep grooves along the sliding tangential direction. There was a lot of debris generated. In addition, the scar became smaller and the damage became slight with increasing nitrogen dose. At the dose of  $13 \times 10^{17} \text{ N}^+/\text{cm}^2$ , the wear damage was very slight and only surface impression could be found. Compared with the implanted Ti6Al7Nb alloy, the samples with DLC coating had the slightest damage (Figs. 4(b), 4(d), 4(f) and 5(b), 5(d), 5(f)). The wear scar was too small to be seen. The damage of three different DLC was contrary to the implanted Ti6Al7Nb alloy mentioned above. The DLC on un-nitrided surface had smaller and slighter wear scar than that on implanted surface, which was consistent to the results of the wear rate shown in Fig. 6. This phenomenon could be attributed to the roughness of the base body. The roughness of surface became larger and the CrSiN films on it were less smooth. Thus, it wore seriously in reciprocating sliding movement situation. In general, the two methods of surface modification (nitrogen ion implantation and DLC coating) had a significant improvement for the wear resistance, specifically for the

**Fig. 4** Morphologies of fretting wear scar at F=10 N: (a) Substrate; (b) Un-implanted+DLC; (c)  $1 \times 10^{17}$  N<sup>+</sup>/cm<sup>2</sup>; (d)  $1 \times 10^{17}$  N<sup>+</sup>/cm<sup>2</sup> + DLC; (e)  $13 \times 10^{17}$  N<sup>+</sup>/cm<sup>2</sup>; (f)  $13 \times 10^{17}$  N<sup>+</sup>/cm<sup>2</sup> + DLC

second method. The first method could be explained that with the increase in the effective range of nitrogen ion implantation and the zone of  $Ti_xN_y$ , one was attributed to the increase of the thickness of implanted layer and the other was due to the structural characteristics of the composite film: little size crystalline grain and compact structure, which could effectively prevent the friction process of crack and due to the high strength hardness of the film.

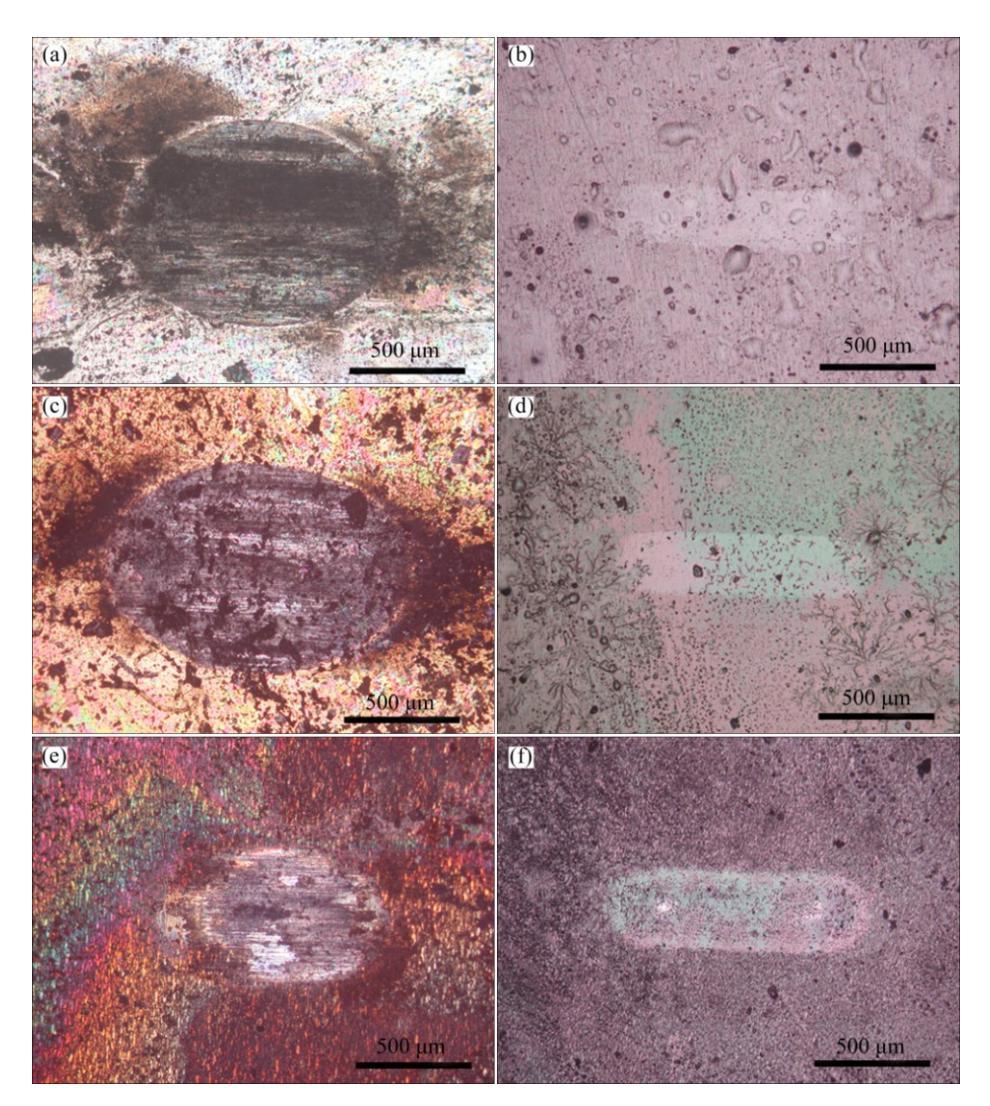
Fig. 5 Morphologies of fretting wear scar, F=50 N: (a) Substrate; (b) Un-implanted + DLC; (c)  $1 \times 10^{17}$  N<sup>+</sup>/cm<sup>2</sup>; (d)  $1 \times 10^{17}$  N<sup>+</sup>/cm<sup>2</sup> + DLC; (e)  $13 \times 10^{17}$  N<sup>+</sup>/cm<sup>2</sup>; (f)  $13 \times 10^{17}$  N<sup>+</sup>/cm<sup>2</sup> + DLC

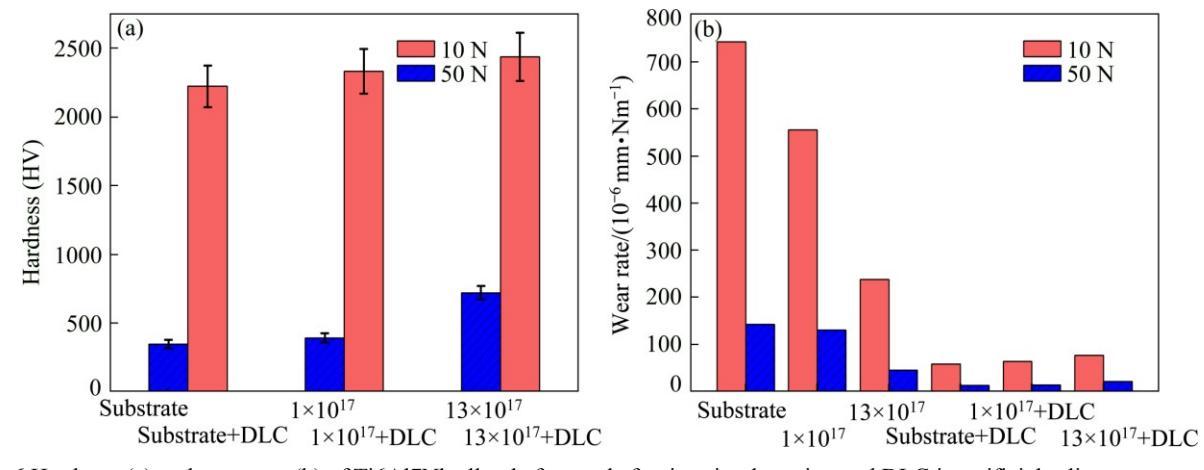
Figure 6 shows the hardness and wear rate during fretting in artificial saliva under normal loads (10 N and 50 N). The hardness increased as the implantation dose increased, and the DLC film deposited on the substrate can increase the hardness greatly. The wear rate was significantly larger under 10 N than that under 50 N for uncoated and plasma nitrided alloys as well as DLC coating. It can be observed that DLC coated sample had revealed drastically reduced wear rate compared to substrate materials due to high resistance towards fretting

in high load as well as low load.

Fig. 6 Hardness (a) and wear rate (b) of Ti6Al7Nb alloy before and after iron implantation and DLC in artificial saliva

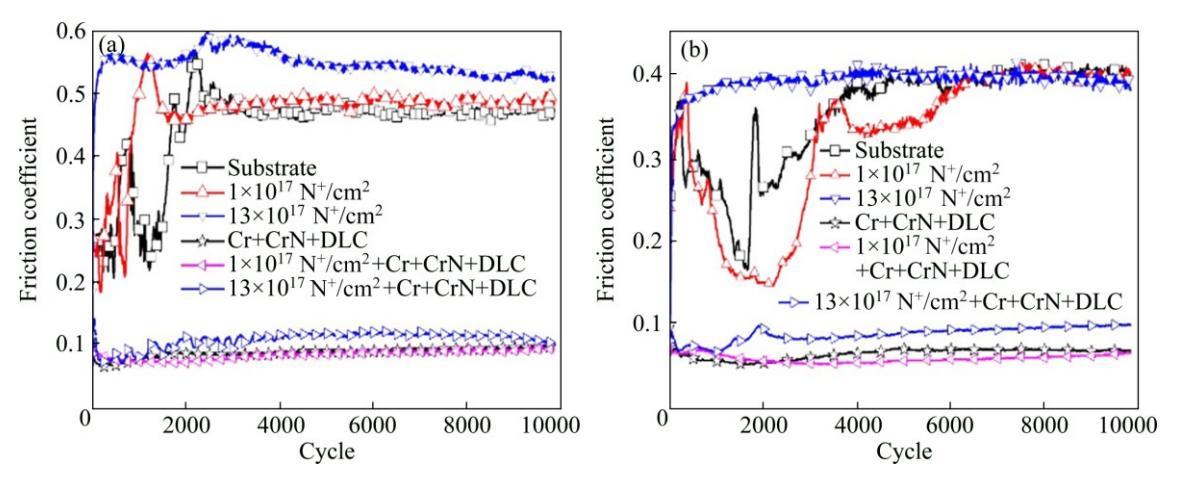
Figure 7 shows the comparison of variation in friction coefficients for surface modified alloys tested under normal loads (10 N and 50 N). In these two conditions, the unmodified and plasma nitrided alloys had exhibited high friction coefficients (between 0.4 and 0.5) compared to the DLC coating, which had very low friction coefficients (below 0.1). For uncoated and plasma nitrided alloys, the friction coefficients decreased from 0.54 to 0.4 as the normal load increased from 10 to 50 N, which could be attributed to the gradual change in contact condition induced by the increasing normal load. A similar slight trend was observed in the DLC coating alloy. For the plasma nitride samples tested under low load (10 N), the friction coefficient had a peak value after a few hundred cycles and then there was a drastic reduction in its value for the low dose  $(1 \times 10^{17} \text{ N}^+/\text{cm}^2)$ . It

remained low for the next thousands of cycles, indicative of steady property. It indicated the gradual erosion of the nitride layer with the progression of fretting cycles. Under high load (50 N), it was similar with that at high dose  $(13 \times 10^{17} \text{ N}^+/\text{cm}^2)$ . But the low dose  $(1 \times 10^{17} \text{ N}^+/\text{cm}^2)$  was different. In the case of DLC coated samples, the friction coefficient decreased after a few hundred cycles. A gradual transition was observed and finally reached a

value of 0.07. The number of cycles after which there was a sharp increase in friction coefficient was considered as the life of the coating. It was worth noting that only one test was conducted in each condition and more carefully planned and repeated experiments were necessary to determine the coating life accurately. However, with the available data in the present study, it might be said that the number of cycles at which failure occurred decreased when the normal load increased. So it could be seen in Fig. 7 that the DLC (Cr–CrN–CrSiN) had no observed decrease, and still was in a stable stage of low friction coefficient. The DLC (Cr–CrN–CrSiN) had superior fretting behavious with low friction coefficients.

**Fig. 7** Evolution of coefficient of friction of implanted and un-implanted Ti6Al7Nb and several DLC specimens during fretting tests in artificial saliva at 37 °C: (a) *F*=10 N; (b) *F*=50 N

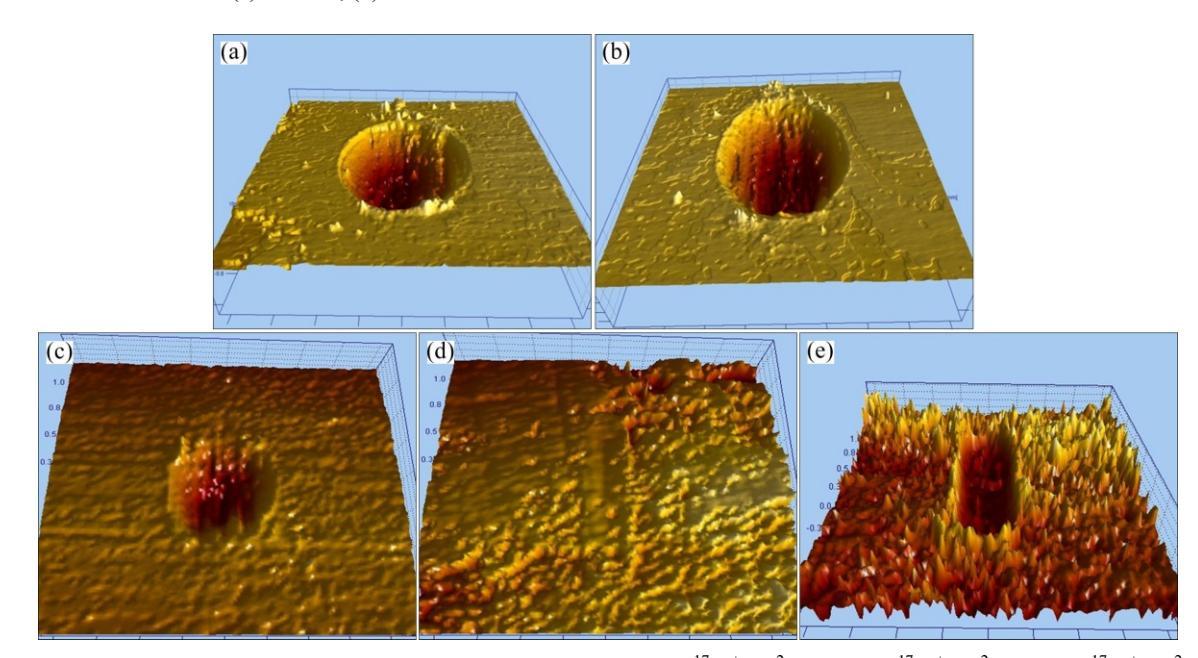
Further researches on wear scar of unmodified and the plasma nitrided alloys were carried out in a non-contact 3D surface profiler as shown in Fig. 8. As shown in Fig. 8, the wear scar was mainly composed of plough grooves and micro cracks. The wear scar of nitride specimen was much smaller and shallower than the untreated ones (Figs. 8(b) and (c)), especially the high dose of nitrogen ion (Fig. 8(c)). The wear scars of DLC coated specimens (Figs. 8(d) and (e)) were the lightest. The damage of DLC coated at high ion dose was worse than that at low ion dose, which was consistent with the results in Figs. 4, 5 and 6. Compared with the untreated wear scar (Fig. 9), the ion implantation surface damage was slighter (Fig. 10). Only micro-cracks and small debris appeared in the superficial zone. The 3D morphologies of the wear scar illustrated the above difference significantly (Fig. 8).

Fig. 8 3D-morphologies of wear scar at F=50 N: (a) Substrate; (b)  $1 \times 10^{17}$  N<sup>+</sup>/cm<sup>2</sup>; (c)  $13 \times 10^{17}$  N<sup>+</sup>/cm<sup>2</sup>; (d)  $1 \times 10^{17}$  N<sup>+</sup>/cm<sup>2</sup>+DLC; (e)  $13 \times 10^{17}$  N<sup>+</sup>/cm<sup>2</sup>+DLC

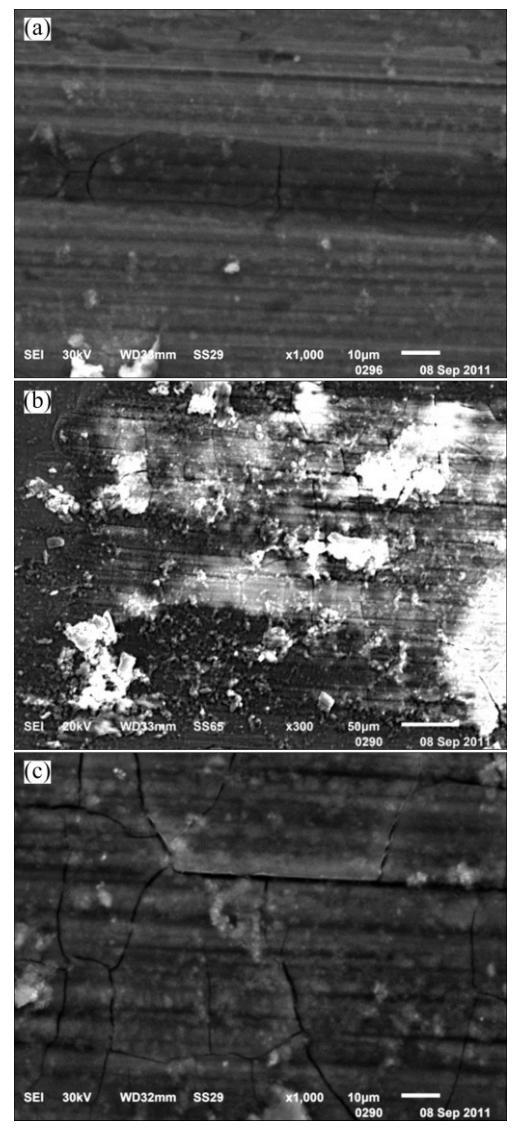
SEM images of fretting scar in artificial saliva lubrication for untreated Ti6A7Nb alloys are shown in Fig. 9. The fretting scars exhibited plough and scratch damage on the fretting area (Fig. 9(a)). The distinct plastic grooves, deformation and the metallic particles

Fig. 9 Fretting wear scar profile of substrate alloy at F=50 N

adhesion were obviously observed in the larger magnification of the worn surfaces (Fig. 9(b)). These results indicated that severe material transfer through adhesive and abrasive wear could occur. The damage mechanism of Ti6Al7Nb alloy was combining with oxidation wear and abrasive wear [36]. The fretting scars of nitrogen ion implanted and DLC coated Ti6Al7Nb alloys were observed in Fig. 10. It can be seen that the damage of the implanted specimens was slighter. Only with slight plough (Fig. 10(a)). With the increase of ion dose, the damage became slighter. The damage mechanism of implantation Ti6Al7Nb layer was slight abrasive wear. There were only surface impressions on the surface of different ion implantation with DLC coating (Figs. 10(c) and (d)). In addition, the unworn zone (A) had high roughness like grain boundary and the worn zone (B) became flatter (Fig. 10(d)). Thus, it could be concluded that the DLC coating almost had no damage except for slight sliding.

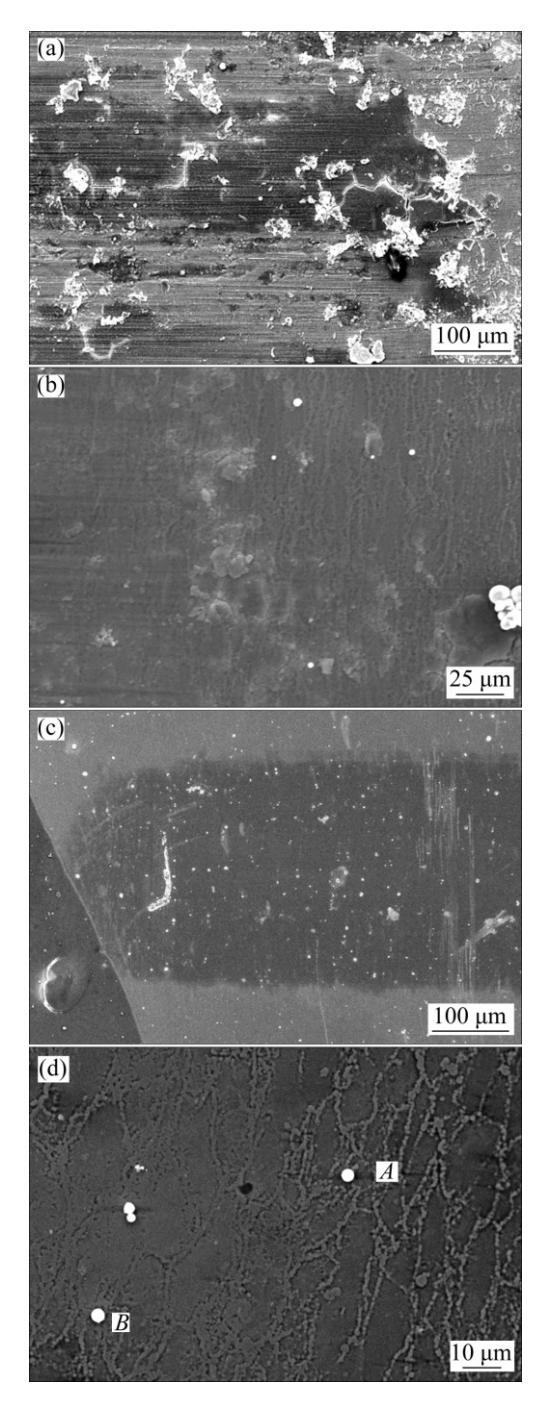
Fig. 10 Morphologies of wear scar of nitrogen ion implantation specimens at F=50 N: (a)  $1 \times 10^{17}$  N<sup>+</sup>/cm<sup>2</sup>; (b)  $13 \times 10^{17}$  N<sup>+</sup>/cm<sup>2</sup>; (c)  $1 \times 10^{17}$  N<sup>+</sup>/cm<sup>2</sup>+DLC; (d)  $13 \times 10^{17}$  N<sup>+</sup>/cm<sup>2</sup>+DLC
