Trans. Nonferrous Met. Soc. China 30(2020) 1290-1299

Effect of cold deformation and heat treatment on microstructure and mechanical properties of TC21 Ti alloy

Abstract: In the present research work on TC21 titanium alloy (6.5Al-3Mo-1.9Nb-2.2Sn-2.2Zr-1.5Cr), the effects of cold deformation, solution treatment with different cooling rates and then aging on microstructure, hardness and wear property were investigated. A cold deformation at room temperature with 15% reduction in height was applied on annealed samples. The samples were solution-treated at 920 °C for 15 min followed by different cooling rates of water quenching (WQ), air cooling (AC) and furnace cooling (FC) to room temperature. Finally, the samples were aged at 590 °C for 4 h. Secondary α -platelets precipitated in residual β -phase in the case of solution-treated samples with AC condition and aged ones. The maximum hardness of HV 470 was obtained for WQ + aging condition due to the presence of high amount of residual β -matrix (69%), while the minimum hardness of HV 328 was reported for FC condition. Aging process after solution treatment can considerably enhance the wear property and this enhancement can reach up t

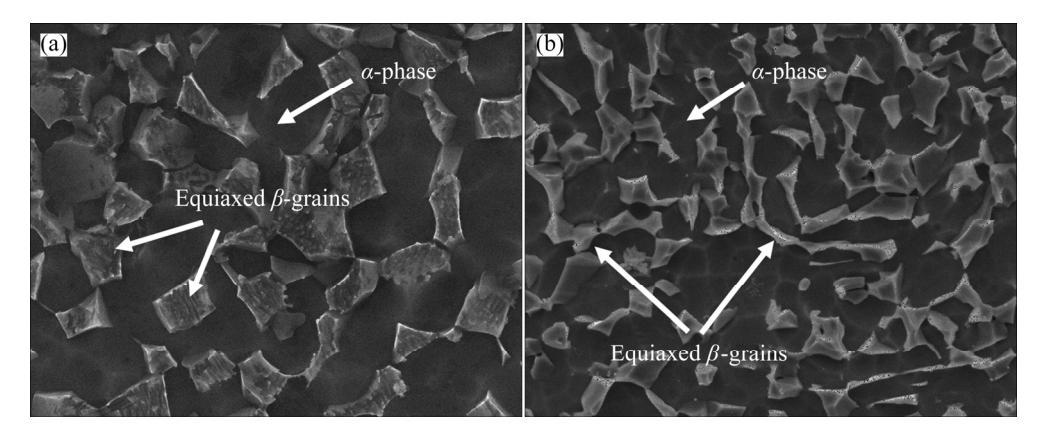
Fig. 1 Microstructures of annealed (a) and 15% cold-deformed (b) TC21 titanium alloys

The microstructures of annealed and postdeformed samples are shown in Fig. 1. The annealed samples showed a structure composed of $\alpha+\beta$ phases (Fig. 1(a)). The volume fraction of α -phase was approximately 65% and the rest was β -phase. Both α and β phases were analyzed using EDS (Fig. 2). α -stabilizing elements such as Al were found in a high content (7.7%) in the α -phase and some β -stabilizing elements (Mo, Nb and Cr) existed in a low content, (Fig. 2(a)). On the other hand, high amount of β -stablizing elements (such as 4.16% Mo, 2.51% Nb and 2.57% Cr, in volume fraction) were found in β -phase (Fig. 2(b)). Neutral elements such as Zr and Sn existed approximately with the same content in both α and β phases. By applying 15% deformation, the structure revealed an elongated and thin β -phase embedded in α phase. In addition, some β -phase due to compression action (as shown by arrows in Fig. 1(b)).

(1) Applying 15% cold deformation on TC21 alloy revealed an elongated and thin β -phase embedded in α -phase.

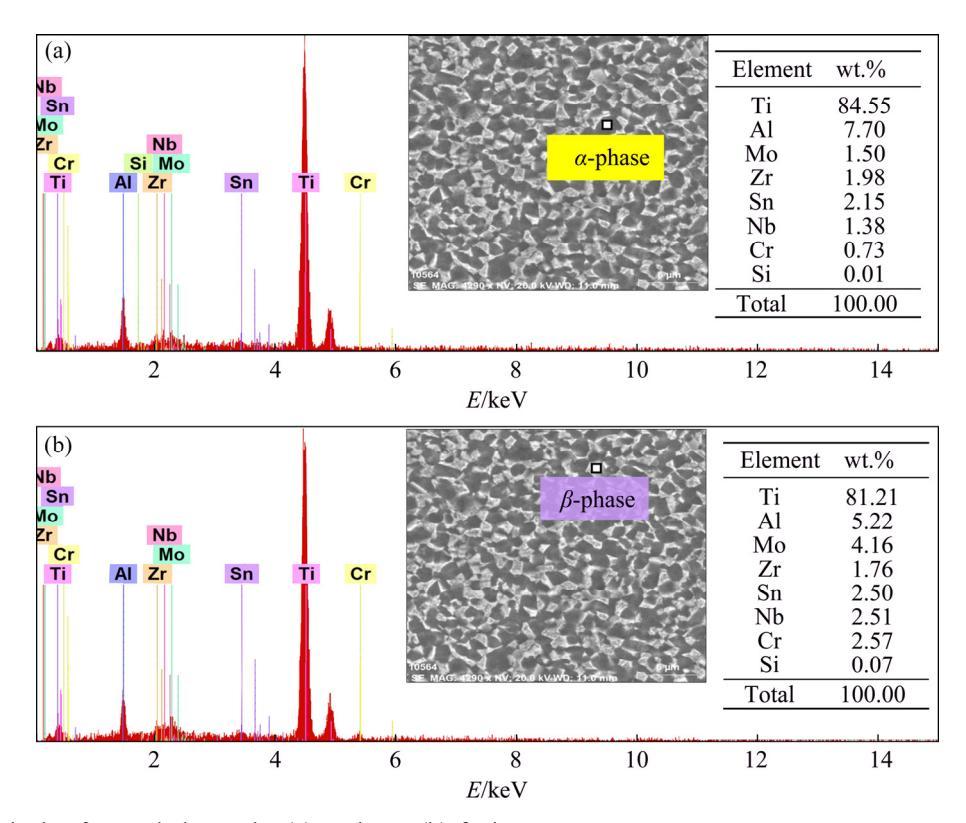
Fig. 2 EDS analysis of annealed sample: (a) α -phase; (b) β -phase

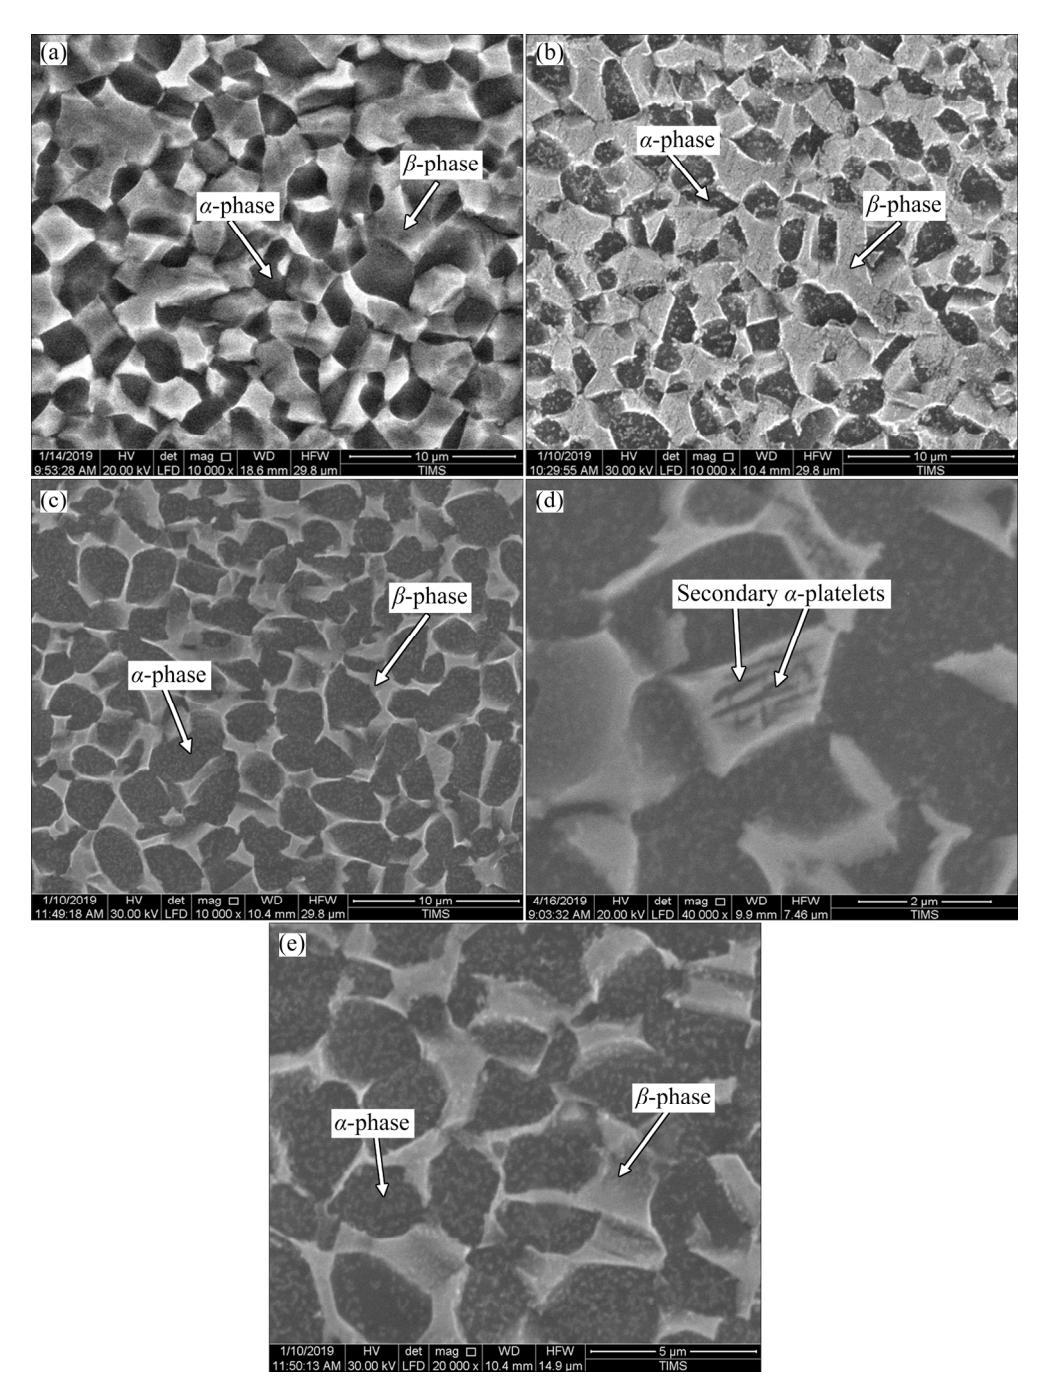
Fig. 3 FESEM images of TC21 alloy after solution treatment at 920 °C followed by three different cooling rates: (a) WQ; (b) AC; (c) FC; (d) AC, with secondary α -platelets; (e) FC, without secondary α -platelets

The microstructural feature of TC21 titanium alloy after solution treatment at 920 °C followed by three different cooling rates of WQ, AC and FC is shown in Fig. 3. The microstructures of all samples are composed of α and β phases, in addition to secondary α -platelets in the case of AC condition. FC samples showed an increase in grain size of primary equiaxed α -phase compared with WQ and AC ones. The volume fraction of primary equiaxed α -phase for FC samples was estimated to be about 68%. It decreased to 56% and 51% for WQ and AC, respectively. There was no obvious difference between WQ and AC samples, except for the tiny secondary α -platelets that precipitated in residual β -phase for the later one. So, the microstructure of AC samples consisted of primary equiaxed α -phase, secondary α -platelets and residual β -phase.

Secondary α -platelets together with residual β -phase called "residual β -matrix strengthened by secondary α -platelets" or residual β -matrix as a short [9]. These precipitated secondary α -platelets at the residual β -phase for AC samples were clear at a high magnification in Fig. 3(d). These secondary α -platelets did not form in the structure of WQ samples because high cooling rate generated a high super-saturation due to diffusion of β -stabilizing

Therefore, it could be concluded that secondary α -platelets precipitated in the residual β -phase at medium cooling rate of AC and did not precipitate in the case of very slow cooling rate (FC) and high cooling rate (WQ). So, a proper super-saturation was considered as a decisive factor for precipitation of secondary α -platelets in the residual β -phase after solution treatment process of TC21 titanium alloy. This observation partially agreed with the reported work published by WANG and LI [18] with variation in the chemical composition.

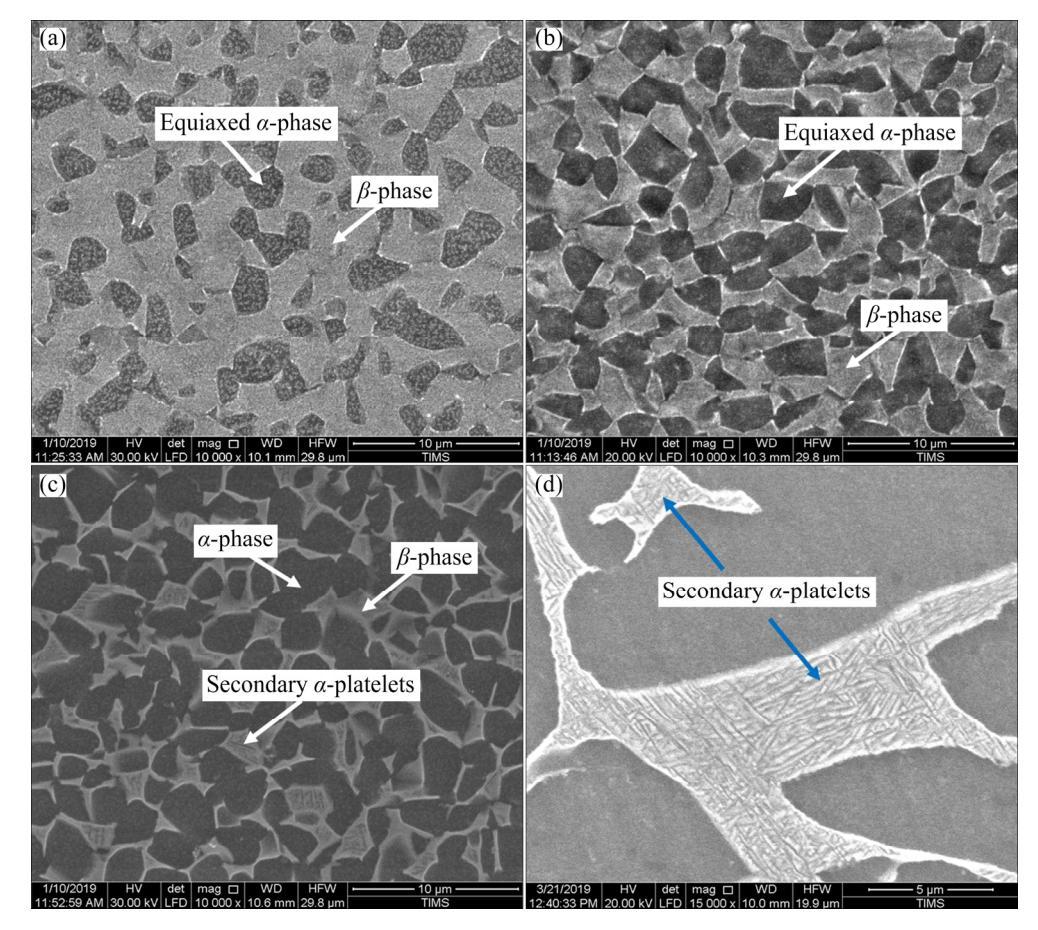
Fig. 4 FESEM images of aged samples: (a) WQ + aging; (b) AC + aging; (c) FC + aging; (d) Secondary α -platelets

As shown in Fig. 4, the microstructure of the aged samples was found to be dependent strongly on solution treatment condition. The morphologies of α and β phases relatively did not change after aging process compared with the solution-treated one. However, there was a change in grain size as well as volume fraction of primary α -phase, residual β -phase and precipitates of secondary

α -phase in all conditions of cooling rates due to aging. Microstructure of WQ + aging gave 31% average volume fraction of primary equiaxed α -phase (Fig. 4(a)). And AC + aging and FC + aging obtained 48% and 64% in Figs. 4(b) and (c), respectively. It was noticed that aging process in the case of FC had no obvious influence on volume fraction of primary α -phase where it decreased from 68% to 64%. The same influence was noticed for AC samples where volume fraction of primary α -phase decreased from 51% to 48%. However, for WQ condition, there was a noticeable decrease in α -phase in which it decreased from 56% to 31%. Due to high cooling rate of WQ condition, β -stabilizing elements in the residual β -phase could not reach a stable condition. Hence, by applying the aging process at low temperature (575 °C) for a long time (4 h) these elements reached the stable condition which led to a reduction obviously in the volume fraction of the primary α -phase. And therefore, there was an increase in the volume fraction of the residual β -phase [19]. On the other hand, fine secondary platelets precipitated in all conditions of the aged samples (Fig. 4(d)). The

secondary α -platelets precipitated in the residual β -phase either in the case of solution-treated samples with AC condition or in all aged conditions. Figure 4(d) is an example showing the secondary α -platelets existing in all cooling conditions of WQ, AC and FC. These results partially agreed with the research carried out by SHI et al [1]; however, there was variation in the heat treatment cycles.

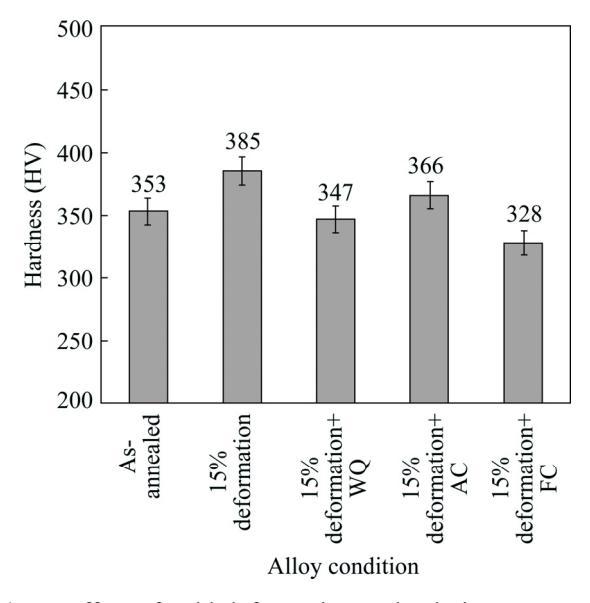
Fig. 5 Effect of cold deformation and solution treatment with different cooling rates on hardness of annealed TC21 alloy

Figure 5 shows hardness variation of the samples cold-deformed and solution-treated with different cooling rates. Due to 15% cold deformation, the hardness increased from HV 353 to HV 385. This means that there is an increase of about 9% in hardness as a result of strain hardening and strengthening mechanisms due to applying 15% cold deformation [20]. EBIED et al [20] observed that hardness of Ti alloys was significantly affected by cold deformation.

After solution treatment, the hardness values of the samples decreased compared with those of the cold deformed sample. FC samples showed the lowest hardness value of HV 328. This could be due to existence of high amount of primary α -phase (68%). While, WQ samples obtained a high hardness of HV 347 compared with FC samples due to the presence of a low amount of primary α -phase (56%) compared with the later one. Moreover, AC samples revealed the highest hardness of HV 366 compared with the other cooling rates due to precipitation of secondary α -phase in residual β -phase. These results partially agreed with the results of NIEH et al [21] with variation in the chemical composition and heat treatment cycles.

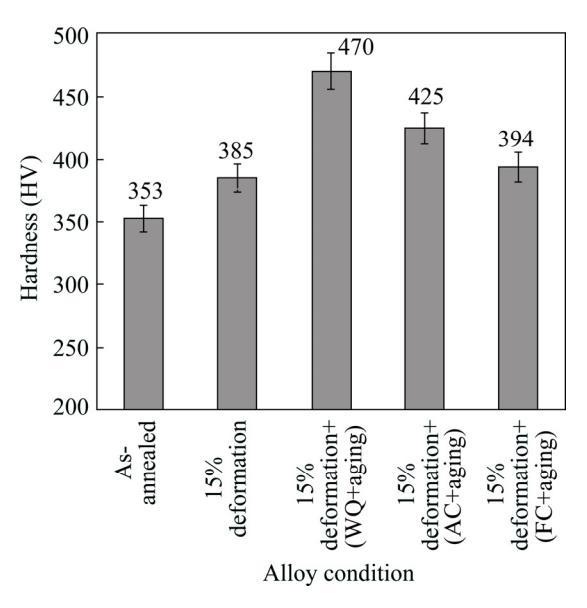
Fig. 6 Effect of aging process on hardness of annealed TC21 alloy

Figure 6 shows the hardness variation of the aged samples. Of course, hardness is affected by aging process due to precipitation of secondary α -platelets in the residual β -phase. FC + aging and AC + aging samples showed hardness values of HV 394 and HV 425, respectively. WQ + aging sample obtained the highest hardness value of HV 470 due to the presence of high amount of residual β -matrix (69%) as well as existence of low amount of primary α -phase compared with the others. This means that there are an increase in hardness values of about 33% compared with the annealed sample and an increase in hardness values of about 22% compared with the deformed one. It was also observed that the three different cooling rates after solution treatment have relatively small effect on hardness. However, the variation in the hardness due to aging process was pronounced. For example, there is an increase in hardness of about 35% in the case of WQ + aging compared with solution-treated samples with WQ due to existence of high amount of the residual β -phase on the account of primary a-phase. Also, the hardness increased by about 20% and 16% in the case of FC + aging and AC + aging compared with solution-

treated samples with FC and AC, respectively. The variation in the hardness of WQ sample was more obvious than that of FC and AC ones. This is because WQ sample contained high volume fraction of secondary α -platelets and residual β -phase. In contrast, the presence of a relatively small amount of residual β -phase and high amount of primary α -phase in FC and AC conditions caused a slight increase in hardness after aging process. Based on hardness results, it can be expected that WQ+aging sample showed better tribological behavior than the others.

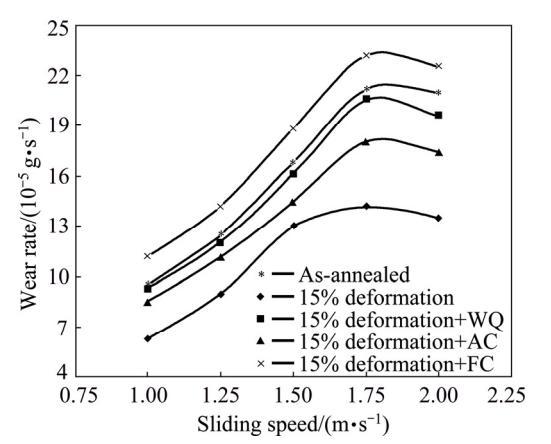
Fig. 7 Wear rate of cold-deformed and solution-treated TC21 alloy as function of sliding speed

The correlation between wear rate and sliding speed from 1 to 2 m/s with a step of 0.25 m/s for different samples is presented in Figs. 7 and 8. Figure 7 shows the wear rate of solution-treated samples after 15% cold deformation and Fig. 8 reveals the wear rate of solution-treated plus aged samples after 15% cold deformation. In both figures, the wear rate increased with increasing sliding speed up to 1.75 m/s and then decreased again at 2 m/s. Since the wear rate was directly proportional to the real area of contact, the aged samples showed lower wear rate than the solution-treated ones. This is attributed to the precipitated secondary α -platelets inside the β -rubs. For the group of solution-treated samples in Fig. 7, the minimum wear rate was obtained for the deformed samples without treatment. This was due to its high hardness value of HV 385 compared with the others. This means that the wear rate of the studied samples could be controlled by their hardness, i.e. by microstructural constituents (α_p , α_s and β). In addition, the fine structure of β -phase obtained directly after 15% deformation played an important role in increasing hardness of the deformed samples and then improving the wear property. On the other hand, FC samples gave the highest wear rate due to their low hardness value of HV 328. Of course, the formed secondary α -platelets in the case of AC condition enhanced the wear behavior and made it in the second rank compared with the others (Fig. 7). According to the Archard theory, there was a good correlation between hardness and wear property of the investigated TC21 alloy.

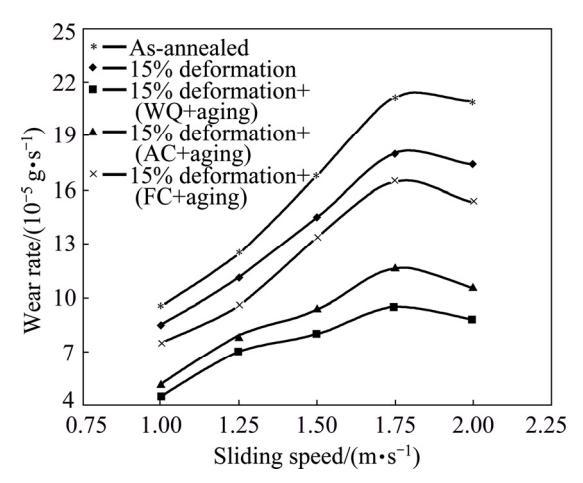
Fig. 8 Wear rate of cold-deformed and aged TC21 alloy as function of sliding speed

Regarding to solution-treated plus aged samples in Fig. 8, the scenario of wear behavior of the investigated samples was totally different because all samples contained secondary α -phase in their structures. The minimum wear rate was reported for water-quenched and aged samples due to the high hardness (HV 470) and the amount of residual β -phase. This may be expected for the aged samples, irrespective of microstructure, where they exhibited higher hardness as compared with the samples without aging. At 1.75 m/s, the enhancement of about 122% in wear property was estimated by applying aging after water quenching $(9.5 \times 10^{-5} \text{ g/s})$ compared with that of the annealed samples $(21.17 \times 10^{-5} \text{ g/s})$. While, the maximum wear rate was obtained for the annealed samples due to their low hardness (HV 353). Regarding to AC samples, there was an enhancement of about 53% by applying the aging process. This was due to the precipitation of secondary α -platelets and also increasing the amount of residual β -phase by aging. Therefore, it could be concluded that aging process after solution treatment could considerably enhance the wear property of TC21 alloy and this enhancement could reach up to about 122% in the case of WC condition compared with the annealed samples. These results partially agreed with the results of ELSHAER et al [9]; however, there was

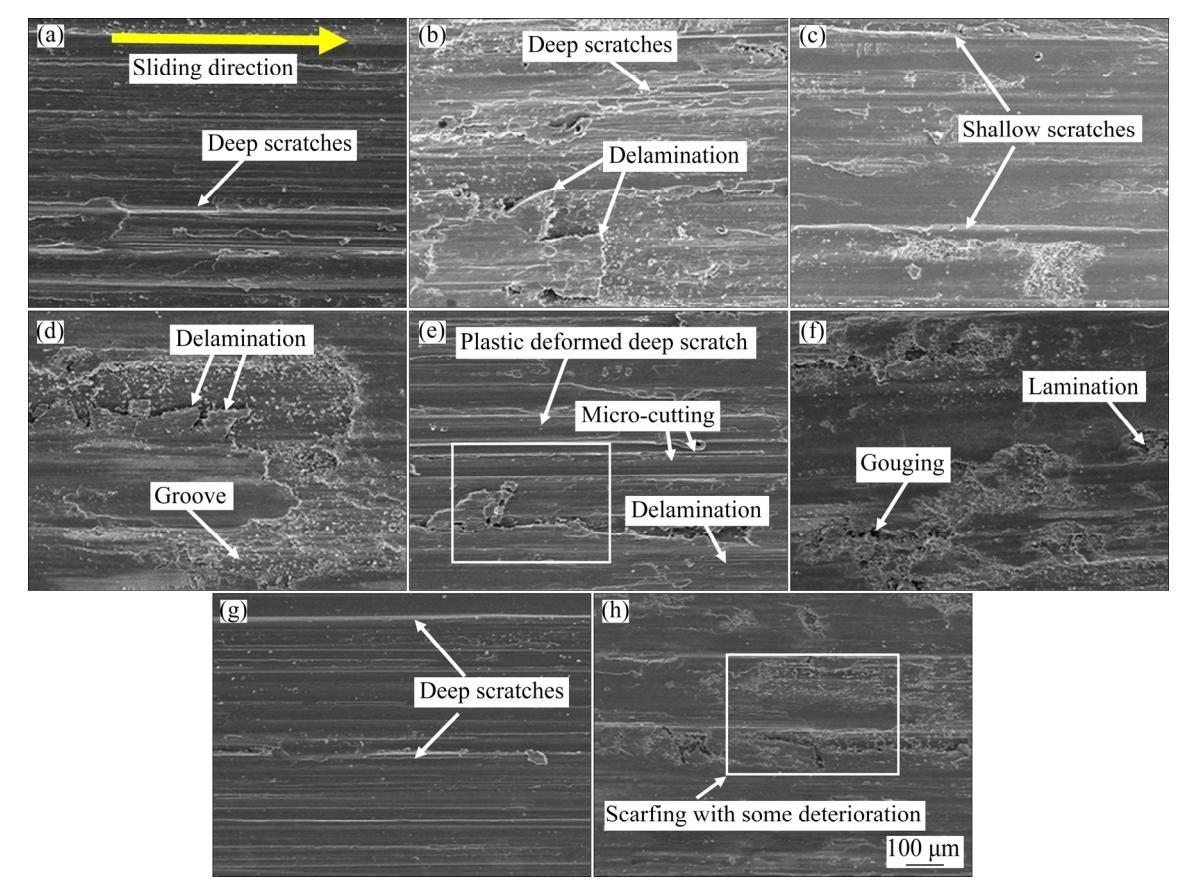
Fig. 9 FESEM images for worn surfaces of some selected samples for both groups of annealed and aged samples (a–d) and solution-treated and deformed samples (e–h): (a) As-annealed, 1 m/s; (b) As-annealed, 1.75 m/s; (c) WQ + aging, 1 m/s; (d) WQ + aging, 1.75 m/s; (e) FC, 1 m/s; (f) FC, 1.75 m/s; (g) As-deformed, 1 m/s; (h) As-deformed, 1.75 m/s

FESEM micrographs shown in Fig. 9 illustrate typical worn surface morphologies of some selected wear samples tested at low and high sliding speeds of 1 and 1.75 m/s, respectively. Some evidences of plastic deformation over the worn surfaces can be seen in most tested samples. The morphological analysis of the wear tracks confirms the above results. Continuous sliding marks with plastically deformed scratches or grooves were seen over the wear tracks specially at low sliding speed of 1 m/s. Extending of plastic deformation or ploughing was found to be higher in the case of high sliding speed of 1.75 m/s.

For solution-treated plus aged group samples, WQ + aging worn surface revealed a flat and smooth worn surface with some shallow scratches at low sliding speed of 1 m/s as shown by the arrows in Fig. 9(c). At high sliding speed of 1.75 m/s the worn surface showed delamination wear mechanism with groove over the worn surface as shown by the arrows in Fig. 9(d). However, annealed samples showed deep scratches over the worn surface at low sliding speed of 1 m/s as shown by the arrow in Fig. 9(a). At 1.75 m/s, the annealed samples revealed delamination wear mechanism with deeper scratches over the worn surface as

shown by the arrows in Fig. 9(b). These worn surface features were confirmed with wear results presented in Fig. 7. For solution-treated sample group, the worn surface of FC samples at low sliding speed of 1 m/s showed multi-wear mechanisms as shown by the arrows and area in Fig. 9(e). These mechanisms are plastic deformed deep scratches, delamination and micro-cutting. This is due to the softening of the wear surface. At a high sliding speed of 1.75 m/s, the FC worn surface showed a gouging wear mechanism with few lamination wear mechanisms as shown by the arrows in Fig. 9(f). For the deformed samples, worn surface showed only deep scratches at 1 m/s as shown by the arrows in Fig. 9(g). And at 1.75 m/s, scarfing wear mechanism can be found with some deterioration on the worn surface as shown by the area in Fig. 9(h). It is obvious here that the presented wear results in Figs. 7 and 8 are totally confirmed with the worn surface features.
