Transactions of Nonferrous Metals Society of China

Trans. Nonferrous Met. Soc. China 31(2021) 156-166

Effect of heat treatment conditions on ballistic behaviour of various zones of friction stir welded magnesium alloy joints

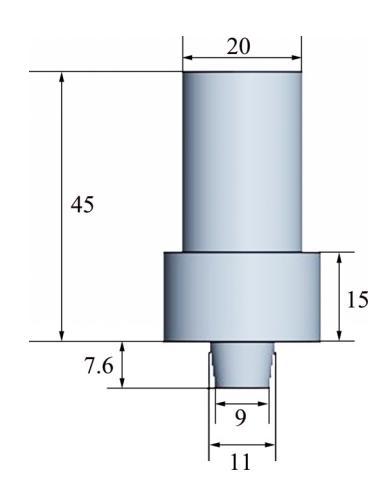
Fig. 1 Dimensions of taper pin FSW tool (Unit: mm)

In order to prepare square butt joints, taper pin tool made of H13 tool steel was used. Taper pin profile has shoulder diameter of 26 mm, pin diameter of 9 mm and length of 7.6 mm. The dimensions of the taper pin FSW tool are shown in Fig. 1.

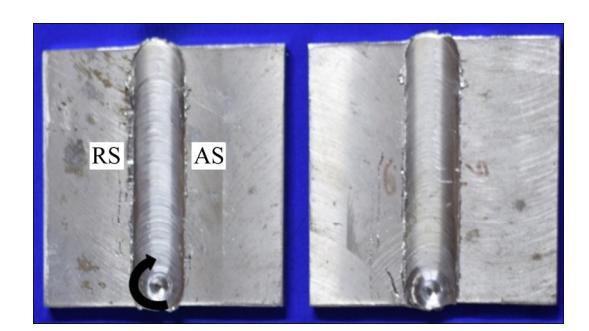
Fig. 2 Defect-free AZ31B friction stir welds

The trial runs indicated that rotation speed (1200 r/min) and welding feed (50 mm/min) are the optimum process parameters to produce defect-free FSW joints. Figure 2 shows the FSW joint obtained

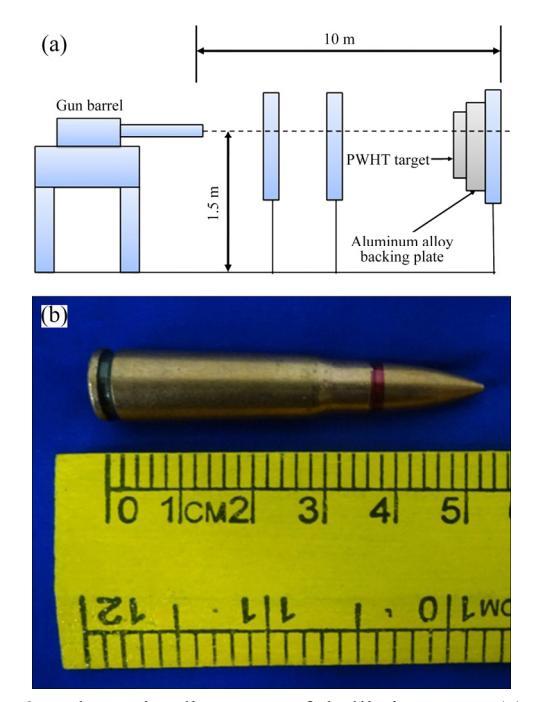
Fig. 3 Schematic diagrams of ballistic setup (a) and 7.62 mm \times 39 mm AP projectile (b)

Ballistic experiments were carried out in three different weld zones such as NZ + thermo mechanically affected zone (TMAZ), HAZ and BMZ. Aluminium alloy 6062 having dimensions of 200 mm \times 200 mm \times 22 mm was used as the backing plate. The Al-6062 backing plate and PWHT Mg alloy as a front plate were firmly clamped together using C-clamps at four edges without any air gap. The mass of the cartridge and the projectile was 18.75 and 7.85 g, respectively. The ballistic experiments were conducted as per MIL-DTL-32333 standard. The PWHT target plates were impacted against 7.62 mm × 39 mm AP projectile at 0° angle of attack with a firing range of 10 m and striking velocity of the projectile was (430±20) m/s. The mass of the gun powder was varied from 1.20 to 1.25 g to obtain the required striking velocity. The schematic diagrams of ballistic setup and the AP projectiles used in the present study are shown in Fig. 3.

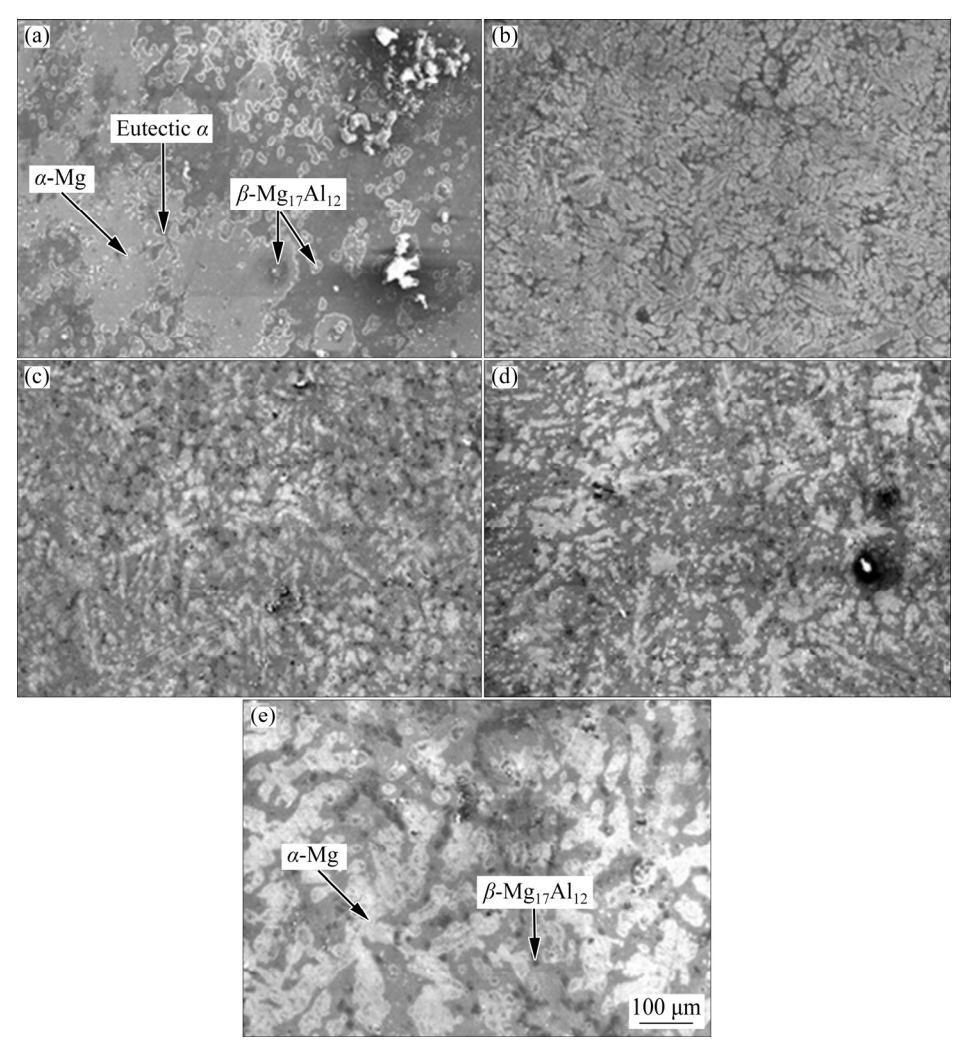
Fig. 4 SEM images of different zones of AZ31B magnesium alloys: (a) Base metal; (b) NZ-FSW; (c) NZ-PWHT; (d) HAZ-PWHT; (e) BMZ-PWHT

Figure 4 shows the SEM images of the AZ31B base metal (BM), non-heat-treated and heat-treated FSW joints. SEM image of BM shows the coarse

and non-homogeneous distribution of β -phase (Fig. 4(a)). The NZ-FSW (Fig. 4(b)) shows considerable changes in microstructure when compared to the BM. NZ-FSW consists of equiaxed grains with a few precipitate particles along the grain boundaries.

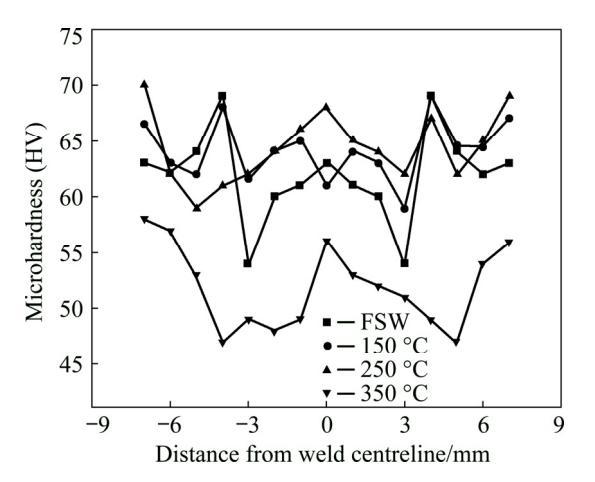
Fig. 5 Microhardness profiles of FSW and PWHT samples at different annealing temperatures

Figure 5 compares the average transverse microhardness of the three different heat-treated joints with that of non-heat treated one.

The microhardness of the HAZ of FSW joint was HV 54, while the microhardness values of the NZ and base metal were about HV 63 and HV 66, respectively. Compared to the base metal, lower

microhardness was observed in the NZ, which is attributed to the dissolution of β -phase. SINGH et al [25] also observed lower microhardness compared to the base metal. The least microhardness value was recorded in the friction stir welded zones, predominantly in the HAZ and TMAZ. However, these zones have undergone thermal softening effect caused by FSW tool. It was also observed that the variation of microhardness of the heat-treated welded joints was significantly influenced by the condition of heat treatment. The average microhardness values of NZ heat-treated welded joints obtained at annealing temperatures of 150, 250 and 350 °C for 1 h were about HV 61, HV 68 and HV 56, respectively.

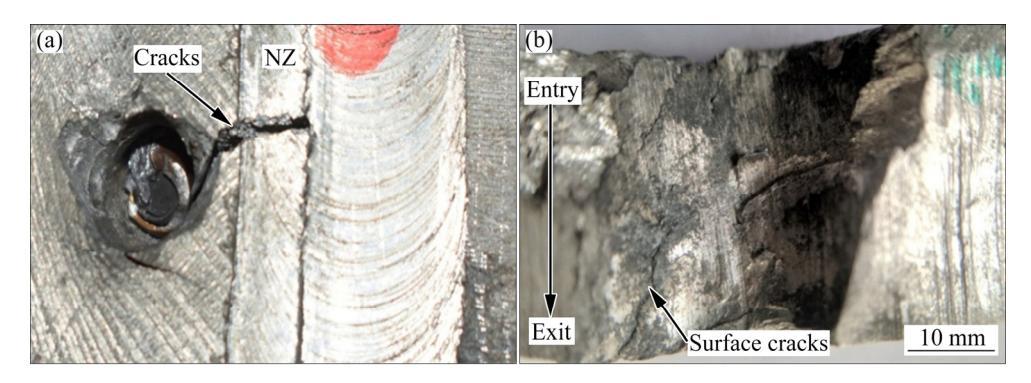
Fig. 6 Damage images of front face and cross-section of NZ-PWHT target plate after ballistic test: (a) Front view; (b) Crater path of projectile

Figures 6(a) and (b) show the front face and cross-section images of the NZ+TMAZ crater region of PWHT targets, respectively.

The projectile impact caused the localized strain around the crater area, which led to the formation of surface crack in the weld region. It was found that the crater width at the entry was higher than that at the exit. Spalling mode failure was noted at the entry of the NZ where the hole diameter was bigger than the actual projectile diameter. It was due to the variation of hardness along the transverse direction. In addition, the ballistic failure mechanism changed from spalling

to plugging mode in the middle. This type of failure was dominated by an induced shear stress during penetration of the projectile. The presence of small surface cracks at the exit of crater clearly indicates that there is loss of ductility.

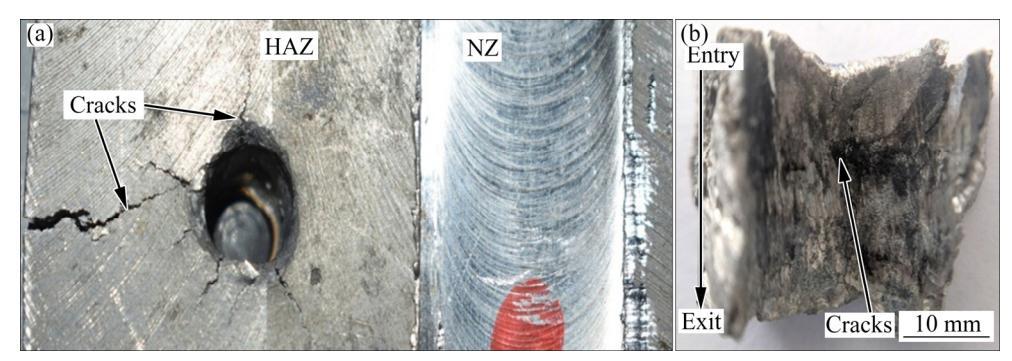
Fig. 7 Damage images of front side and cross-section of HAZ-PWHT target plate after ballistic test: (a) Front view; (b) Crater path of projectile

Figures 7(a) and (b) show the damage images of front face and cross-sections of HAZ target plate. Radial cracks were observed on the front face of the HAZ. The contact of the projectile on the target reduced the strength and developed high compressive stress. The compressive stress waves changed the fracture behaviour from ductile to brittle mode. Hence, it led to the formation of more cracks around the crater region compared to the NZ. Theses cracks did not propagate towards the weld regions because these regions have higher microhardness and finer grains compared to the HAZ.

The plugging failure mode was observed on the crater cross-section of the HAZ. In addition to plugging failure, the ductile deformation was observed by extending the corners of crater at the entry.

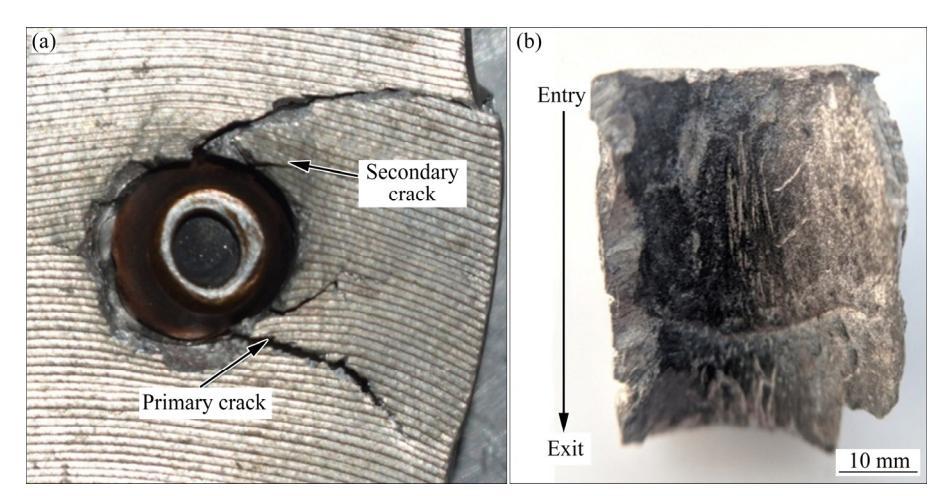
Fig. 8 Damage images of front face and cross-section of BM-PWHT target plate after ballistic test: (a) Front view; (b) Crater path of projectile

Figure 8(a) shows front face image of BM target plate, revealing the presence of primary and secondary cracks. Large continuous cracks are known as primary cracks. The cracks are formed due to the initial stress waves caused during the contact of the projectile with the target.

During the projectile impact into the target, the front steel core tip causes higher compressive stress which may exceed the ultimate compressive strength of the material. These compressive stresses produce localized stress waves that cause the formation of initial cracks. Small cracks around the crater region are considered as secondary cracks. These cracks were formed because of the reflected shock waves from the backing plate. The penetration of the projectile in the BMZ was lower than that of NZ and HAZ for the same thickness. However, the front face image clearly indicated that the projectile did not penetrate more compared to other zones. In the case of NZ and HAZ there was a shift in the projectile path which was noticed on the front face of the targets after ballistic impact. This was due to the variation of hardness along the transverse direction. The projectile path of this region was followed to the least surface hardness. Figure 8(b) shows the carter cross-section of BMZ. In this case, the failure mechanism was dominated by ductile hole expansion without any cracks on the crater wall. The crater width at the exit was less than that at the entry. However, the ballistic failure mechanism did not change from the entry to the exit of the projectile path. This was due to uniform hardness of the BMZ when compared to other zones.

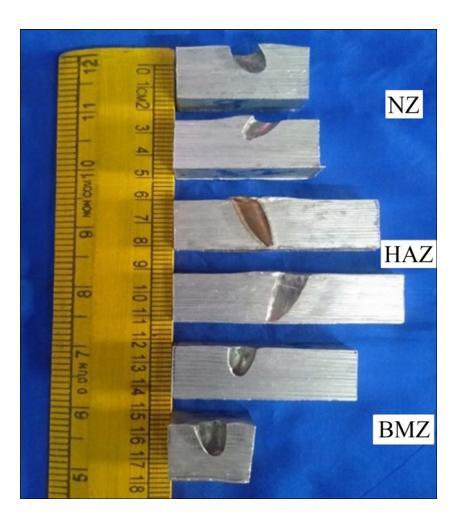
Fig. 9 Penetration channels of Al6062 backing plates after ballistic tests

In the present work, ballistic performance was determined by measuring the DOP of the projectile into the 22 mm thick Al6062 backing plate. After the projectile impact, the backing plate was detached from the target and sectioned using hack saw. The penetration channels of Al6062 backing plates for the corresponding targets are shown in Fig. 9. Ductile hole formation was observed at the penetration channels of the Al6062 backing plates corresponding to different heat-treated weld zones.

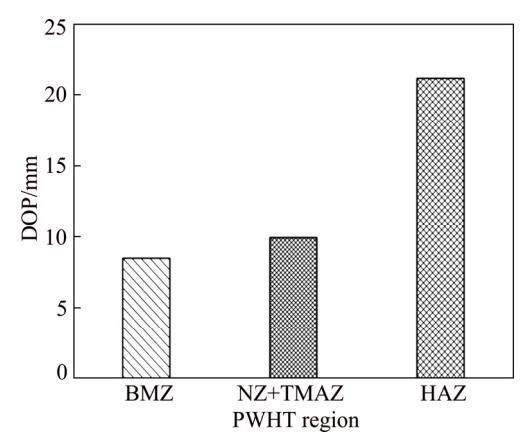
Fig. 10 DOP values of heat-treated weld zones

The average DOP values of different heattreated weld zones are shown in Fig. 10. It can be seen that the measured DOP values for NZ+TMAZ, HAZ and BMZ were 9.91, 21.14 and 8.46 mm, respectively. The BMZ has a slight decrease in DOP value compared to the NZ+TMAZ.

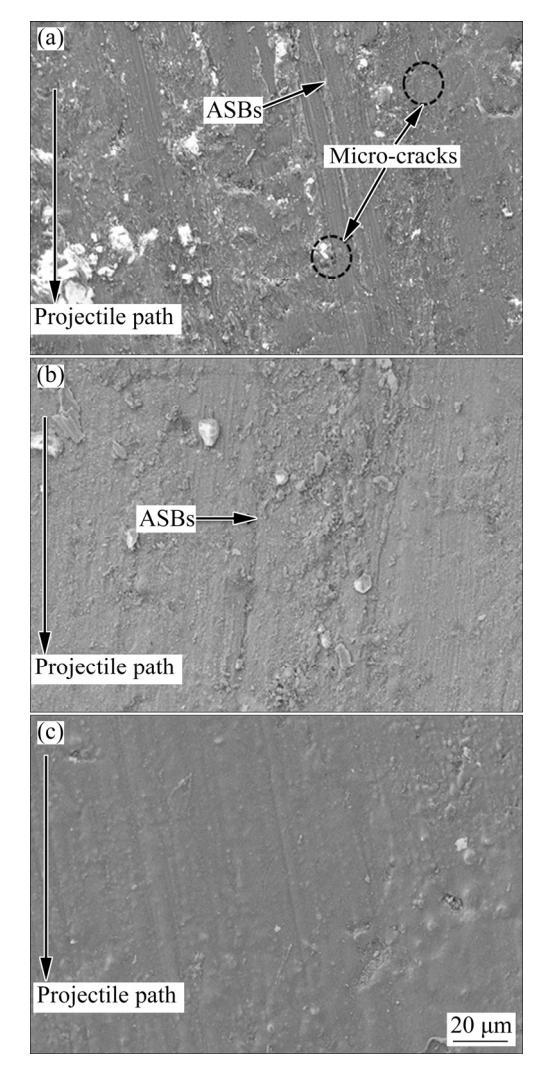
Fig. 11 SEM images of post-impact ballistic NZ-PWHT crater cross-section regions: (a) Entry; (b) Middle; (c) Exit

To investigate the fracture behaviour and failure mechanisms of targets, SEM analysis was carried out in crater region. The fracture surfaces of all three regions showed the creation of adiabatic shear bands (ASBs), especially more ASBs were observed at the entry (Fig. 11(a)). More ASBs caused the formation of cracks which in turn affected the ballistic performance. ASBs induced micro-cracks around the crater cross-section of the entry.

The presence of higher ASBs lines at the entry confirms that the majority of the kinetic energy of the projectile was absorbed in this region compared to other regions which led to the deflection of projectile and restricted the penetration (Figs. 11(b) and (c)). MISHRA et al [15] found that the deflection of projectile at the target lowered the kinetic energy of the projectile, which significantly reduced the ASBs.

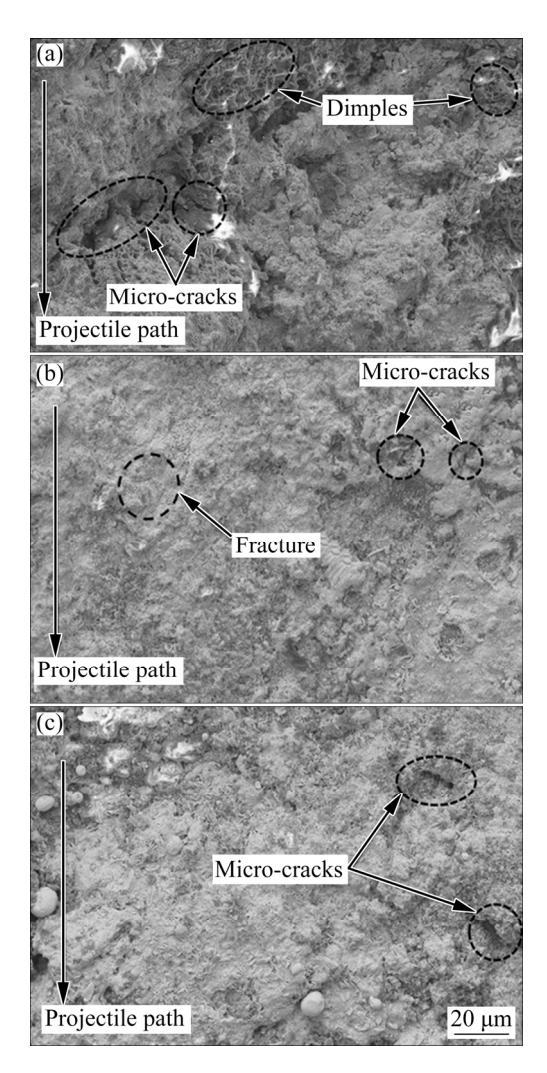
Fig. 12 SEM images of crater cross-section in different regions of HAZ-PWHT: (a) Entry; (b) Middle; (c) Exit

Figure 12 shows the SEM images of crater cross-section in different regions of HAZ-PWHT. The fracture surface of HAZ at the entry showed

the presence of dimples, which indicated the failure mechanism was dominated by ductile hole enlargement and indicative of crack growth, voids and coalescence. It was also noted that all the three regions i.e. entry, middle and exit regions showed the formation of micro-cracks. Thus, one can expect the absence of ASBs and presence of cracks in HAZ when compared to NZ. The formation of cracks was due to the inability of the material to accommodate the radial stresses. The presence of micro-cracks at the entry, middle and exit was the reason for a reduction in ballistic performance. The formation of micro-cracks on the crater surface was due to the local temperature rise; hence, it may cause thermal softening effect and produce tensile stress.

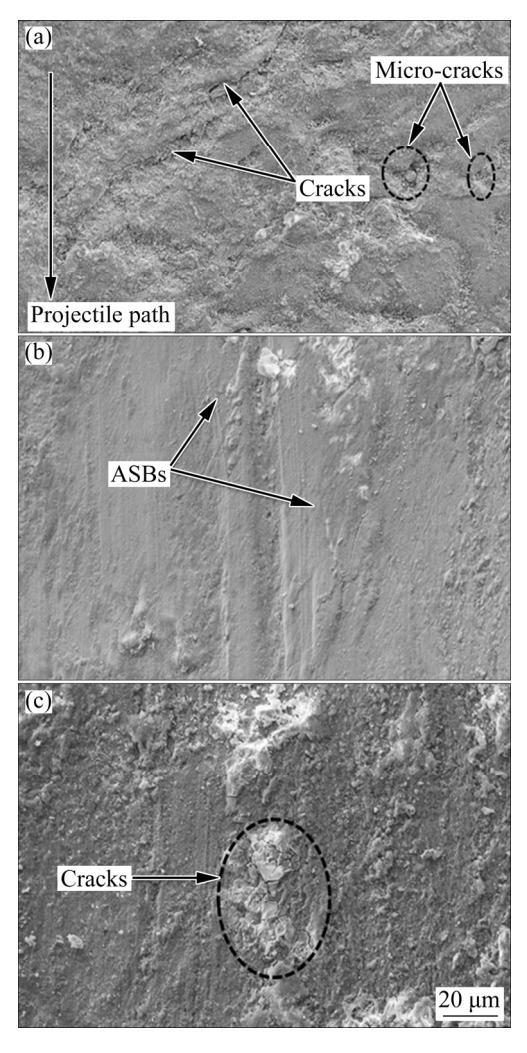
Fig. 13 SEM images of crater cross-section in different regions of BMZ-PWHT: (a) Entry; (b) Middle; (c) Exit

Figure 13 shows the SEM images of crater cross-section in different regions of BMZ-PWHT. The presence of cracks at the entry of crater cross-section indicated that the penetration process was dominated by ASBs. The crater wall surfaces showed the formation of cracks at the entry and exit, and few ASBs at the middle. The presence of the shear bands in the middle of crater surface of the BMZ confirmed that the failure caused stress waves from the circumference of the specimen. The reflected stress waves contributed to the formation of ASB [25]. The contact stress waves on the front face caused crack initiation and crack propagation along the thickness direction, which was indicated in the higher magnification SEM fracture images of the entry. The formation of cracks was due to lack of ability of the target to accommodate the shear strain generated by the projectile and influences of radial and tangential stress [15]. The presence of cracks on the BMZ crater surface was mainly due to the presence of coarse α -Mg and retained spherical Mg17Al12 phase between grain boundaries that led

to the initiation of cracks during the projectile penetration. However, these cracks were not observed in the surface level as discussed earlier. The small discontinuous crack was present at the exit, which indicated that the complete projectile impact energy was not transferred to the backing plate. Hence, it slightly reduced the depth of penetration compared to NZ-PWHT. Even though a larger number of ASBs were noticed in NZ compard to BMZ, its ballistic performance was not significantly inferior to that of the BMZ. From the fracture SEM images of BMZ it was understood that there was a change in fracture mode from ductile to mixed mode. In addition, the hardness of the target significantly influenced the change in ballistic failure mechanism [9,26].
