TC18 钛合金耳片的断口形貌及疲劳性能

摘 要:对TC18 钛合金直耳片的疲劳性能进行研究,测试在不同处理状态及平均应力水平下耳片的疲劳 S_{max}—N 曲线,并利用扫描电镜(SEM)对疲劳试样断口的典型裂纹源形貌和裂纹扩展形貌进行观察分析。结果表明:热处理状态和平均应力对耳片疲劳寿命有较大影响;在相同的平均应力下,机械加工后退火处理的试样具有较高的疲劳寿命;在相同退火处理状态下,平均应力水平高,疲劳寿命长;疲劳裂纹主要在夹杂物、材料表面缺陷及次表面内部缺陷等处形成;在裂纹扩展区,对试样加载的应力水平越高,裂纹扩展速率也越大。
 关键词:TC18 钛合金;疲劳性能;断口形貌;疲劳源;疲劳裂纹扩展区
 中图分类号:TG 113 文献标志码:A

Fractograph and fatigue behavior of TC18 titanium alloy lugs

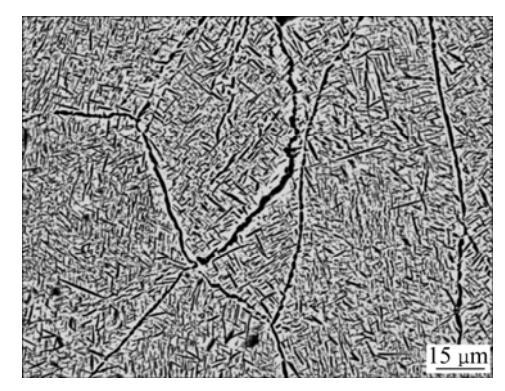
图1 TC18 钛合金显微组织

本实验用TC18钛合金为进行双重退火的模锻件, 其显微组织为近似的网篮组织,如图1所示。采用线 切割工艺从合金锻坯上切取耳片的机械加工毛坯试 样。去应力退火热处理制度采用GJB3763。对全部机 加工试样表面进行荧光检验,按照HB/Z61—1998标 准进行。拉-拉疲劳试验按照HB5287—1996标准进 行。表1列出了疲劳试验所采用试样的状态及疲劳试 验的应力水平。疲劳试验采用PLG-GZ100C高频疲劳 试验机。对不同条件下的耳片进行疲劳试验,获得 *S*max—曲线。采用JSM-5800扫描电镜对断口形貌进行 观察。采用JXA-8100电子探针对试样的显微组织进 行观察。疲劳试验耳片尺寸示意图如图2所示。

Fig.1 Microstructure of TC18 titanium alloy

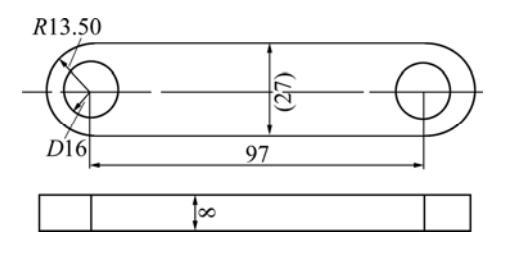
Fig.2 Size diagram of fatigue test lugs (mm)

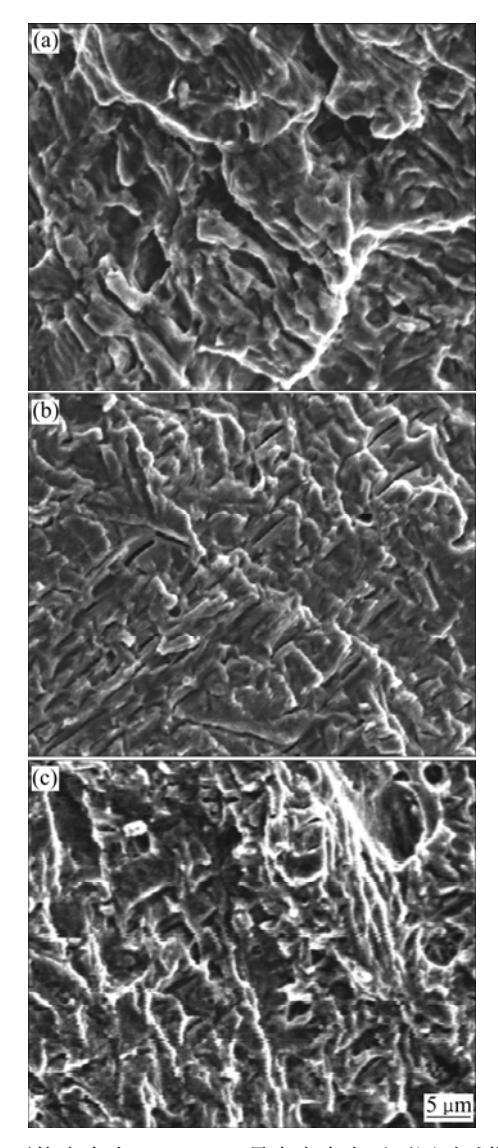
图 5 平均应力为 378 MPa、最大应力水平不同时试样断口的典型扩展区形貌

对加载平均应力为 378 MPa 并进行去应力退火后 试样断口的裂纹扩展区形貌进行观察。所有试样在该 区域内均可观察到疲劳裂纹的存在。典型扩展区形貌 及显微组织如图 5 所示。

Fig.5 Typical fatigue crack propagation appearance of sample annealed at different stress ($\overline{\sigma} = 378$ MPa): (a) $S_{\text{max}} = 510$ MPa; (b) $S_{\text{max}} = 430$ MPa; (c) $S_{\text{max}} = 410$ MPa

对平均应力水平相同,最大应力水平不同的试样 断口扩展区形貌进行观察。一般情况下,恒幅疲劳应 力循环与疲劳条带并非一一对应,往往是几个疲劳循 环才形成一个微观可见的疲劳条带^[19]。由于疲劳裂纹 和交变应力有近似对应的关系,而且疲劳裂纹扩展越 长、裂纹尖端应力强度因子越大,则疲劳裂纹间距越 宽^[20]。由图 5(a)~(c)可知,对应的疲劳裂纹宽度依次 为 2.0、1.5、1.3 µm。加载的应力水平越高,裂纹扩 展速率也越大^[15]。

3) 加载的应力水平越高,裂纹扩展速率也越大。
