Trans. Nonferrous Met. Soc. China 33(2023) 2672–2686

# Effect of coating thickness on interfacial adhesion and mechanical properties of Cr-coated zircaloy

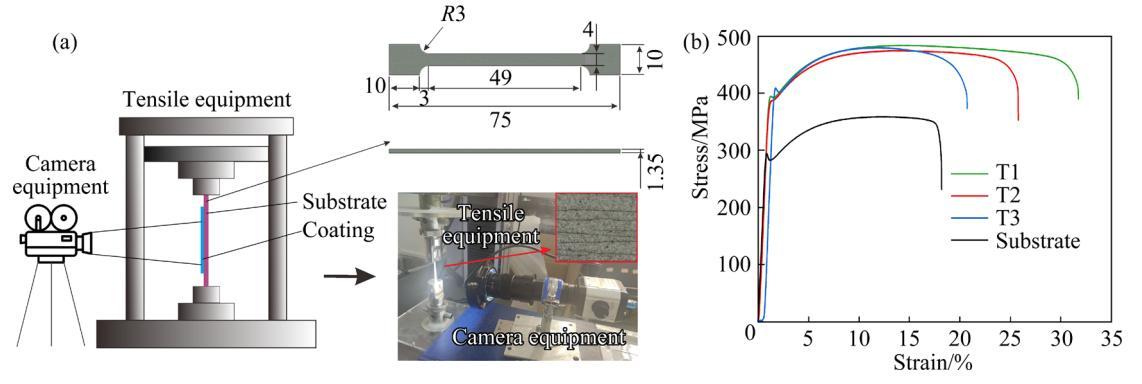
**Fig. 1** Experimental equipment and sample size (a) (unit: mm) and stress-strain curves of Samples T1–T3 (with thicknesses of 15, 20 and 25  $\mu$ m, respectively) and substrate (b)

The experimental equipment and sample size are shown in Fig. 1(a). The measurement range of the device was 0-10 kN, and the experiment was performed at a constant speed of 0.05 mm/min under controlled displacement (measured by the microcomputer electronic mechanics tester, ETM104B). A high-magnification optical microscope was equipped for the real-time observation (Cpt-200x, China), and magnification of 200 was used by considering the field of view, clarity, and stability of microscope. The strain of the first crack was determined through repeated three tests, and the scanning electron microscopy (SEM, Apreo 2C, USA) was employed to assist the checking of the strains. The sample was cut from the middle along the loading direction and polished to observe the cross-section after the test. The stress–strain curves of the samples are shown in Fig. 1(b). It can be observed from the figure that the coating significantly enhances the strength and elongation of the zirconium alloy. In addition, the elongation decreases with increasing coating thickness.

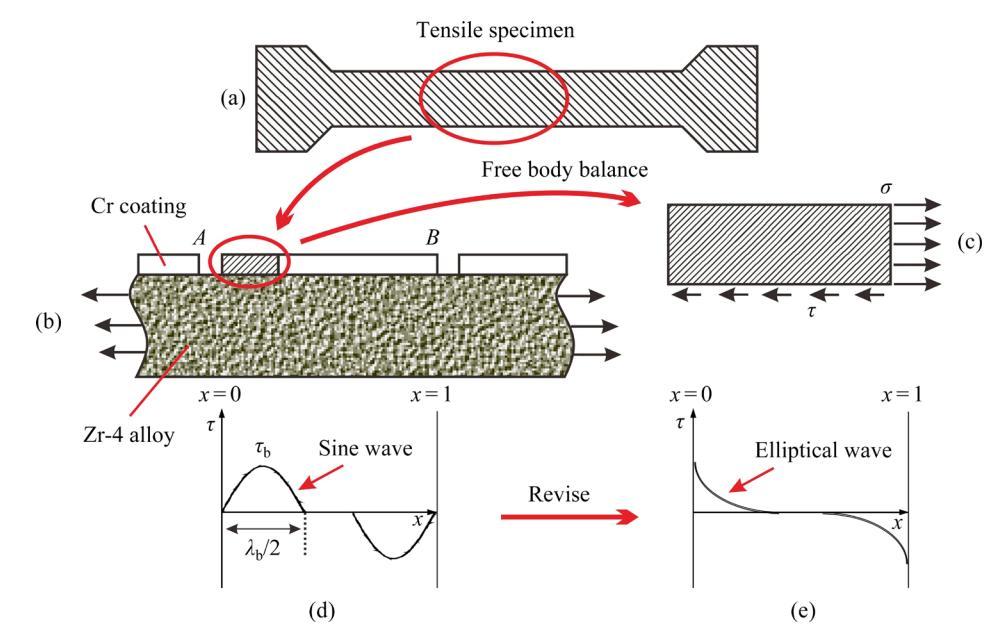
**Fig. 2** Schematic diagram describing shear strength theory of brittle coating and ductile substrate ( $\tau$  is the shear stress, x is distance from Point A,  $\tau_b$  is maximum value of shear stress,  $\lambda_b$  is sine curve wavelength): (a) Tensile specimen; (b) Cross-section diagram of red circle part of specimen; (c) Free body balance; (d, e) Two different distribution forms of shear stress

experiment (Fig. 2(a)). A thin Cr coating was deposited onto a relatively thick substrate, and uniaxial tensile deformation was applied to the sample (Fig. 2(b)). The substrate was deformed by plastic deformation, while the coating was deformed by elastic deformation. The coating was destroyed, and parallel transverse cracks were generated with increasing strain. The relationship between the tensile strength  $\sigma_b$  and the fracture strain  $\varepsilon_f$  of the coating is shown as follows [23]:

As shown in Fig. 2, the distance between the adjacent cracks A and B is L. The deformation of the substrate increased the shear stress at the interface, which was transferred to the coating during the stretching process. AB part was applied to the free body balance condition. Thus, the accumulation of shear stress acting on AB part should be zero when AB part was in a static state at a certain moment. Therefore, the shear stress of the AB part should be antisymmetric, as shown in Fig. 2(d). AGRAWAL and RAJ [23] assumed that the distribution of the shear stress ( $\tau(x)$ ) was in a sinusoidal form as follows:

Then, a part between A and B (the red circled part in Fig. 2(b)) was selected, and this part was also applied to the free body balance condition, as shown in Fig. 2(c). In this free body, the in-plane stress and the shear stress balanced each other. Assuming that the length of this part is x, the inplane stress is a function of distance x [23], that is

According to Eq. (3) and the distribution of the shear stress (Fig. 2(d)), the maximum in-plane

Then, through finite element analysis, CHEN et al [26] found that the shear stress at the interface between the coating and the substrate was distributed in an approximate elliptical form (Fig. 2(e)), rather than the assumed sinusoidal form. The formula is as follows:

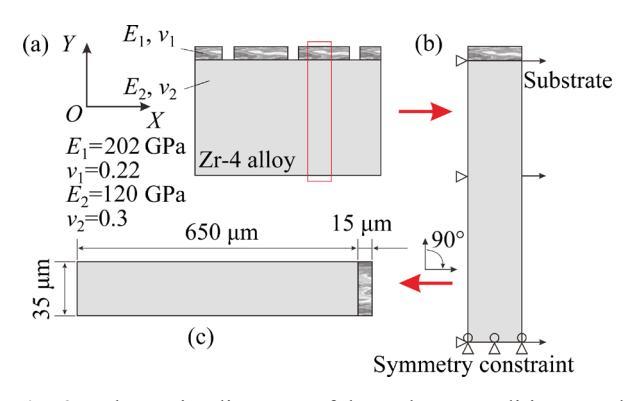
Fig. 3 Schematic diagram of boundary conditions and geometric dimensions of finite element model

In Section 2.2, various distributions of the interface shear stress that led to different equations for calculating shear stress were introduced. Therefore, the finite element analysis was used to determine the distribution of the shear stress at the interface between the Zr alloy and the Cr coating before the calculation (Fig. 3).

needed to be considered and studied (Fig. 3(a)). The thickness of the substrate was regarded as infinite compared to the thickness of the coating, thus, only half of the substrate was modeled, as shown in Fig. 3(b). Symmetry constraints about the X axis were set at the bottom of the model, and displacement constraints on the X axis were set on the left side of the substrate. The coating was a free body which was not constrained based on the actual situation. Then, 7% tensile strain was applied to the right side of the substrate. As is shown in Fig. 3(c), the thicknesses of the coating and the substrate were 15 and 650 µm, respectively, and the length of the model was 35 µm. As an elastic material, the Young's modulus and the Poisson's ratio of the Cr coating are 202 GPa and 0.22, respectively. The substrate was defined as an elastoplastic material with Young's modulus of 120 GPa and Poisson's ratio of 0.3. The plasticity data of the substrate were determined from the tensile experiment. Young's modulus was determined from the measurement of nanoindentation, and Poisson's ratio was obtained from Ref. [27]. The simulation was conducted using ABAQUS. The distribution of the interface shear stress was antisymmetric with respect to Y axis, so only half of the length needed to be analyzed.

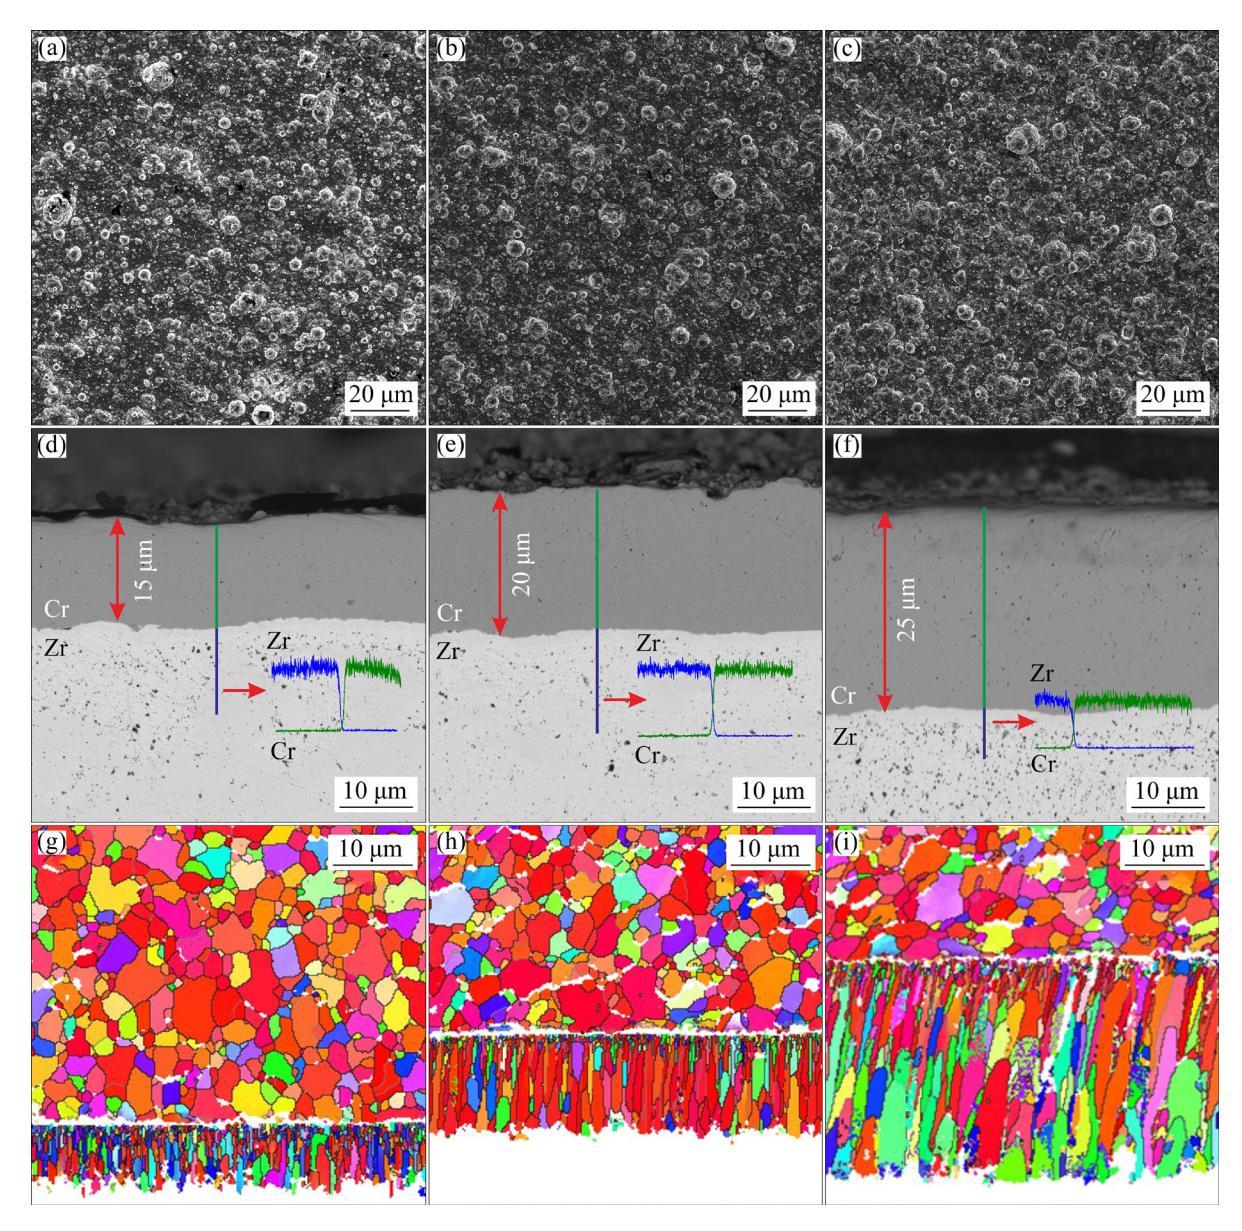
**Fig. 4** Surface (a–c), cross-section (d–f) morphologies, and EBDS images (g–i) of three samples: (a, d, g) T1; (b, e, h) T2; (c, f, i) T3

Figure 4 shows the scanning electron micrographs of three coatings with various thicknesses. The morphologies of the surface (Figs. 4(a-c)) showed many spherical particles on the surface of the coating, which were the droplet particles formed by the multi-arc ion plating process [28]. The cross-section morphologies in Figs. 4(d–f) showed that the thicknesses of the coatings were 15, 20, and 25  $\mu$ m, respectively. The coatings had a dense structure, and the interfaces between the coating and the substrate were clearly visible. The microstructure of the samples was obtained by EBSD (Figs. 4(g–i)). The EBSD images showed the columnar crystals of the Cr coating. The coating grains become larger as the coating thickness increases. The three samples were marked as T1 (15  $\mu$ m), T2 (20  $\mu$ m), and T3 (25  $\mu$ m), respectively.

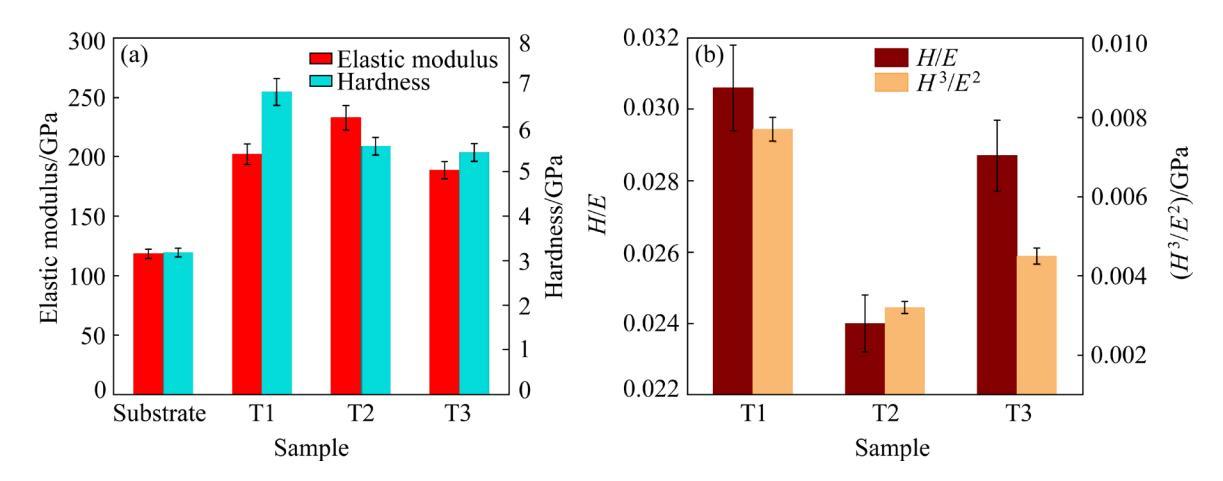
Fig. 5 Elastic modulus and hardness measured by nanoindentation test (a) and H/E and  $H^3/E^2$  value evolution of Cr coatings with respect to thickness (b)

The elastic modulus and the hardness values of the substrate and the Cr-coated samples are shown in Fig. 5(a). The elastic moduli of the substrate, T1, T2, and T3 were (118±3.91), (202.16±8.6), (232.75±10.4), and (188.74±7.2) GPa, respectively, and their corresponding hardness values were (3.18±0.10), (6.79±0.3), (5.57±0.2), and (5.43±0.2) GPa. Figure 5(b) showed the H/E and  $H^3/E^2$  (H is the hardness) ratios. It is well known that the H/E and  $H^3/E^2$  ratios are related to elastic and plastic deformation resistance of the coating [29,30]. The higher H/E ratio indicates a better deformability of the coating. The higher  $H^3/E^2$  ratio indicates the higher resistance to cracks propagation [30,31]. Figure 5(b) shows that the ratios of H/E and  $H^3/E^2$ have a similarly evolutionary tendency with increasing coating thickness. T1 with the 15 µm thickness has the best performance of elastic deformation and resistance to crack initiation and propagation. The H/E and  $H^3/E^2$  of T1 reached 0.0306 and 0.0077 GPa, respectively.

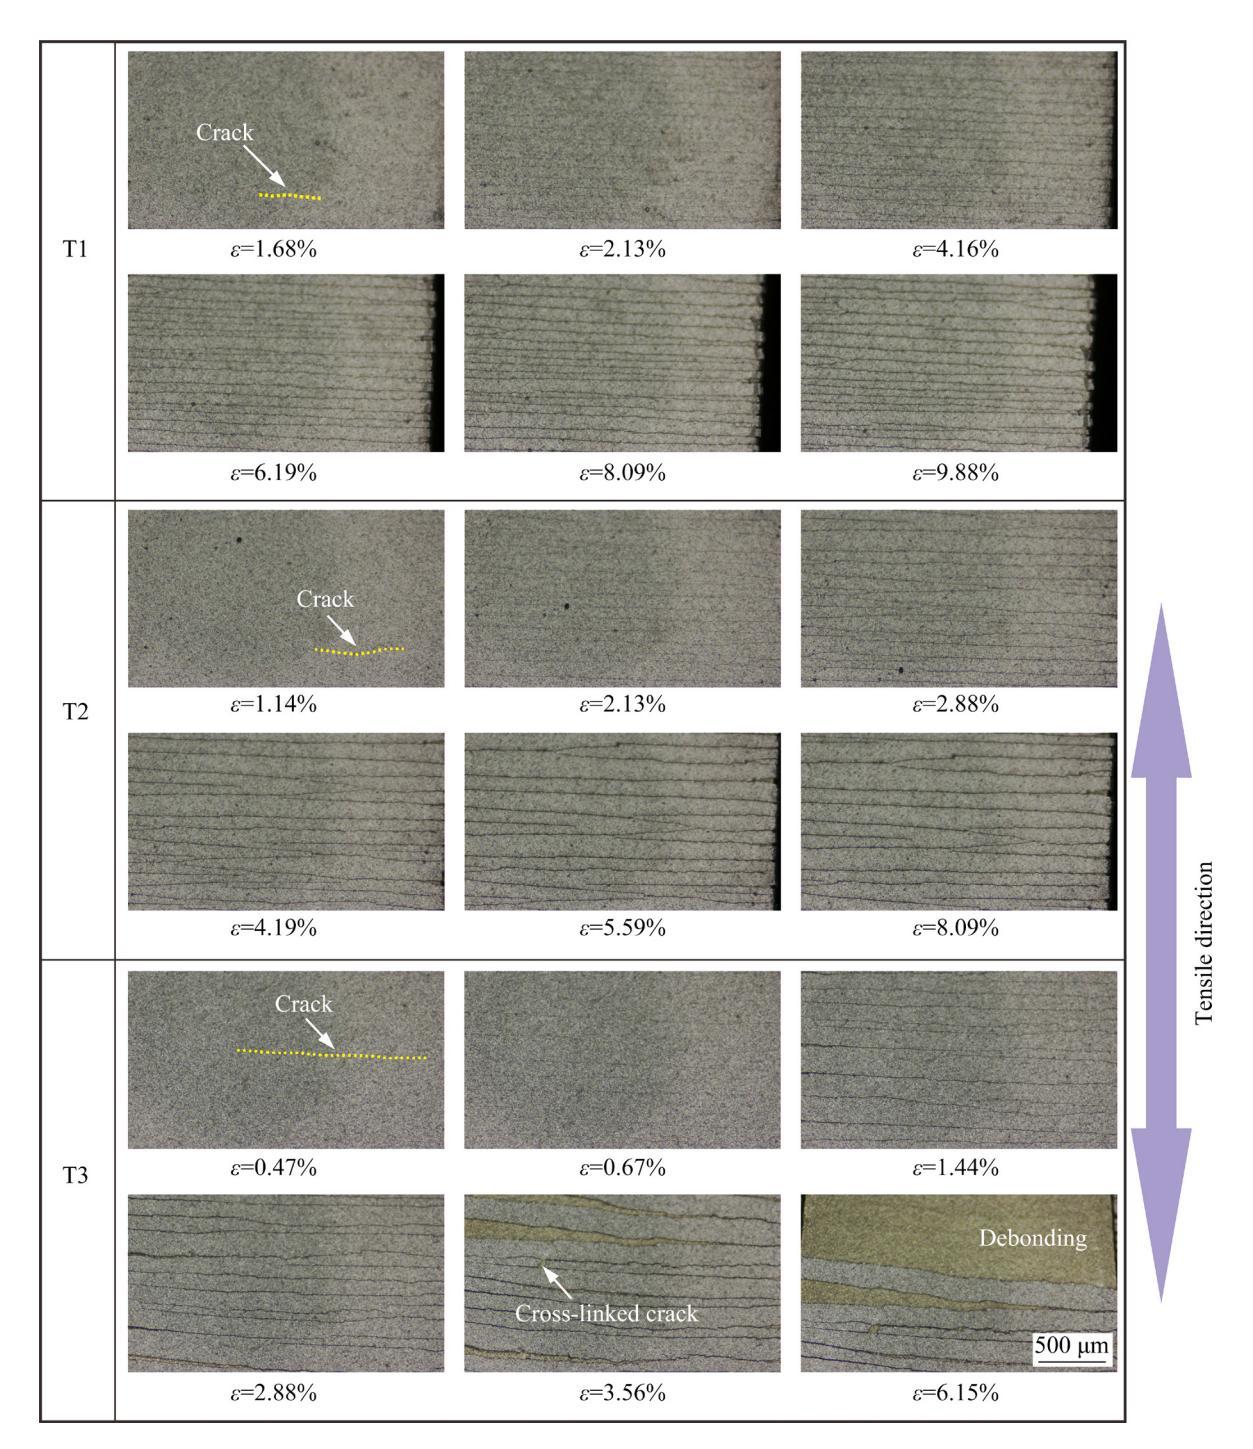
Fig. 6 Evolution of cracks and surface of samples with different thicknesses during tensile failure process by real-time observation

Figure 6 shows the evolution of the cracks on the surface of the samples during the tensile process. The strains of the three cracked T1, T2, and T3 were 1.68%, 1.14%, and 0.47%, respectively. Therefore, the corresponding tensile strengths of the three coatings were 3.40, 2.65, and 0.89 GPa according to Eq. (1). These results indicated that the tensile strength of the coating decreased with the increase of the coating thickness. This phenomenon is due to the fact that the thickness of the Cr coating becomes larger and the grain size also increases as the processing time is prolonged. The small size of the grain improves the

tensile strength [32]. With the increase of  $\varepsilon$ , the new parallel cracks on the surface of the coating quickly appeared, and the crack density increased rapidly. When  $\varepsilon(T1)$  reached 6.19%, the crack tended to become saturated until it broke. The strains were 2.88% and 1.44% respectively when the cracks of T2 and T3 reached saturation. However, the number of cracks decreased under continuous tension. When  $\varepsilon(T3)=3.56\%$ , obvious cross-linked cracks

parallel to the tensile direction were observed, and the coating began to debond when  $\varepsilon$ =6.15%. Cross-linking cracks occurred due to the Poisson effect [33].

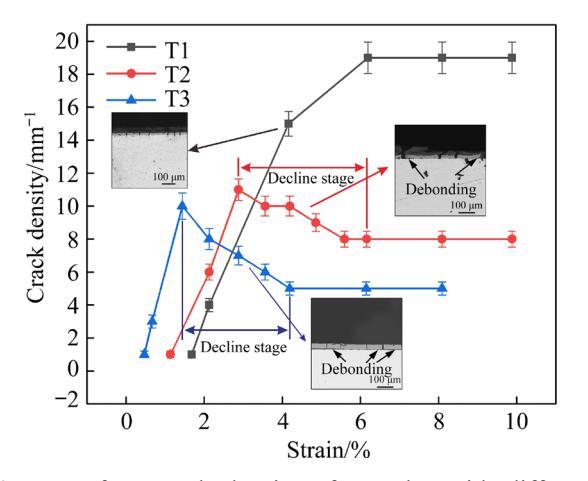
Fig. 7 Surface crack density of samples with different thicknesses under tension

The crack densities of the three samples were evaluated to quantitatively study the surface cracking of the coating under tension. Crack density is defined as the number of cracks per unit length in the tensile direction. The curves of the crack

densities of the three samples obtained from the tensile experiment are shown in Fig. 7. The crack density of T1 increased rapidly before saturation and then remained stable until it was broken. The crack densities of T2 and T3 quickly reached the maximum and then showed a downward trend until saturation. Thus, as shown in previous studies in Refs. [25,27], the thinner the coating was, the greater the crack density was when the coating was saturated. However, the intermediate processes of the crack density were different. The crack density of T2 and T3 decreased dramatically after the strain exceeded a maximum value, and the decrease of T3 was larger than that of T2. These were due to the separation of the interface between T2 and T3, and severer peeling of the coating of T3 (indicated by arrows), resulting in the fact that new cracks become more difficult to form, and the new crack formation rate is lower than the tensile strain rate. The increase of the coating thickness resulted in the change of its adhesion properties. The thicker coating is easy to peel off from the substrate under large strain condition, resulting in the variation of coating mechanical properties. Moreover, the strain in the tensile direction continued to increase, enlarging the crack gap and also resulting in a decrease of the crack density.

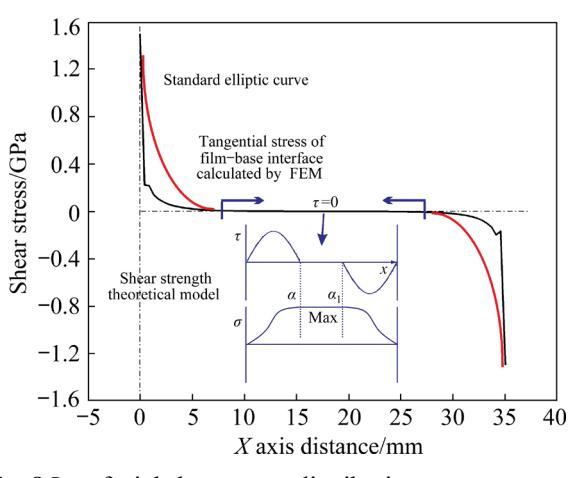
Fig. 8 Interfacial shear stress distribution

Figure 8 shows the distribution of the interface shear stress obtained by the FEM analysis. The small picture at the upper right corner reflects the data obtained by the finite element calculation. The shear stress of the interface is distributed antisymmetrically. Therefore, the data of the other half of the length are completed based on this principle (The black curve at the center of the graph). The red curve is a standard quarter of elliptic curve. The distribution of the interface shear stress between the Zr alloy substrate and the Cr coating is similar to an elliptical curve. This result is consistent with that proposed by YANAKA et al [34] and JEONG and KWON [35]. Part of the interface shear stress was close to zero (blue arrow area), and this part corresponded to the area with the largest in-plane stress in the A-R model. LI et al [30] used FEM to make a model with cracks and found that as the width of crack became smaller, the data were closer to an elliptical curve. Figure 8 shows that Eq. (7) should be considered to calculate the shear stress of the Zr-Cr interface.

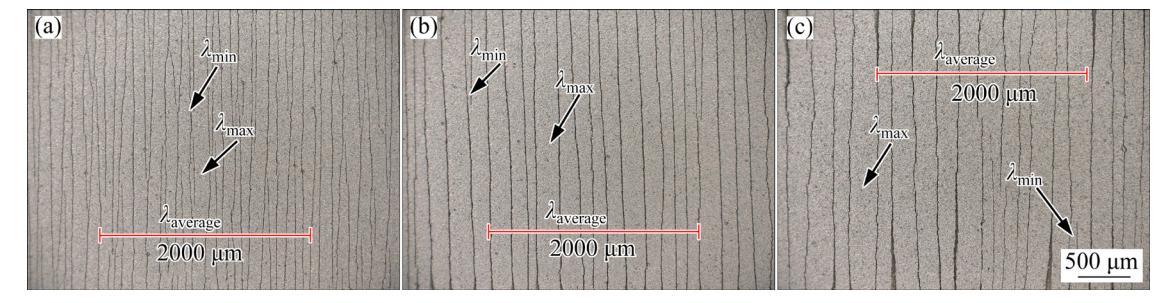
Fig. 9 Surface cracks at tensile saturation stage: (a) T1; (b) T2; (c) T3

Figure 9 shows the cracks on the surface of the sample at the tensile saturation stage. As the coating thickness increased, the crack interval  $\lambda$  increased. A 2000 µm line was drawn in the figure, and the number of the cracks was counted. The average crack interval was determined through dividing 2000 by the corresponding number of the cracks (N), i.e.,  $\lambda_{\text{average}} = 2000/N$  the shear strength of the interface was calculated by Eq. (7). The data and calculation results are listed in Table 1. The average shear strengths of the interfaces of T1, T2, and T3 were 342.50, 193.24, and 68.33 MPa, respectively. As the coating thickness increased, the shear strength of the Zr-Cr interface decreased. The shear strength of the interface indicated the ability of the interface to resist damage. Thus, the thinner the coating was, the stronger the resistance to shear failure was at the interface between the coating and the substrate during the tensile test. In addition, this

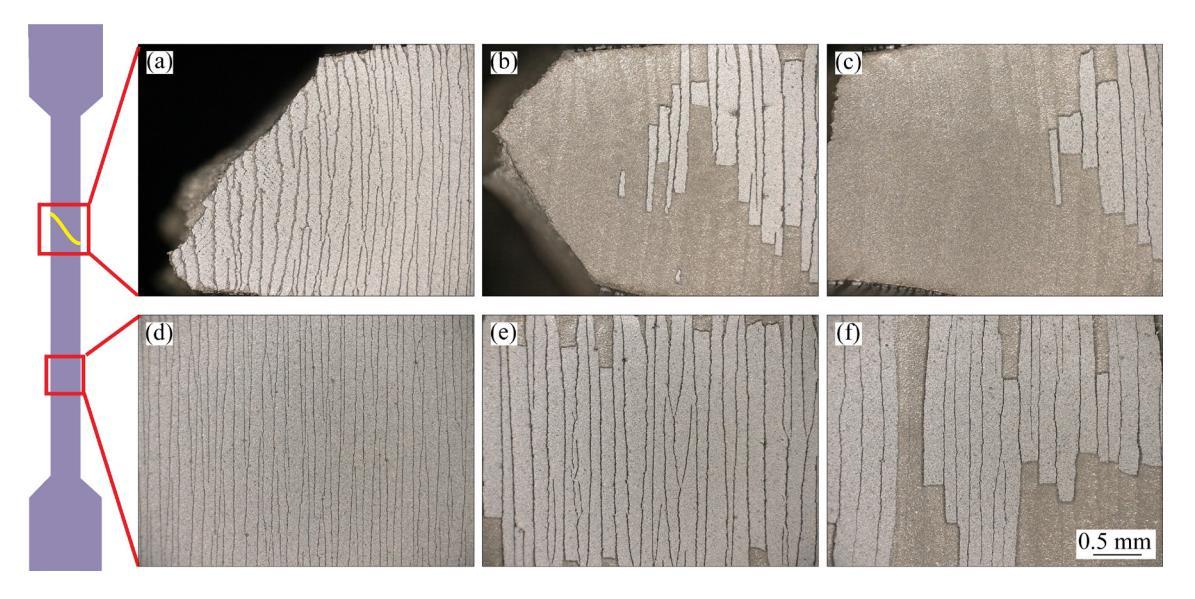
**Fig. 10** Surface morphologies of samples after fracture: (a-c) Fracture of T1, T2 and T3, respectively; (d-f) Non-fracture of T1, T2 and T3, respectively

Figure 10 shows the morphology of the sample surface after tensile fracture. Representative areas in the fracture and nonfracture regions were characterized and analyzed. The fractures of the three samples showed the typical morphology of the tensile strain, which fractured along  $45^{\circ}$  due to the maximum stress in the direction of  $45^{\circ}$ . The coating of T1 adhered tightly to the substrate after breakage,

showing that the coating had good adhesion performance. However, the coatings of T2 and T3 were debonded, and as the thickness of the coating increased, the degree of debonding became severer. Part of the coating debonding indicated that not only the interface between the coating and the substrate became separated, but also the cracks formed parallel to the tensile direction inside the coating, which caused the breakage of the coating. The thicker the coating was, the easier the production of cross-linked cracks was.

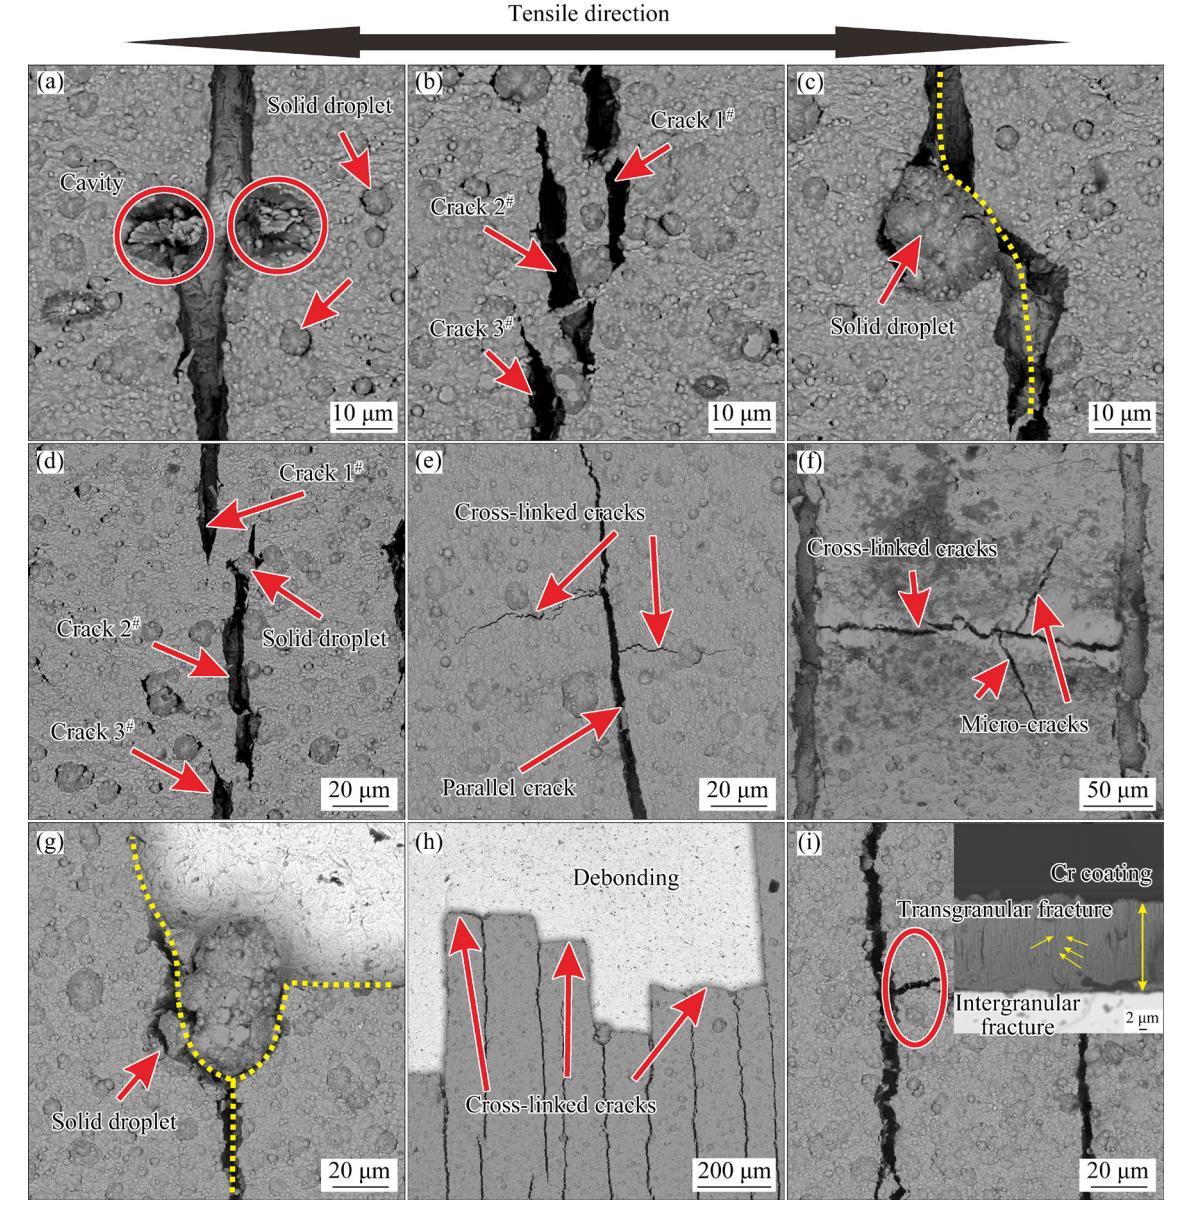
Fig. 11 Surface morphologies of samples with different coating thicknesses after fracture: (a-c) T1; (d-f) T2; (g-i) T3

The surface morphologies of the samples were further analyzed by SEM (Fig. 11). Many spherical particles were found on the surface of the coating,

which were the droplet particles caused by the multi-arc ion plating [28]. These droplet particles were generated by the arc point emission on the Cr target and were usually considered as a technology defect because they would reduce the coating performance [36,37]. Some cavities were observed on the surface of the coating (Fig. 11(a)), and these cavities were caused by the falling of the droplet particles. Larger droplet particles would not fall from the surface and would cause crack deflection (Figs. 11(c) and (g)). The parallel cracks on the surface of the coating were not continuous but were composed of many small cracks as determined after magnified observation (Figs. 11(b) and (d)). Several defects in the coating produced cracks at the same

time during deformation, and each defect began to expand and finally converged to form large parallel cracks. As the thickness of the coating increased, cross-linked cracks gradually appeared on the surface of the coating (Figs. 11(e), (f), (h), and (i)). The cross-linked cracks were formed due to the Poisson effect. The substrate underwent strong plastic deformation during tensile strain, while the deformation of the coating was considerably small, which was incompatible with the deformation of the substrate. Therefore, perpendicular to the tensile direction, the coating underwent a compression effect and was bent due to the deformation incompatibility, resulting in cross-linked cracks parallel to the tensile direction [33]. The crosslinked cracks were more likely to appear when the plastic deformation of the sample was larger. The Poisson effect was also confirmed according to Fig. 10, which showed that more cross-linked cracks appeared near the tensile fracture. Moreover, Figs. 10 and 11 show that the thinner the coating was, the better the bending resistance was. Figure 11(i) displays the cross-section of the cross-linked crack (small picture at the upper right corner). The cross-section of the Cr coating showed intergranular and transgranular fracture.

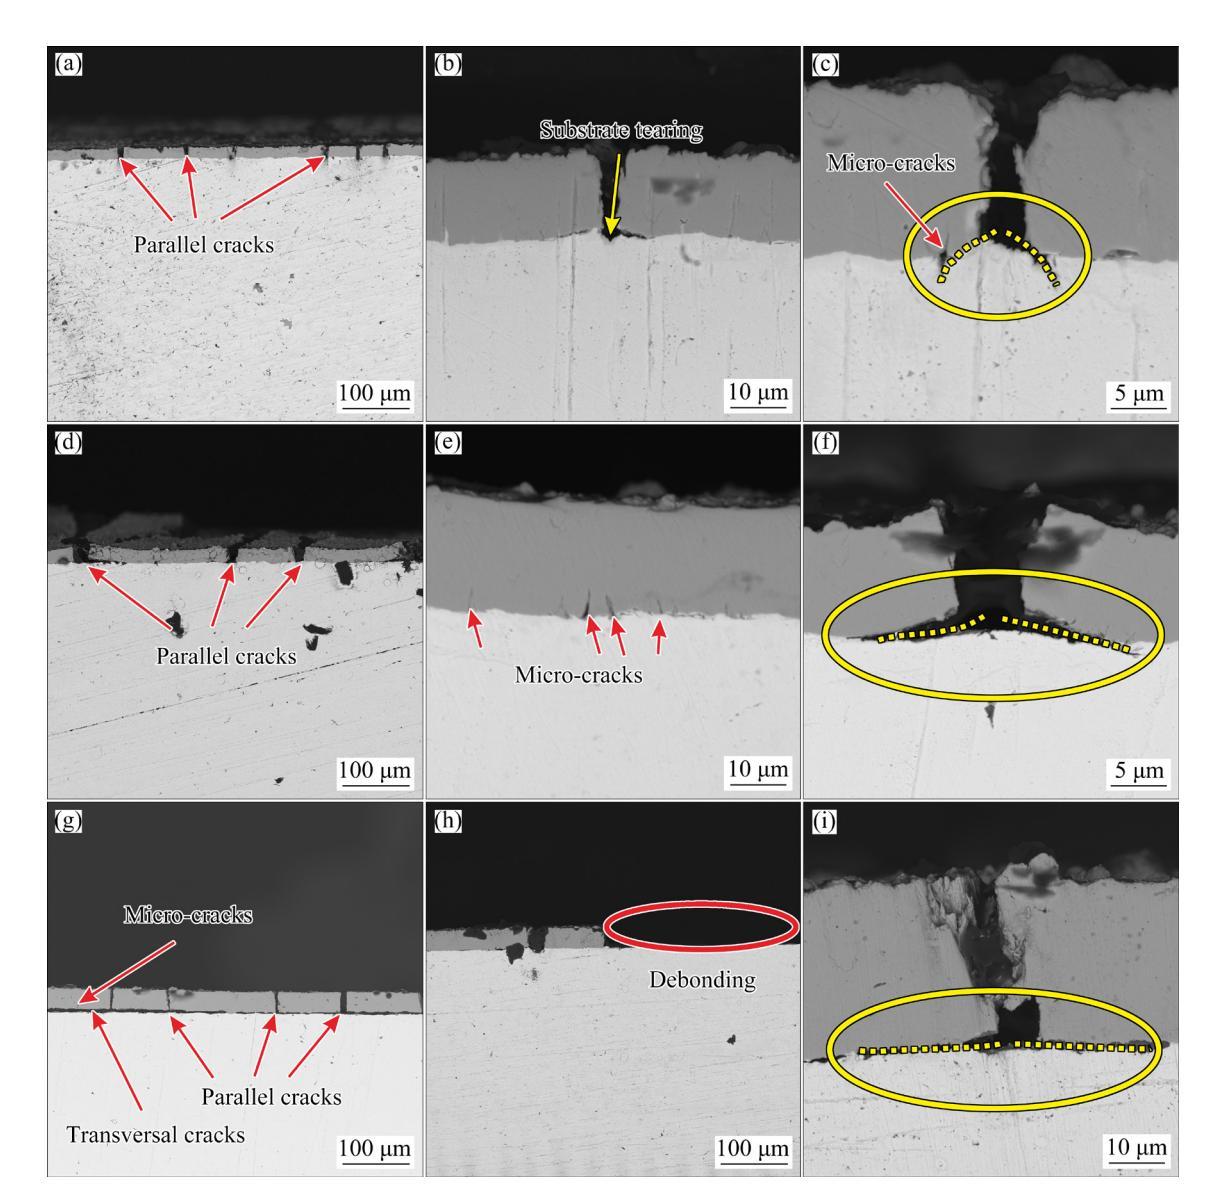
**Fig. 12** Cross-sectional morphologies of samples with different coating thicknesses after fracture: (a–c) T1; (d–f) T2; (g–i) T3

Figure 12 shows cross-sectional morphologies of the fractured samples. Comparison of the cross-sections of the three samples showed that as the coating thickness increased, the interfacial adhesion performance declined. The coating of T1

remained completely adhered to the substrate after tensile fracture, which indicates that the coating has excellent interfacial adhesion properties (Fig. 12(a)). However, the interface of T2 showed a certain degree of damage (Fig. 12(d)), and T3 showed a greater degree of damage (Figs. 12(g) and (h)). These results are consistent with those of the interface shear strength in Section 3.2. The greater the shear strength was, the better the interface damage resistance was, and the less likely the formation of transversal cracks was. Many microcracks were observed at the interface (Figs. 12(c), (e) and (g)), indicating that the cracks initiate at the interface, which is consistent with the results of previous studies [27]. In addition, analyzing the failure behavior of coating is helpful

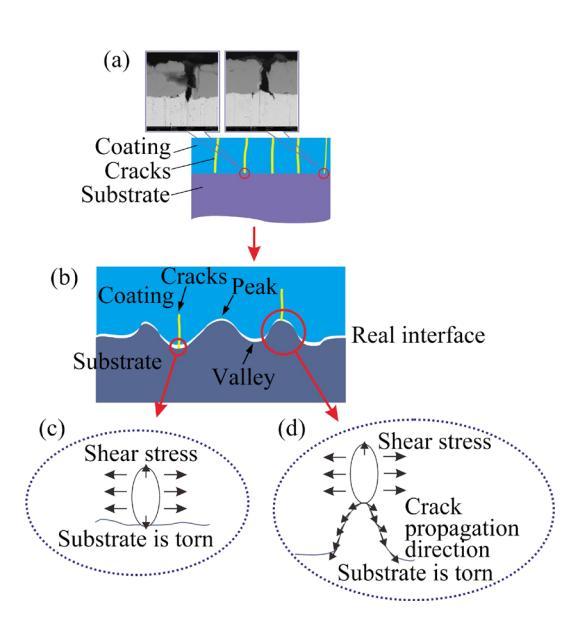
**Fig. 13** Interface failure mechanism of samples with different coating thicknesses

Studies have shown that the fracture mode of the Cr-Zr system is very similar to that of the brittle coating-ductile substrate system [38]. During the tensile process, the shear stress generated at the interface was moved to the coating to form cracks due to strain incompatibility [39]. Therefore, cracks generally start from the interface (Fig. 12(e)). JIANG et al [27] used finite element calculations to prove that the vertical crack tip is a high-stress concentration area; that is, the stress concentration area occurs at the interface, which leads to the plastic failure of the substrate at the interface under large tension. Interestingly, this phenomenon has two different fracture modes (Fig. 13(a)). As the coating thickness increased, this phenomenon gradually disappeared. In response to this interesting phenomenon, we tried to analyze its mechanism, as shown in Fig. 13. Contrary to the theoretical horizontal interface, the real interface was uneven and undulating (Fig. 13(b)), similar to a wave. When the crack appeared in the wave valley, the stress was concentrated in the valley, as shown in Fig. 13(c). When the crack appeared at the wave peak, the crack propagated along the slope to the valley, resulting in an angular deviation of the stress at the interface, as shown in Fig. 13(d). The continuous shear stress at the interface acts as a

driving force to promote the formation of interface cracks [40]. When the stress and the energy release rates reach a critical value, cracks will appear. However, as the coating thickness increases, the interface shear strength decreases, and the interface fracture toughness decreases [22]. These characteristics indicate the ability of the interface to resist damage decrease [41]. Therefore, when the stress is concentrated at the interface and the energy needs to be released, the samples with thicker coatings will be more likely to form interface cracks. This phenomenon shows that the energy released along the interface causes the cracks to expand along the interface. By contrast, the energy of the thinner coated samples at the interface is not easy to be released along the interface. Instead, this energy diffuses into the substrate to cause damage. In addition, as previously mentioned, the cracks propagating to the substrate form different expansion angles because they are in different specific positions. As shown in Fig. 13(c), when the stress concentration was at the valley, the crack vertically expanded into the substrate. When the stress concentration was at the peak of the wave, the crack entered the substrate at a specific angle along the slope (Fig. 13(d)).
